**Installation of up-to-date laminated timber window into a wall with external thermal insulation composite system (ETICS), without shading system, horizontal section S=1:5**

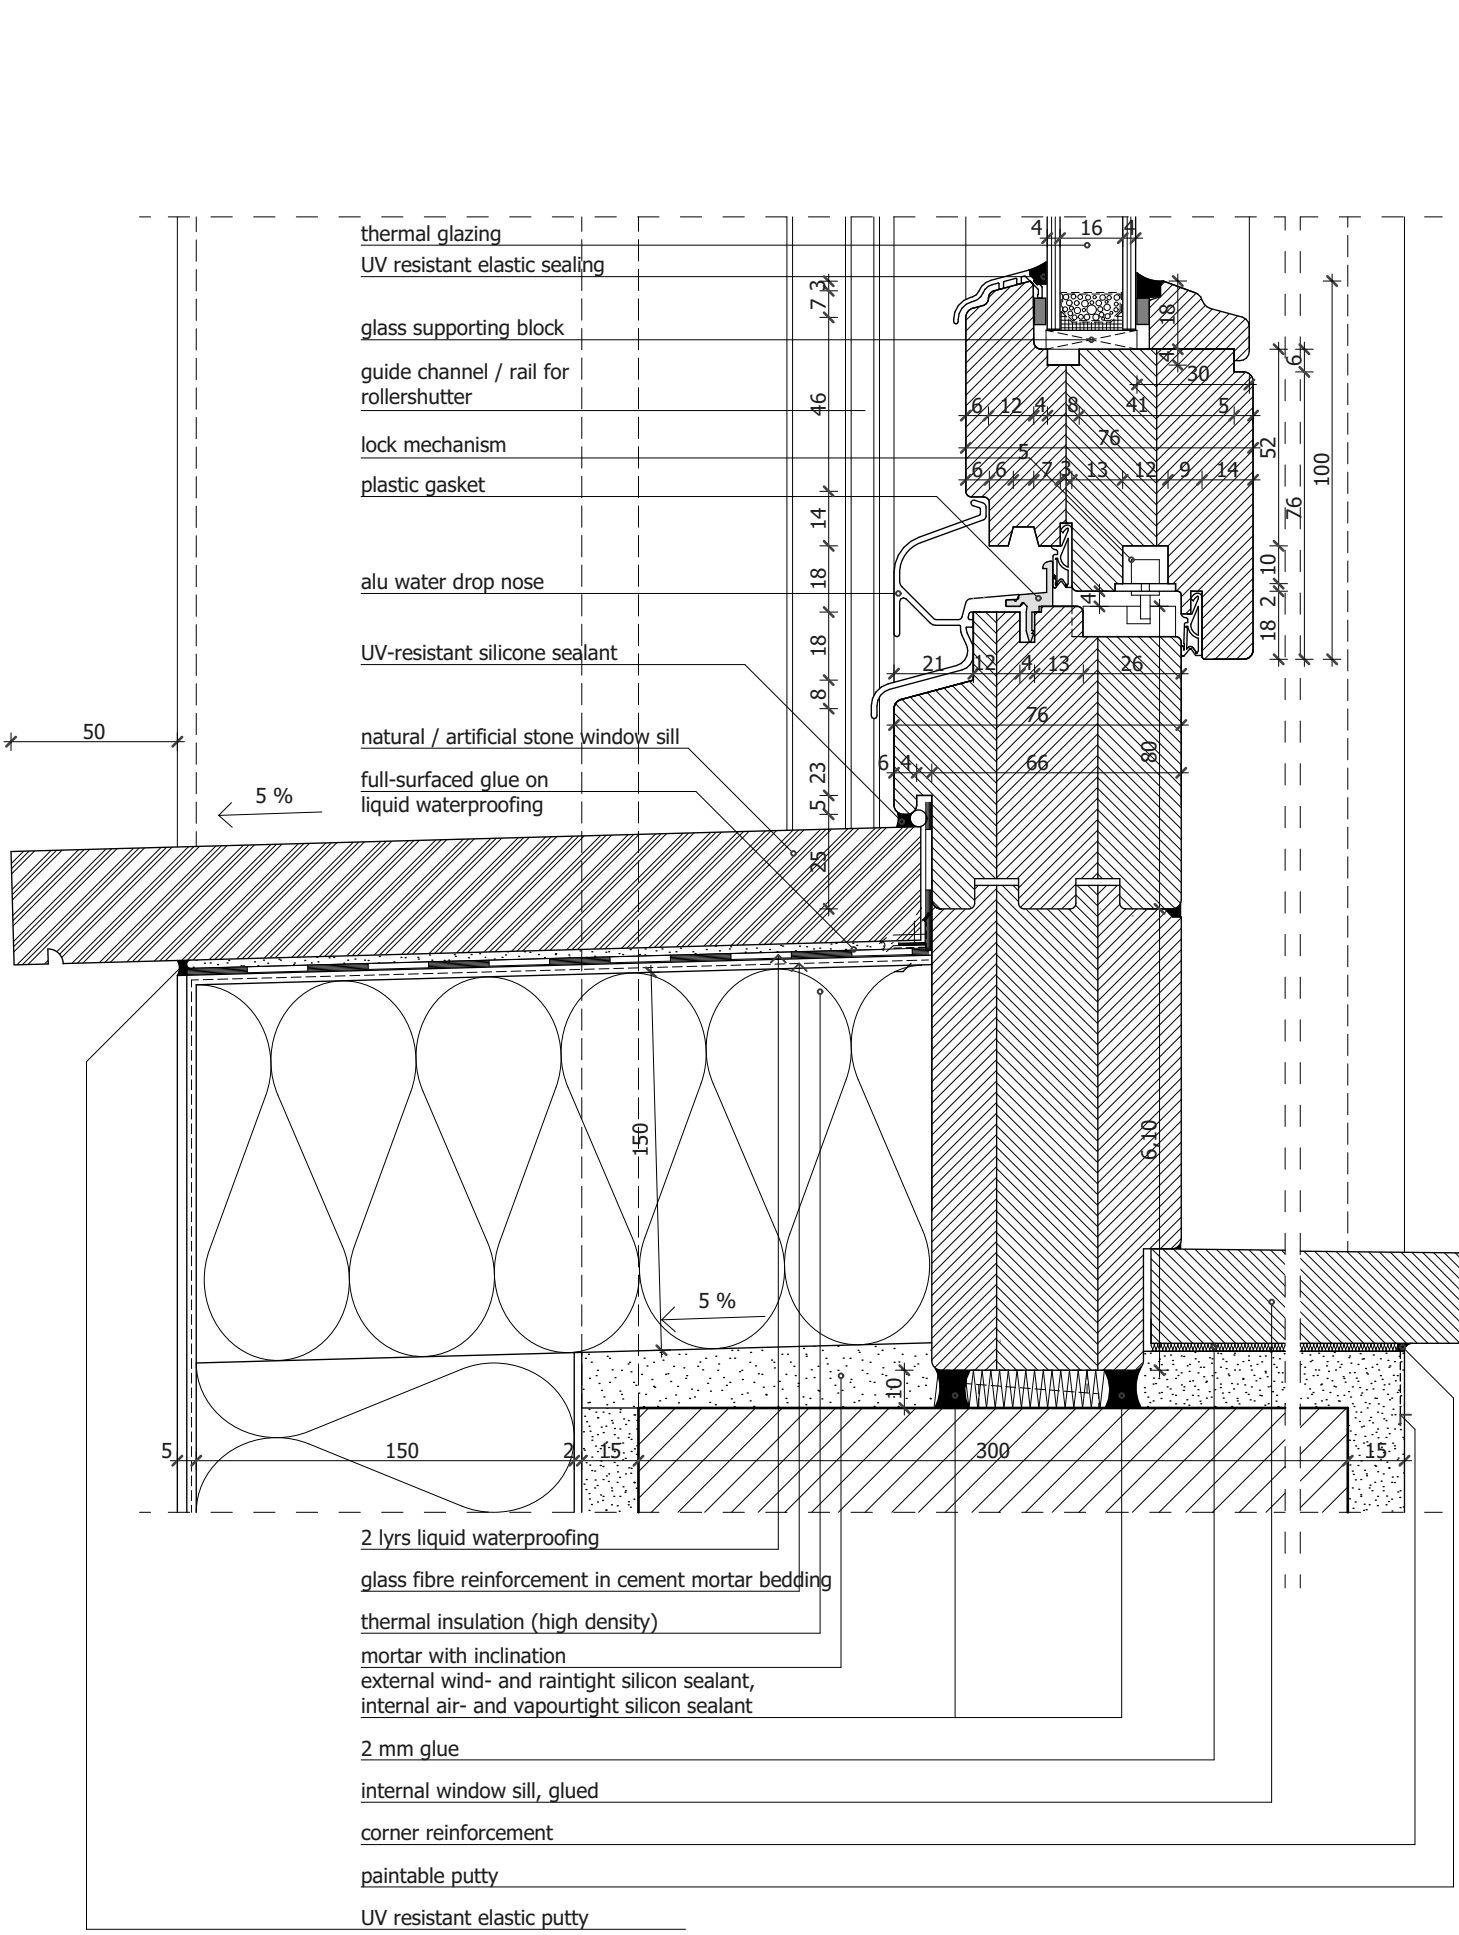
**Installation of up-to-date laminated timber window into a wall with external thermal insulation composite system (ETICS), with hidden rollershutter box and frame extension, vertical section S=1:5**
