# **BUILDING REHABILITATION**

## **2. FLOORS, ROOF STRUCTURES**

**Lajos Gábor, Takács PhD**

BME Department of Building Constructions

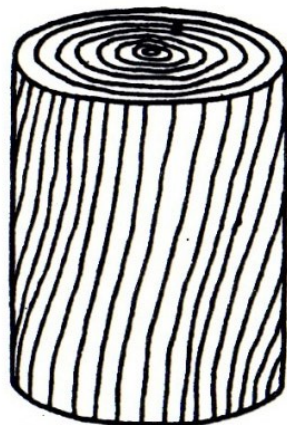
contortion

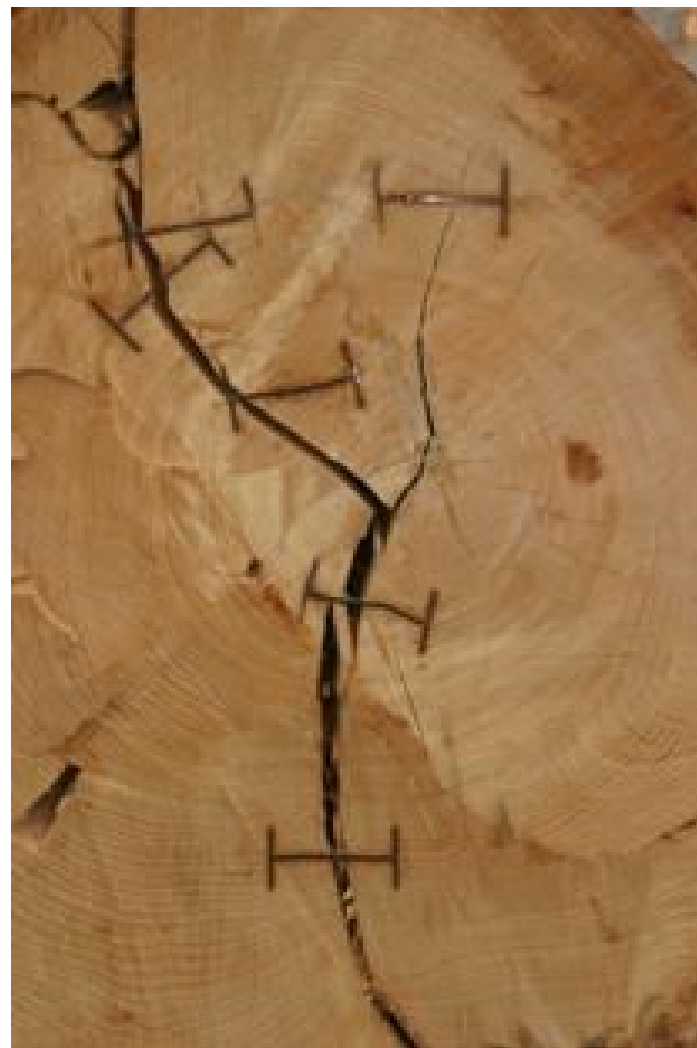
cracks

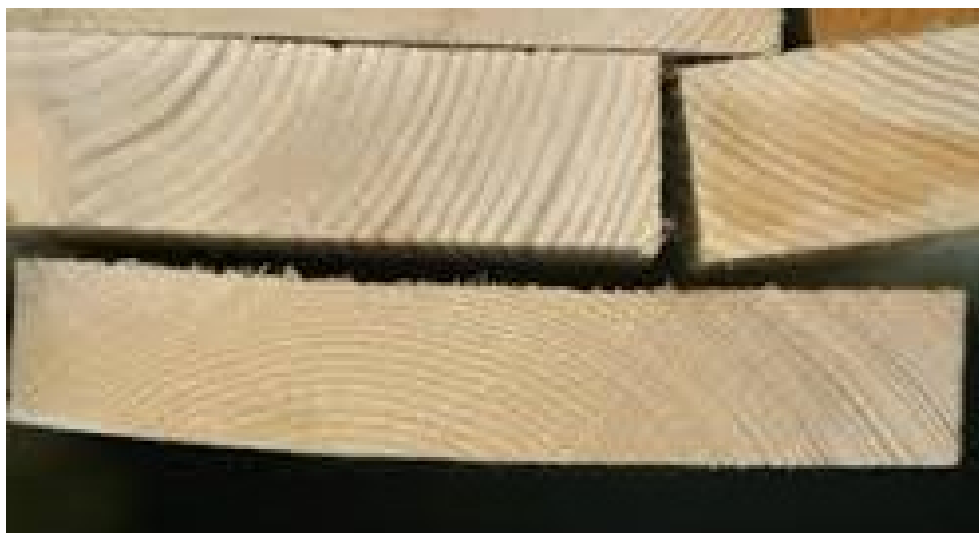
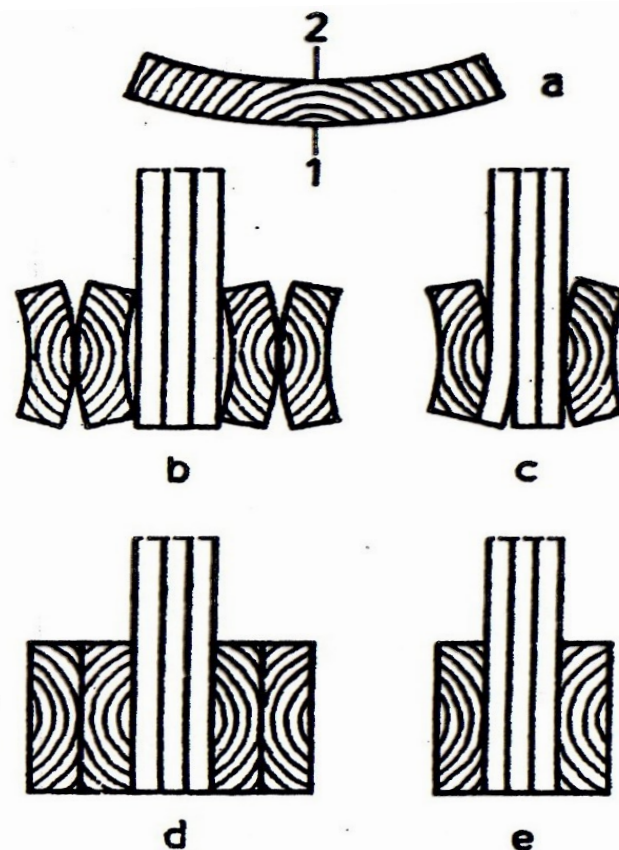
Movements during drying – twisting, cracking - are not the mistake of the timber but the timber treatment.

a: direction of the twisting during drying

Glueing of complex beams:

b, c: improper (can be delaminated)

d, e: proper

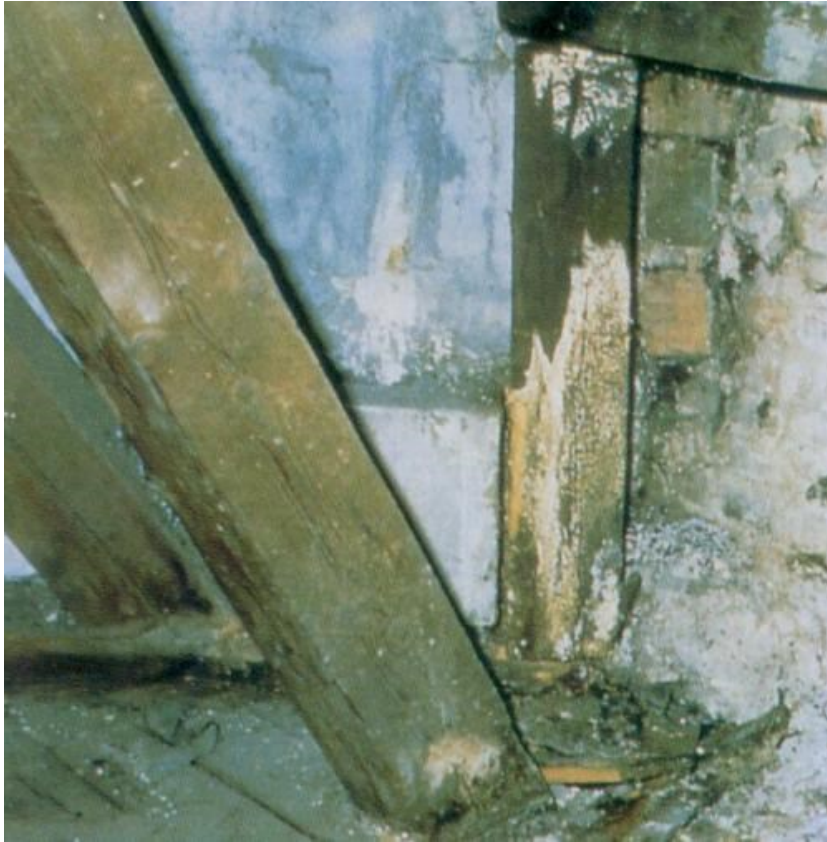
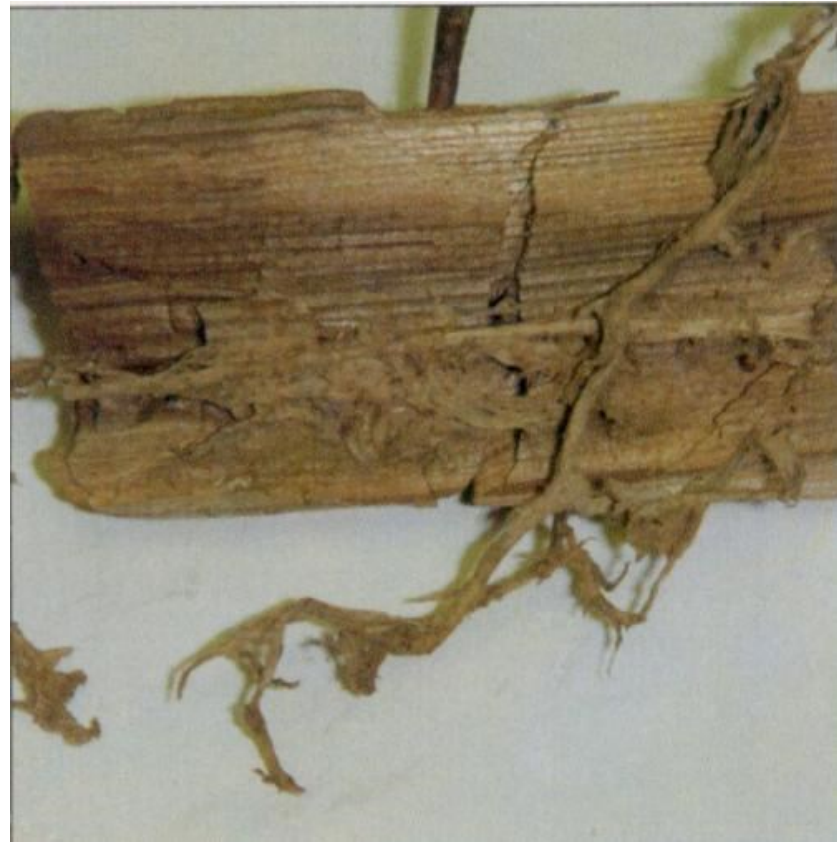
# BIOLOGICAL DETERIORATIONS: FUNGAL DECOMPOSITION

Spore of fungi can be found in the air so there should be only a given, continuous moisture content for the inhabitation – usual reasons are: water penetration, high moisture content  
Typical points are: eaves, chimney and other roof penetrations

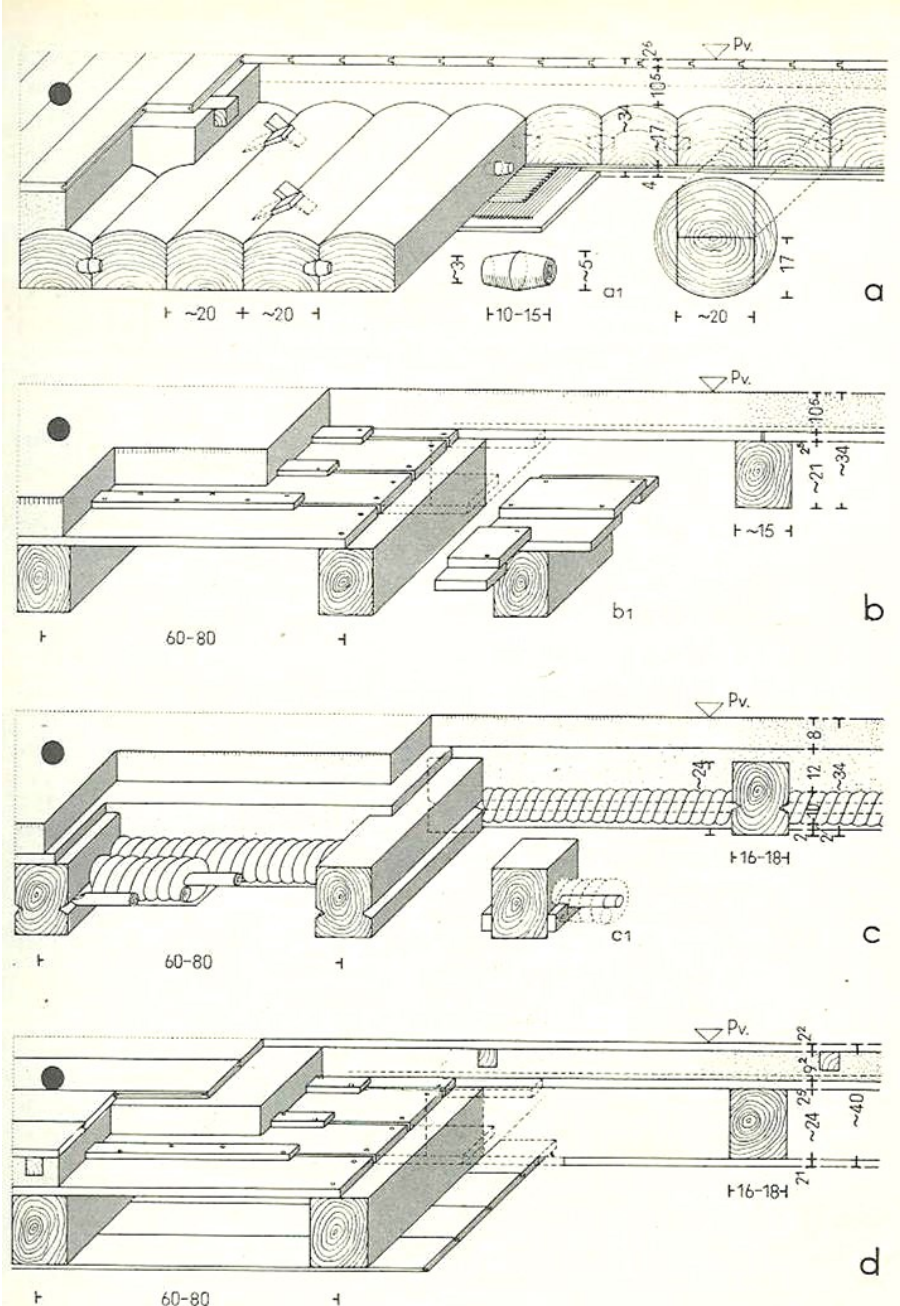
# TIMBER FLOOR SLABS

Dowelled beams

Suspended beams with boards (joints covered with timber battens)

Suspended beams with boards above and below (above: joints covered with timber battens, below: boards are plastered with straw net reinforcement)

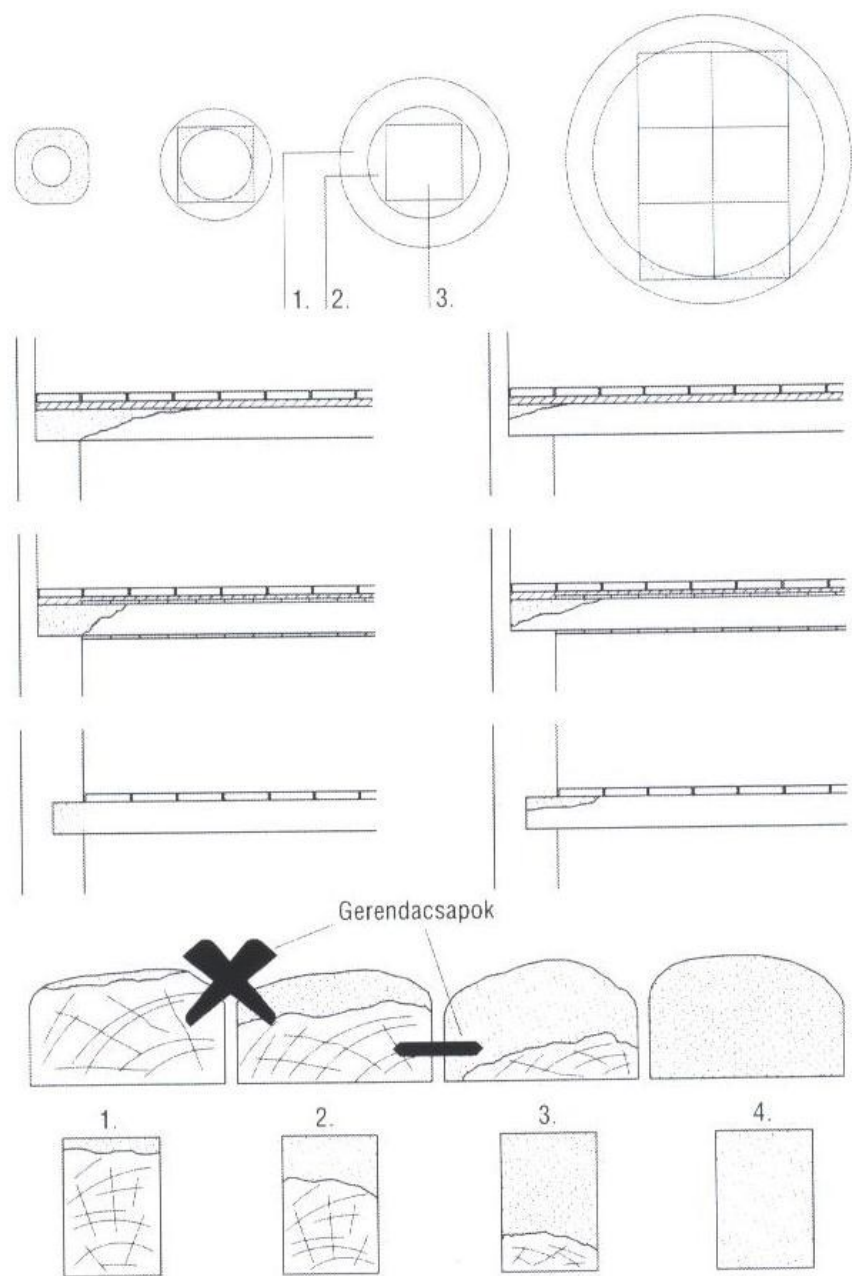
# TIMBER FLOOR SLAB FAILURES

- Design and construction problems
- Inadequate loadbearing capacity (stress limit is decreasing with the ageing of the timber)
- Combustibility: reaction-to-fire is D-s2,d0 but the resistance-to-fire performance is better than unprotected steel
- Crack and twisting of the timber – reason: timber logs are usually sawn in wet condition – drying phase is 1-3 years long
- Biological deteriorations
  - Insects
  - Fungal infection: due to moisture exposure – in the middle of the floor slab or at the wall connection (due to condensation)

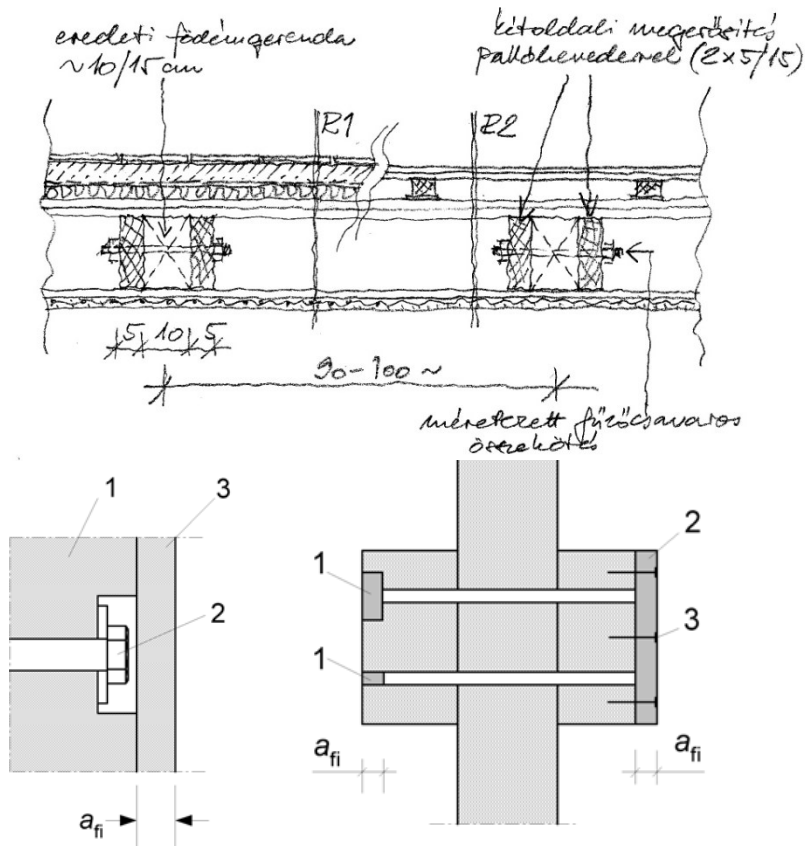
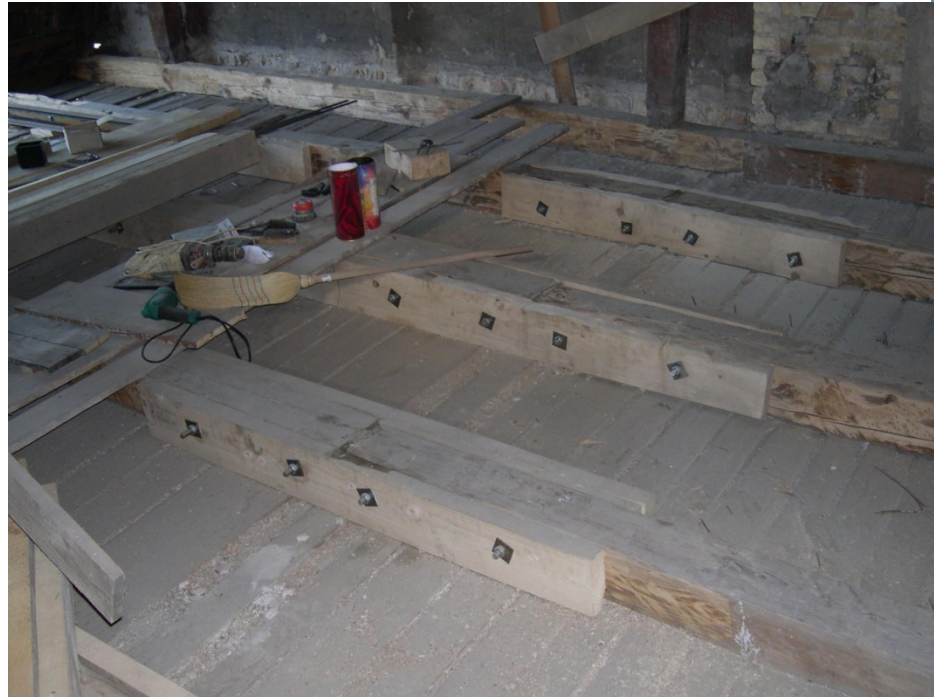
# STRENGTHENING OF TIMBER FLOOR SLAB

Suspended timber floor slab: strenghtening with a pair of planks (fixed with threaded rods and nuts)

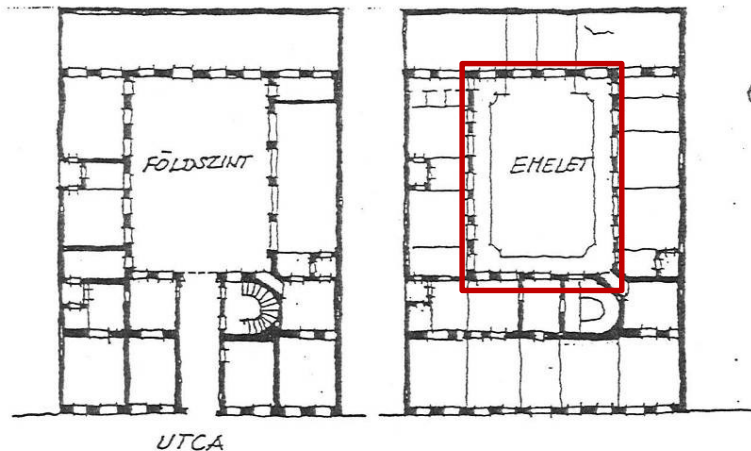
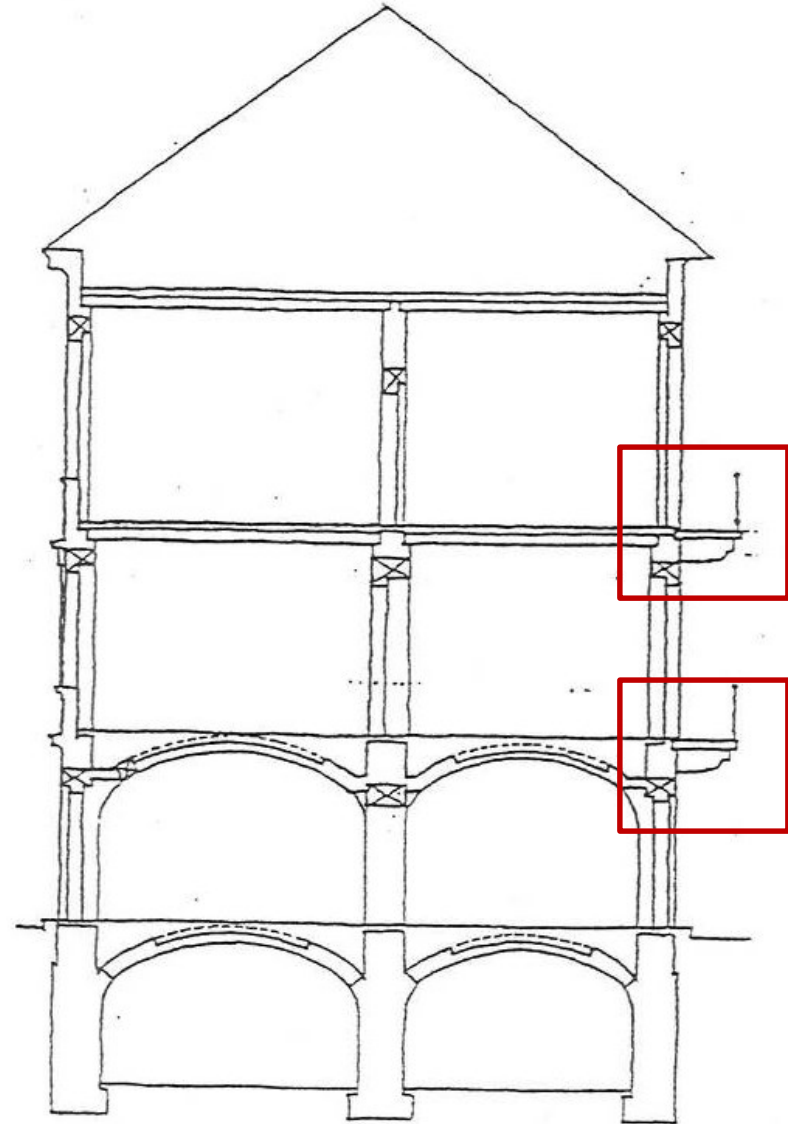
# NATURAL STONE STRUCTURES – STONE CORRIDORS, STAIRS

**Cracks:** overloading, dynamic load

**Wearing:** stairs

**Frost:** around handrail fixings (traditional way: cast lead, improper bracing: cement mortar – latter absorbs water)

**Structural stability problems** (lack of loading)

**Material damage** of exposed structures (acid rain, salty snow, soot accumulation, other chemicals)

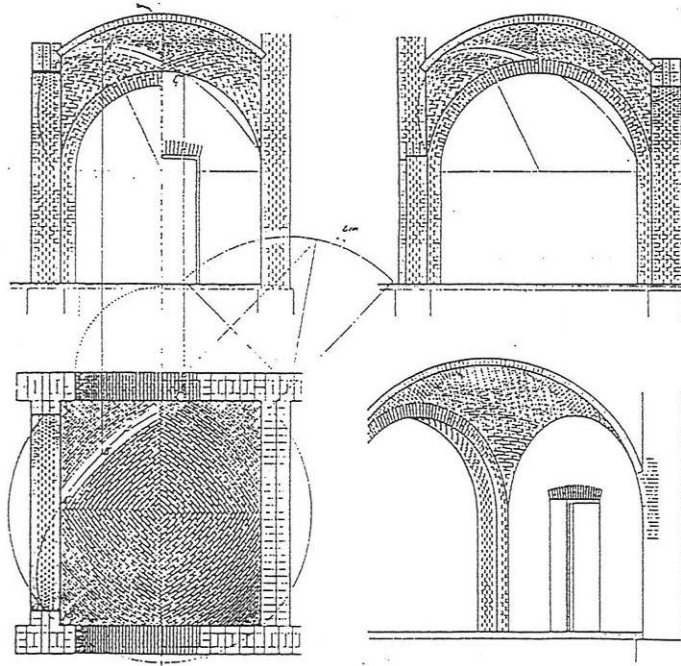
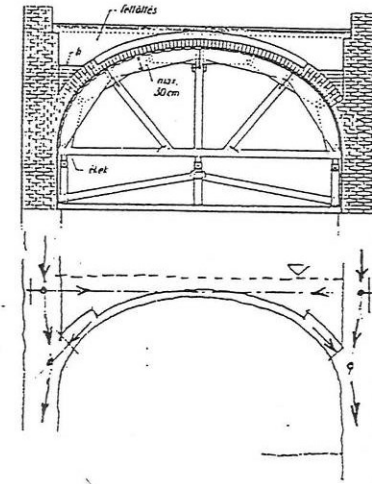
4.3.1. Donga és fiókos donga boltozat

4.3.1. barrel vault

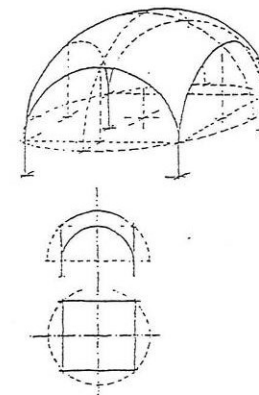
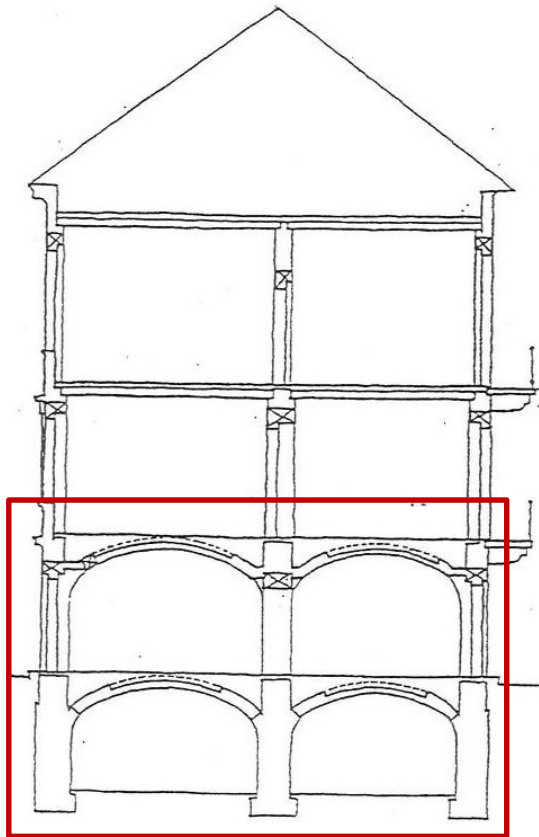
4.3.2. Cseh boltozat  
sémája és falazása

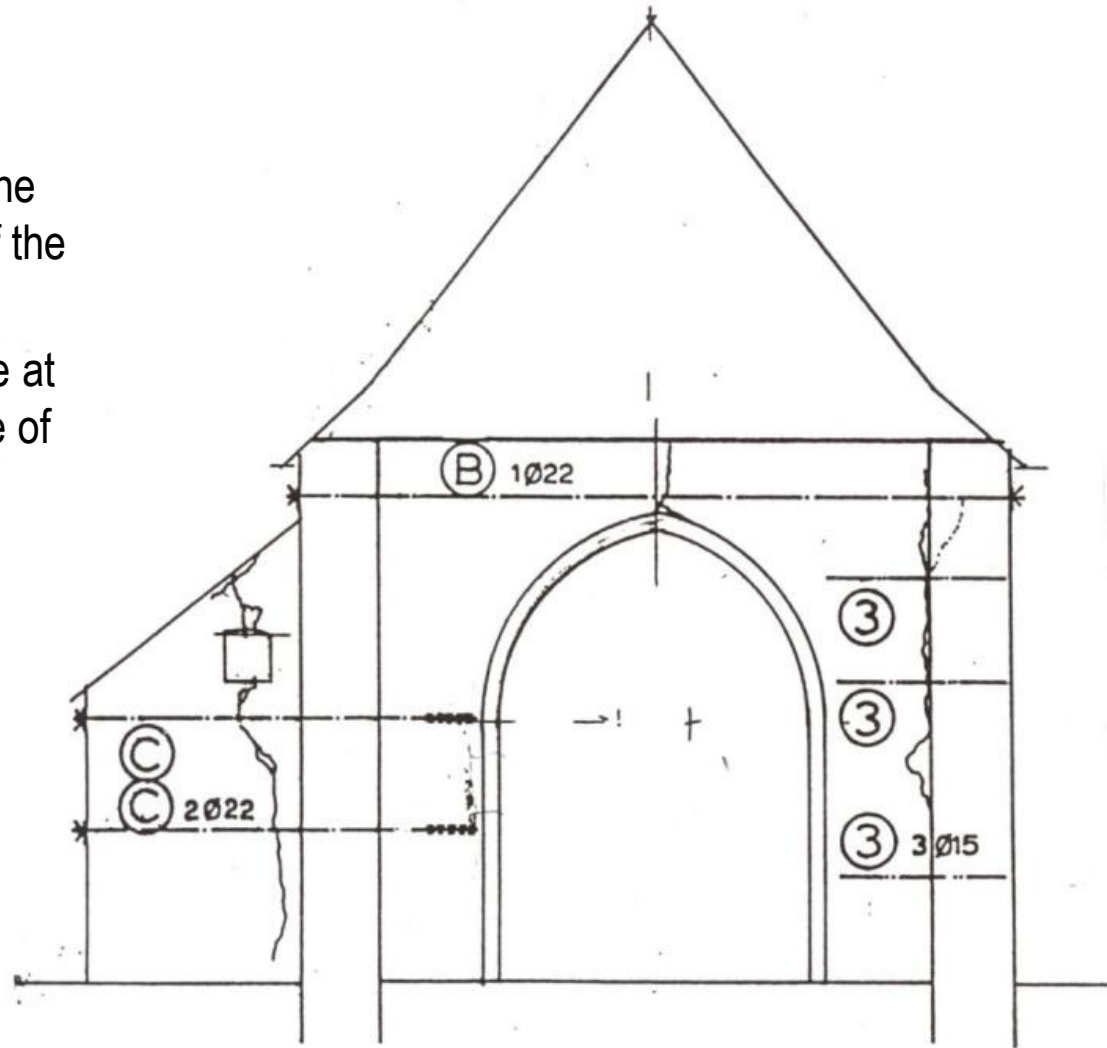
# VAULTED FLOOR FAILURES

Problems are usually caused by  
inequal foundation settlements or  
improper supports (piers, walls)

Overloading is not typical due to the  
enormous loadbearing capacity of the  
structures

Dynamic loads can cause damage at  
the crown (earthquake, fire, failure of  
other structure etc.)

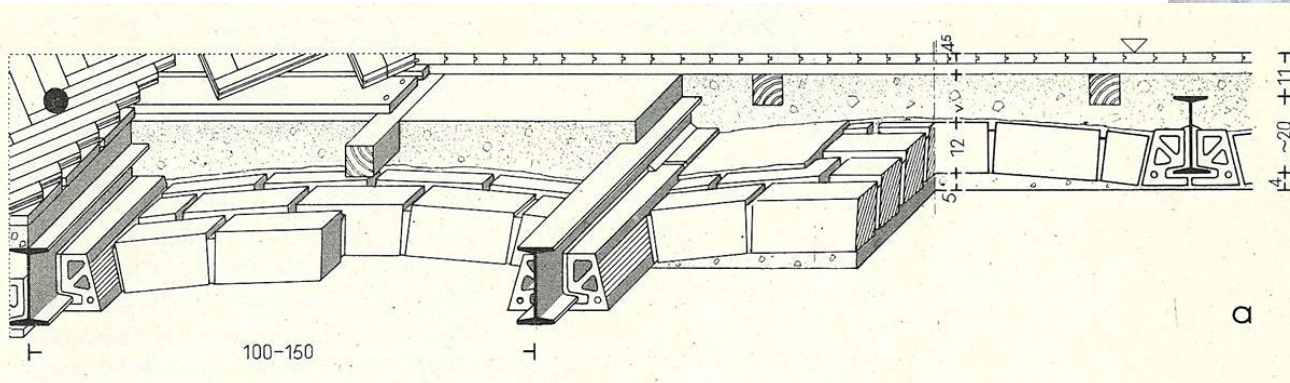
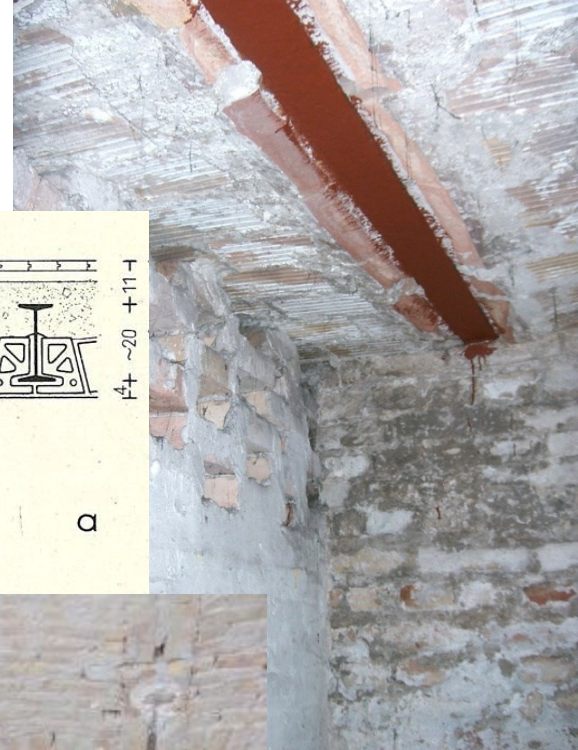
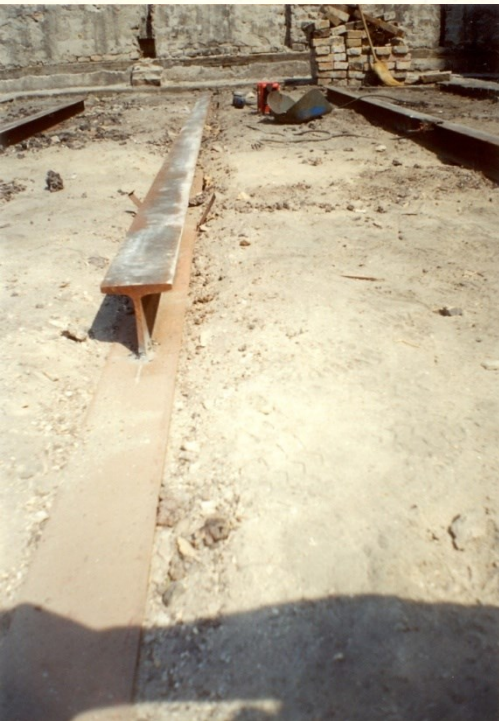
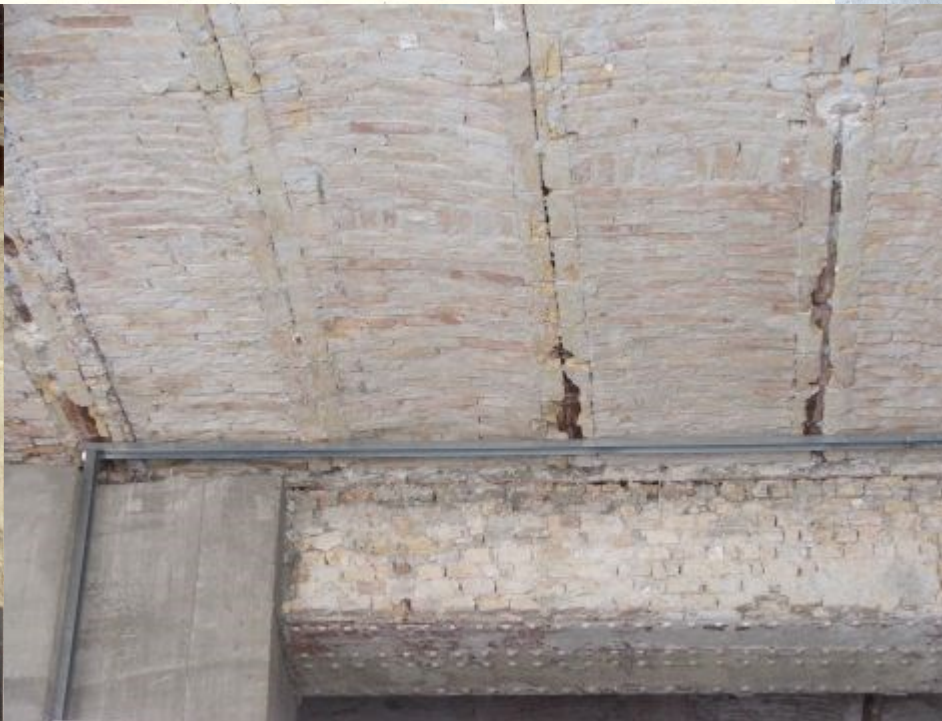
# FLOOR SLABS WITH STEEL BEAMS

Jack arch slab:  
hot rolled steel  
beams and flat  
brick arches  
(with or without  
abutment brick  
members)

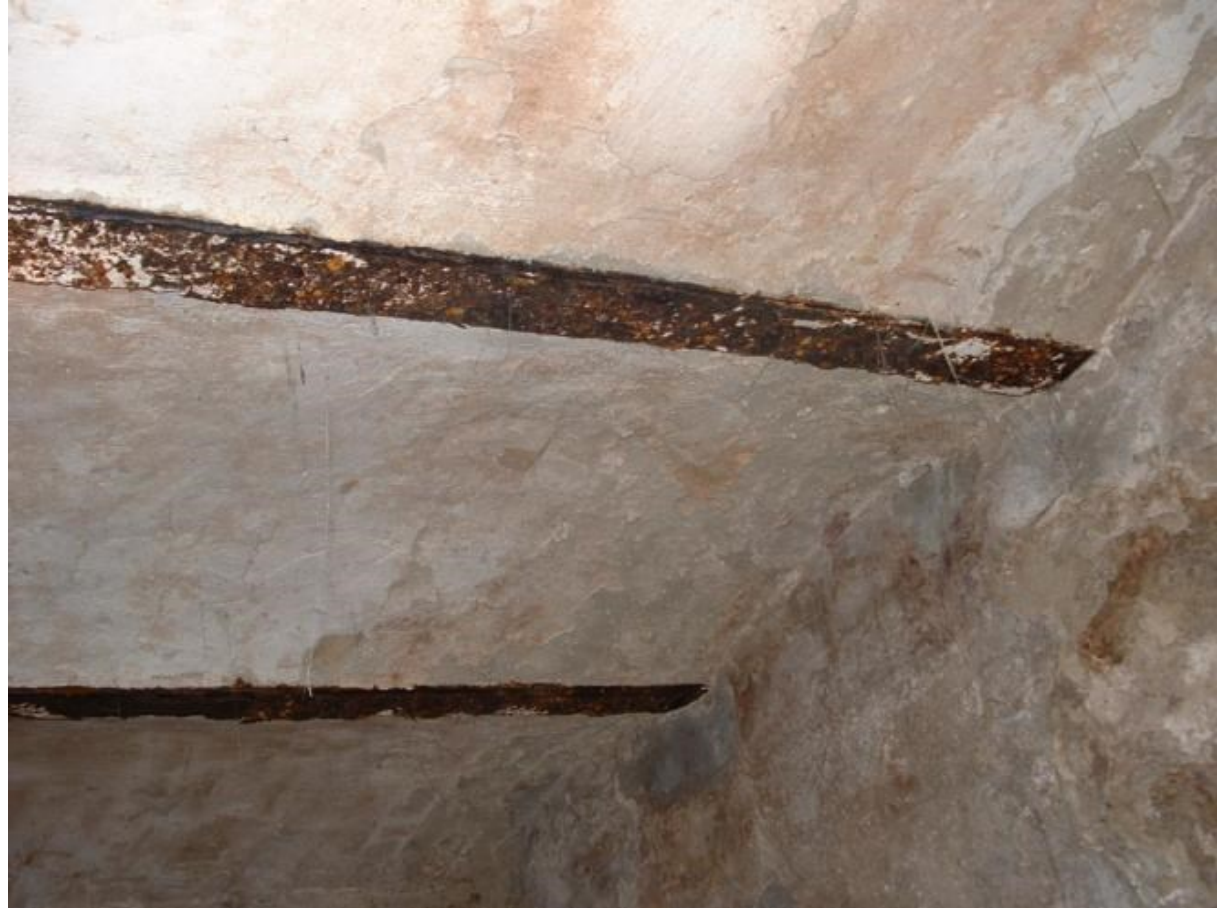
# FLOOR SLABS WITH STEEL BEAMS - FAILURES

- Improper loadbearing capacity, overloading
- Support failure
- Corrosion (water leakage, vapour condensation, or improper desing – it was forbidden to use over basement without waterproofing)

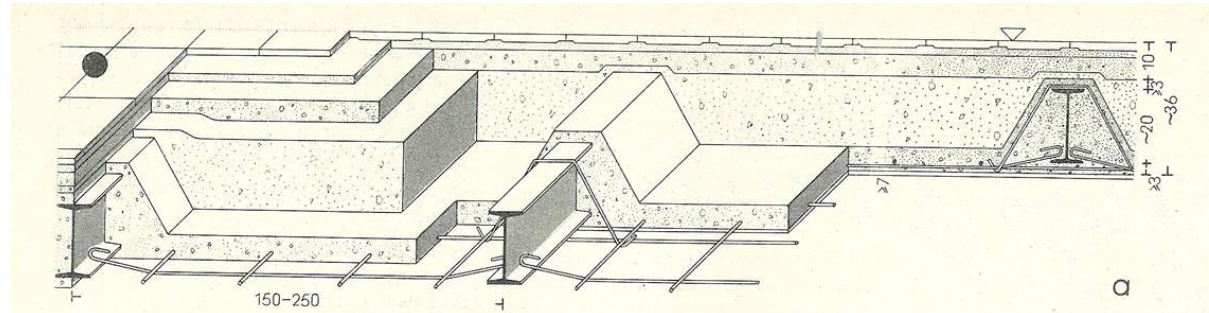
Upright steel beams with  
RC beams

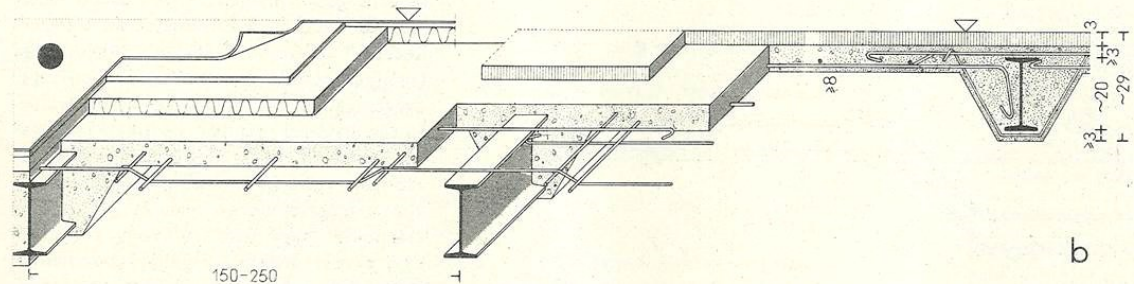
Downstand steel beams  
with RC slabs

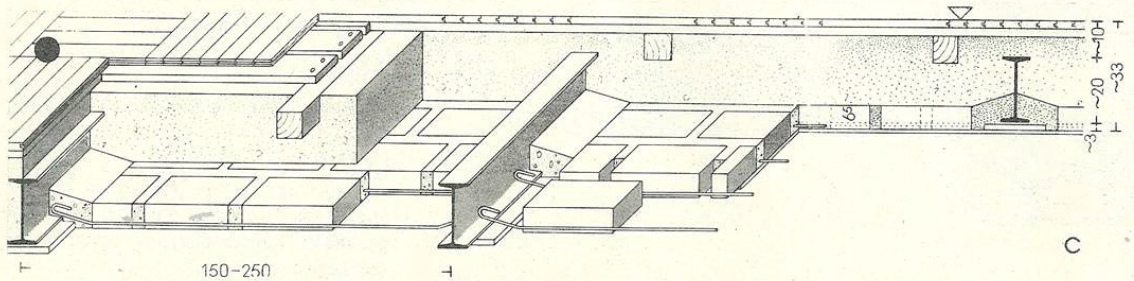
Upright hot rolled steel  
beams with RC brick infill

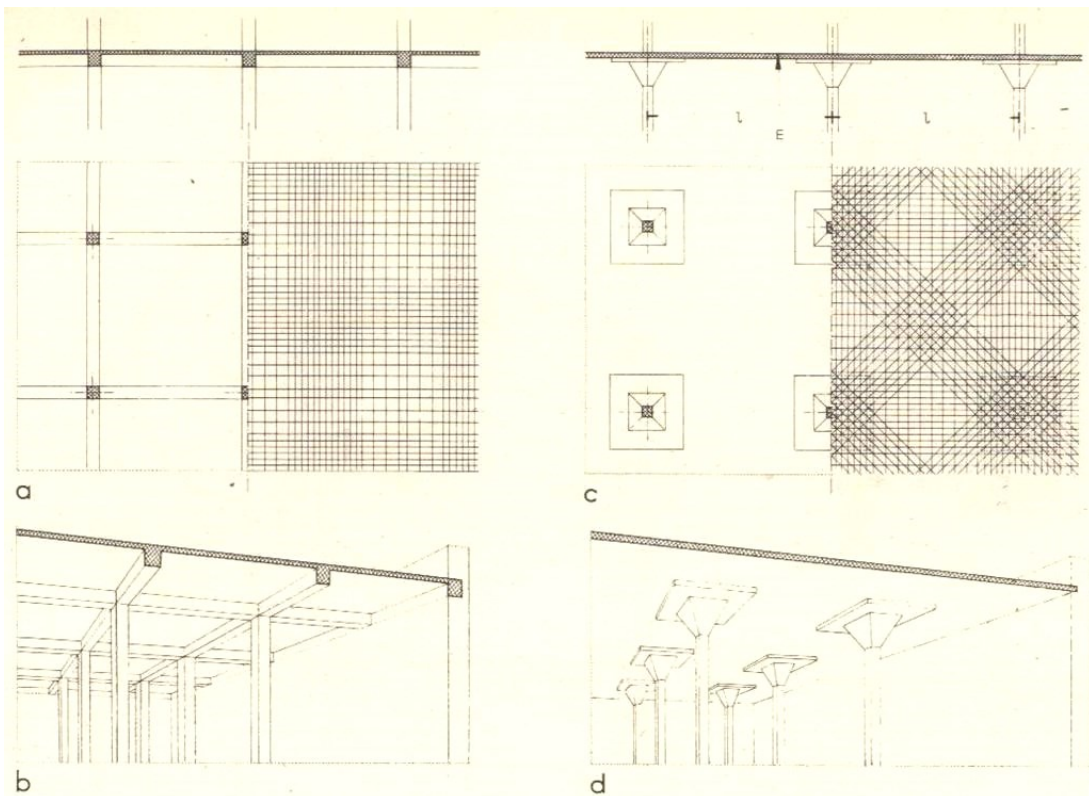
Double downstand beams

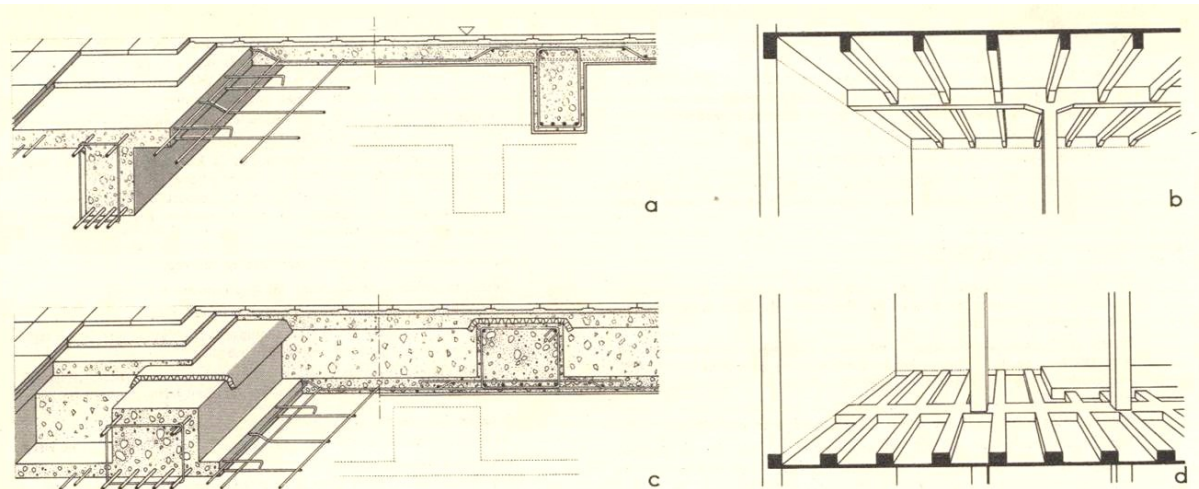
Downstand beams

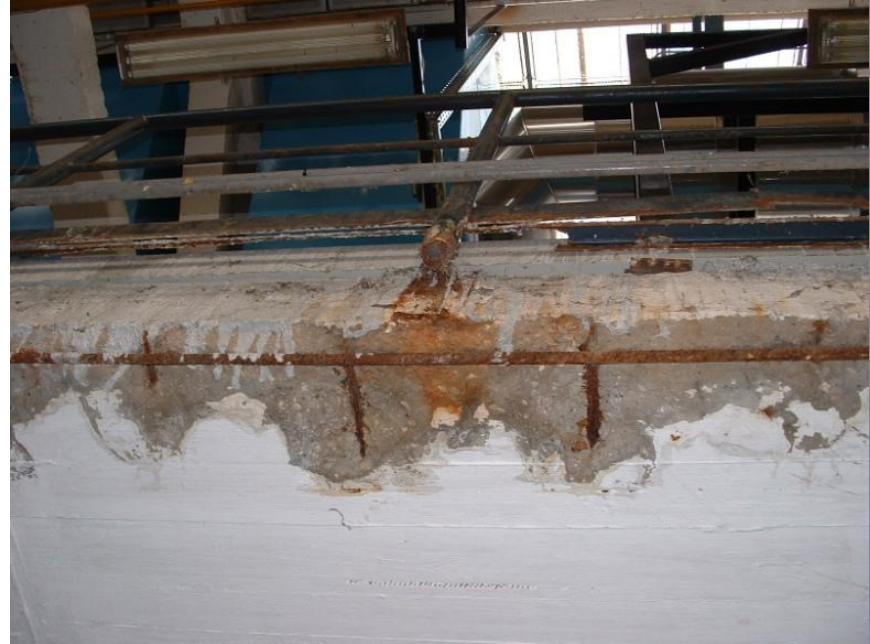
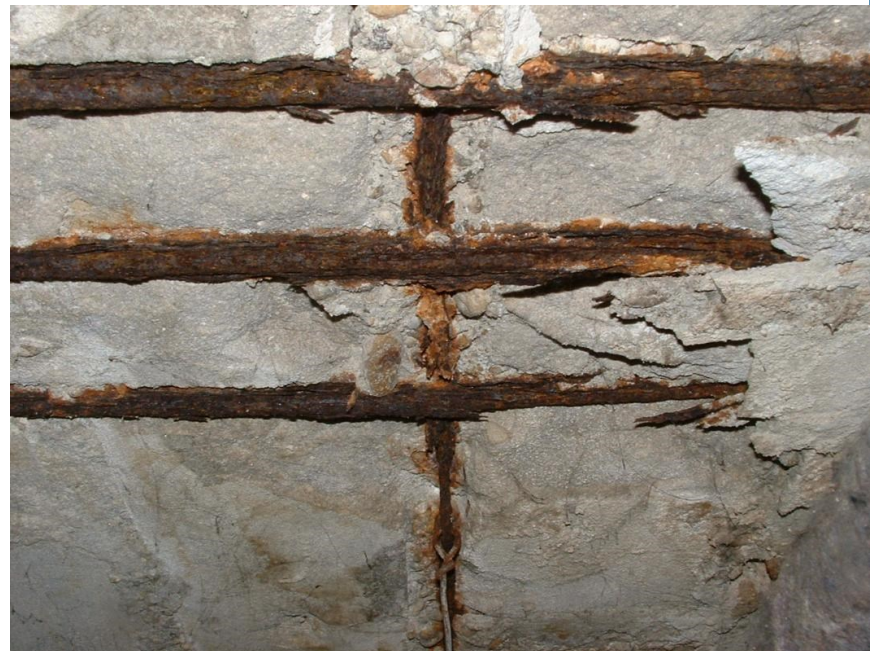
# MONOLITHIC RC FLOOR SLAB FAILURES

- Improper loadbearing capacity, overloading
- Support failure
- Corrosion (improper concrete cover – corrosion of the reinforcement, concrete corrosion)

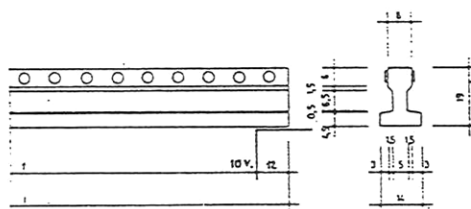
E type of beams  
(prestressed) with concrete  
infill elements

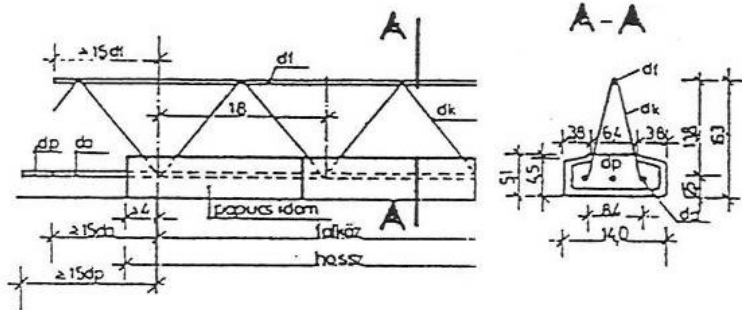
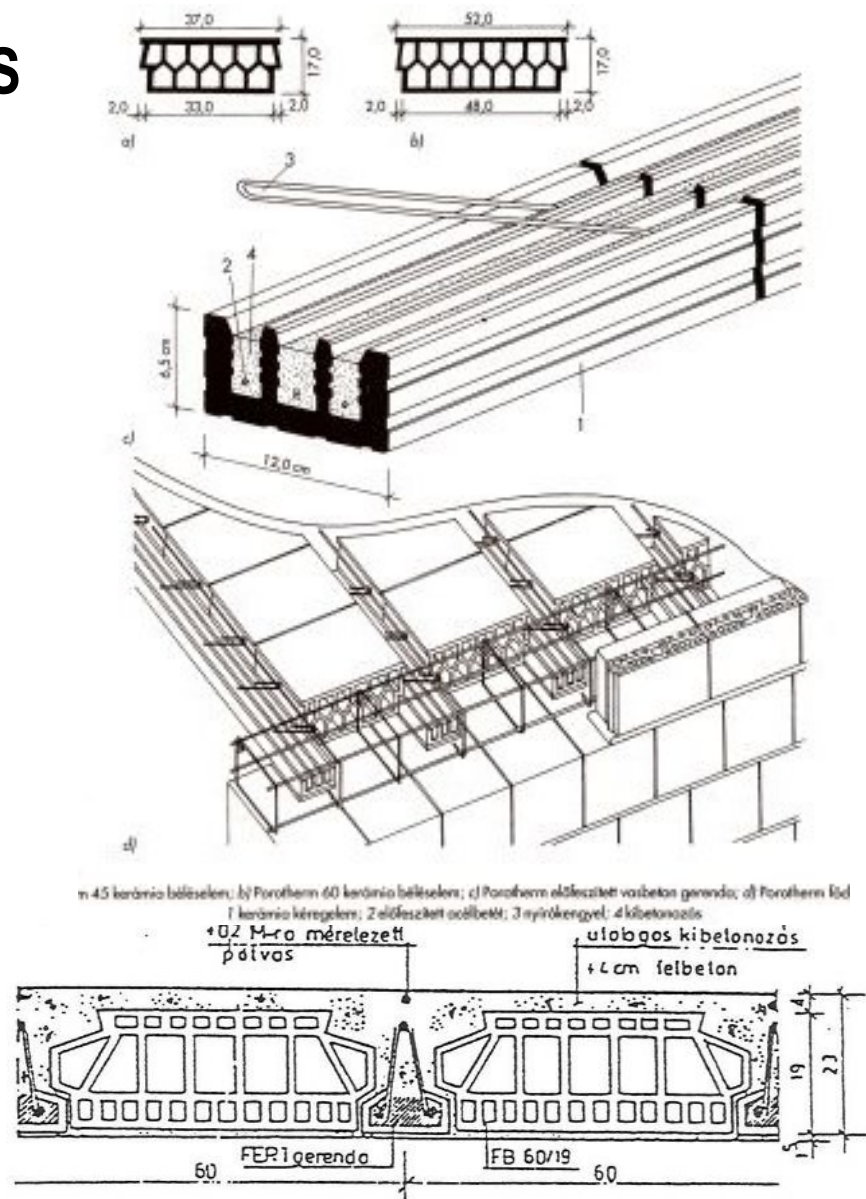
## SEMI-MONOLYTHIC RC FLOORS

Up-to-date floor (prestressed)

FERT floor (non-stressed)

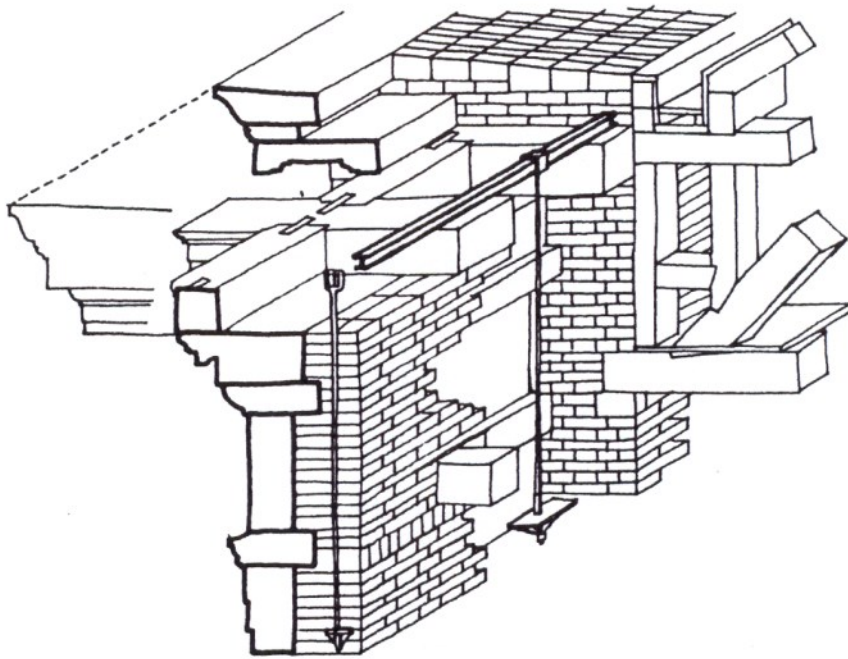
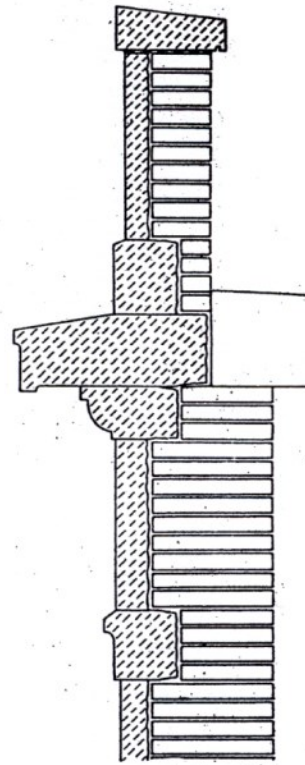
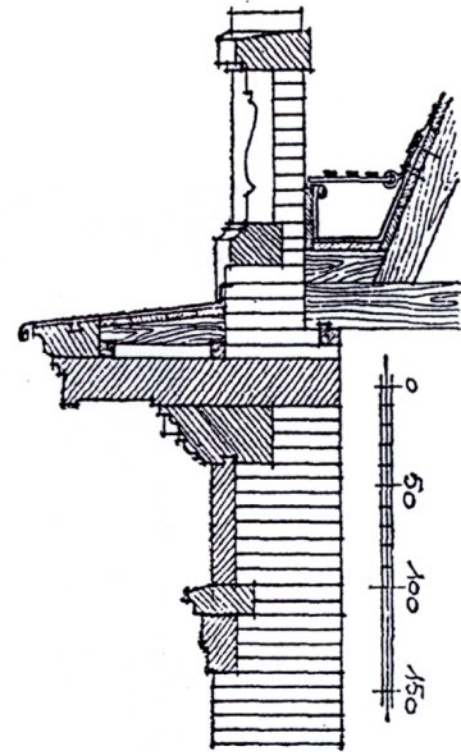
# CORNICE PROBLEMS

Structural stability: anchoring problems of the cantilevered members

- corrosion – water leakage, vapour condensation,
- fire,
- Improper reconstruction works

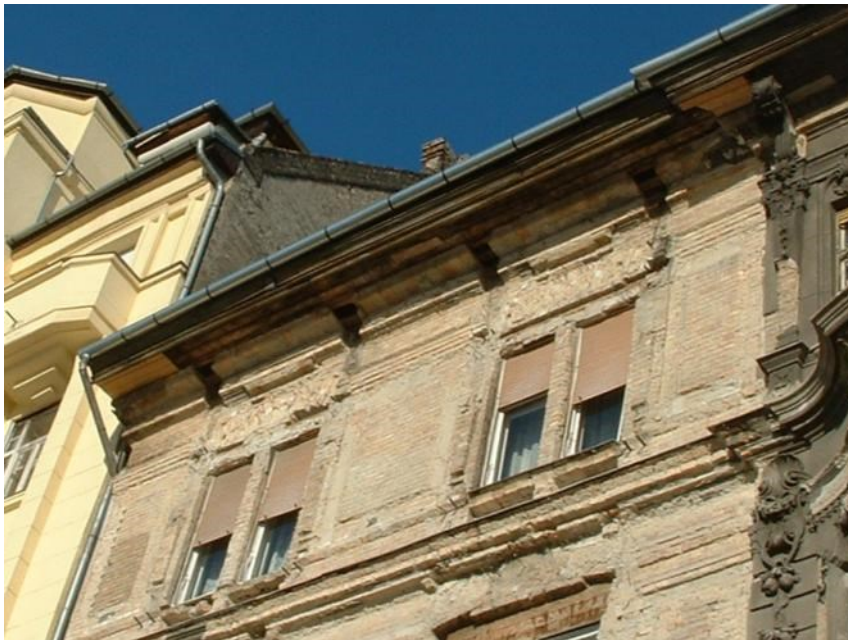
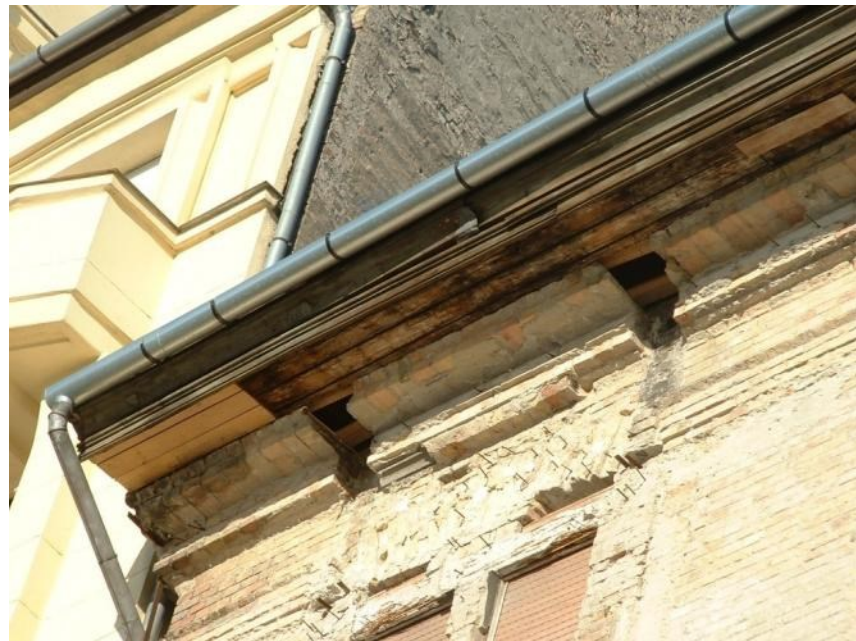
# CORNICE PROBLEMS

- Structural stability: anchoring problems of the cantilevered members (corrosion) – water leakage, vapour condensation
- Solution: first to repair the gutter and the flashings, then the cornice

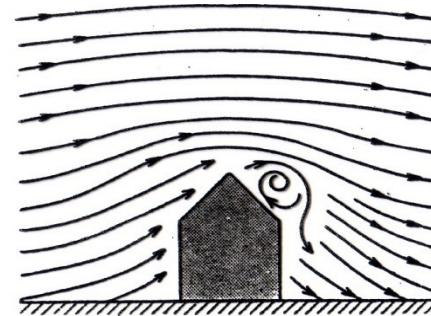
Wind pressure and -suction

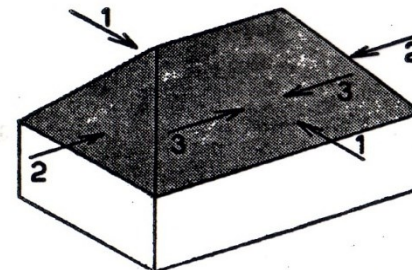
Direction of wind forces

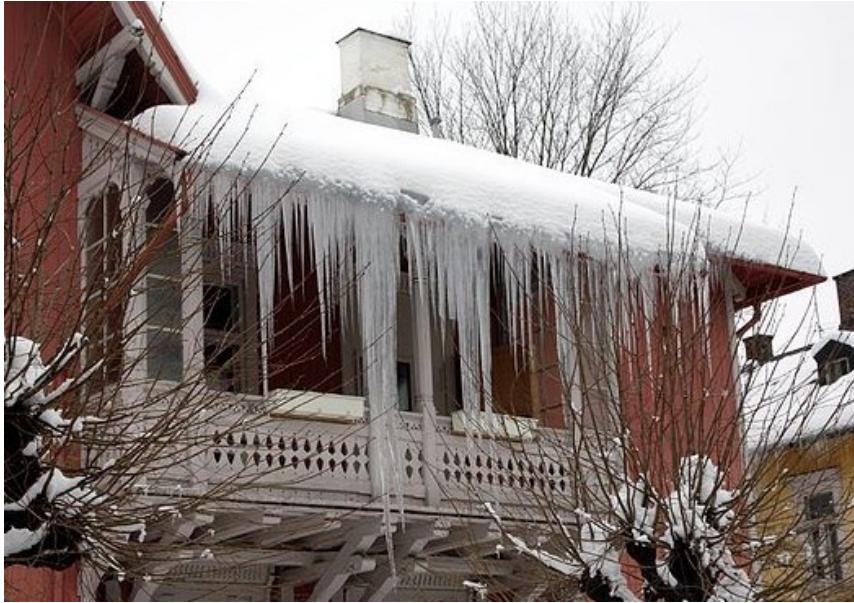
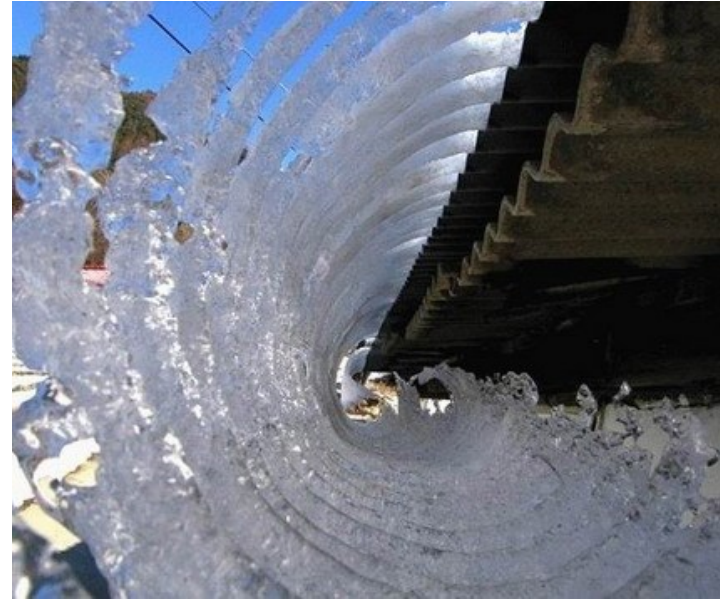
# SPECIAL EXPOSURES ON PITCHED ROOFS: SNOW, ICICLES

- Due to the heat loss from inside, snow melts on the roof, but the molten snow freezes again around the eaves where there is no heat loss
- It may overload the eaves and can cause water backflow
- Solution: ventilating the roof, providing external temperature below the roof cladding
