# **BUILDING REHABILITATION**

## **2. FLOORS, ROOF STRUCTURES**

**Lajos Gábor, Takács PhD**

BME Department of Building Constructions

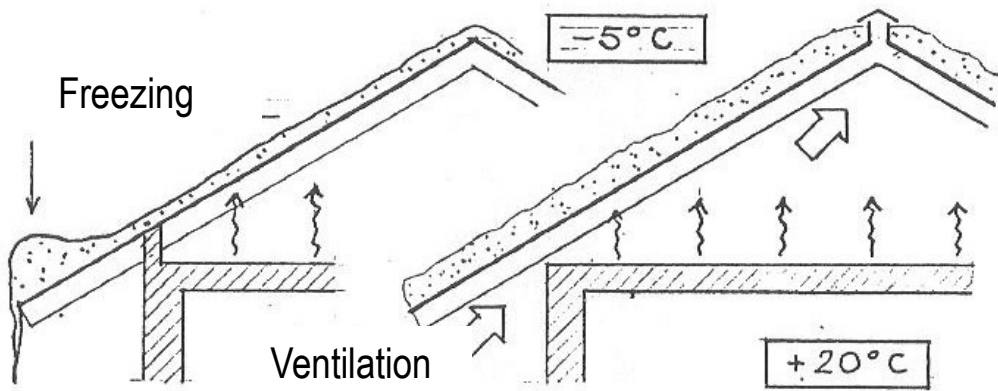
Snow, ice (extra loads in winter conditions)

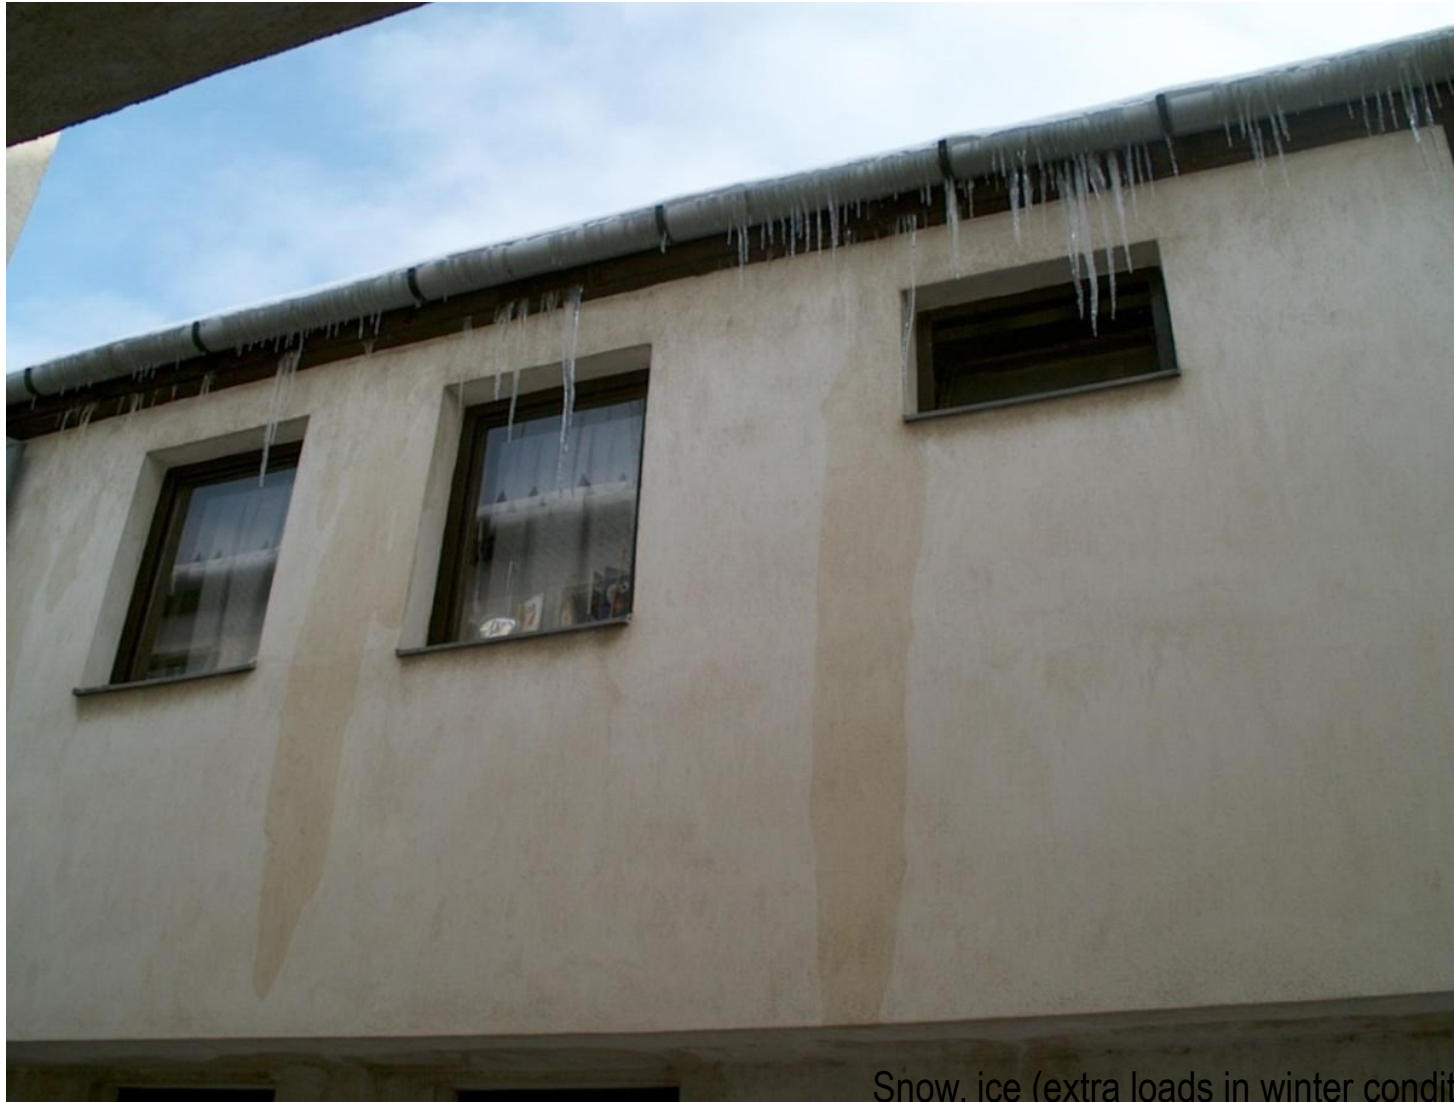
# SPECIAL EXPOSURES ON PITCHED ROOFS: SNOW, ICICLES

Snow, ice (extra loads in winter conditions)

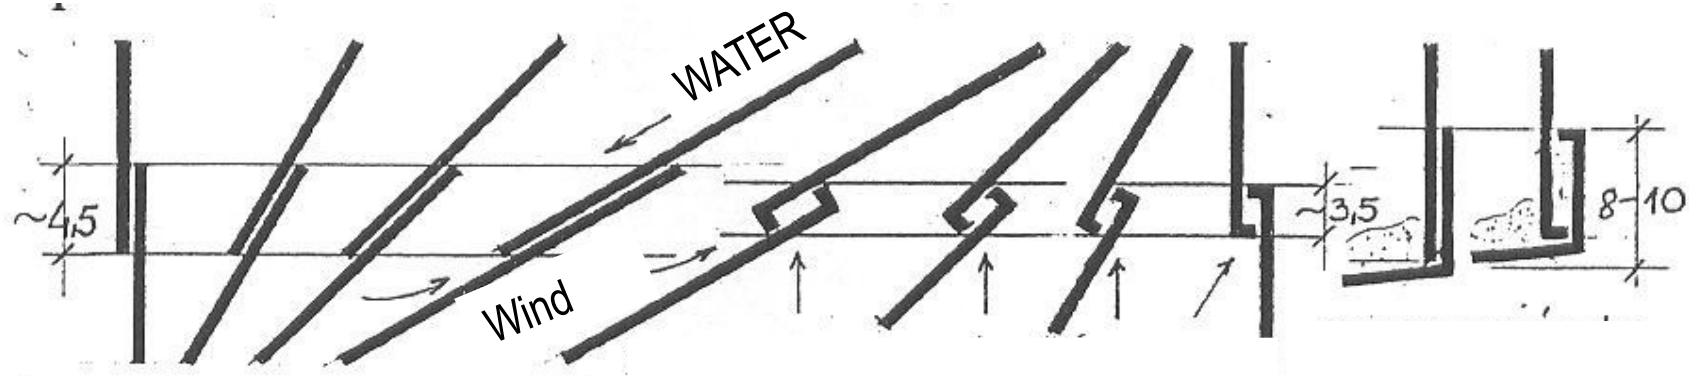
Overlapping of the roof covering elements – decompression gap

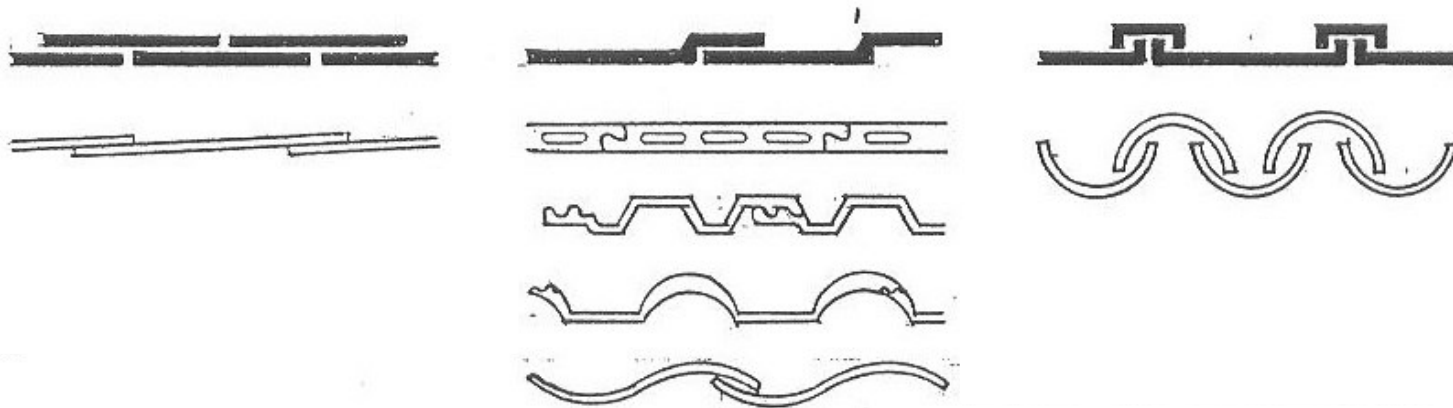
Single and double layer plain covering – interlocking roof covering – tegula-imbrex covering

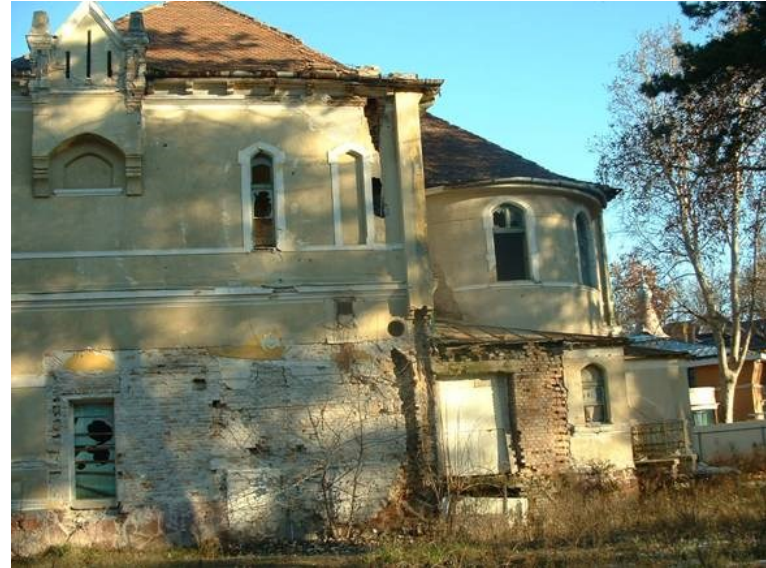
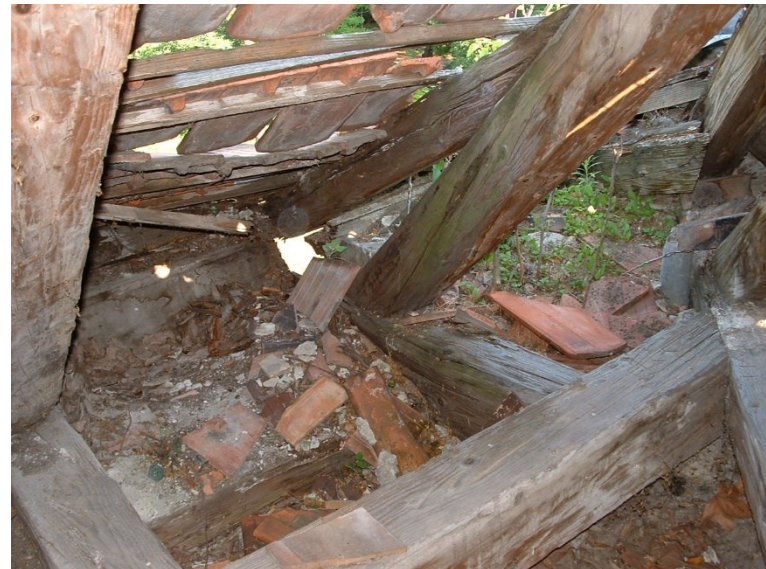
# PITCHED ROOF STRUCTURE AND ROOF COVERING FAILURES

- Timber mistakes (cracks, twisting etc.) – usually minor problems
- Water penetrations (mainly at the eaves and at the penetrations like chimney, dormer windows, skylight windows etc.)
- Biological deteriorations (fungal infection, insects)
- Frost damages

- Visual inspection – at daylight, from inside out
- Water test (leakage)

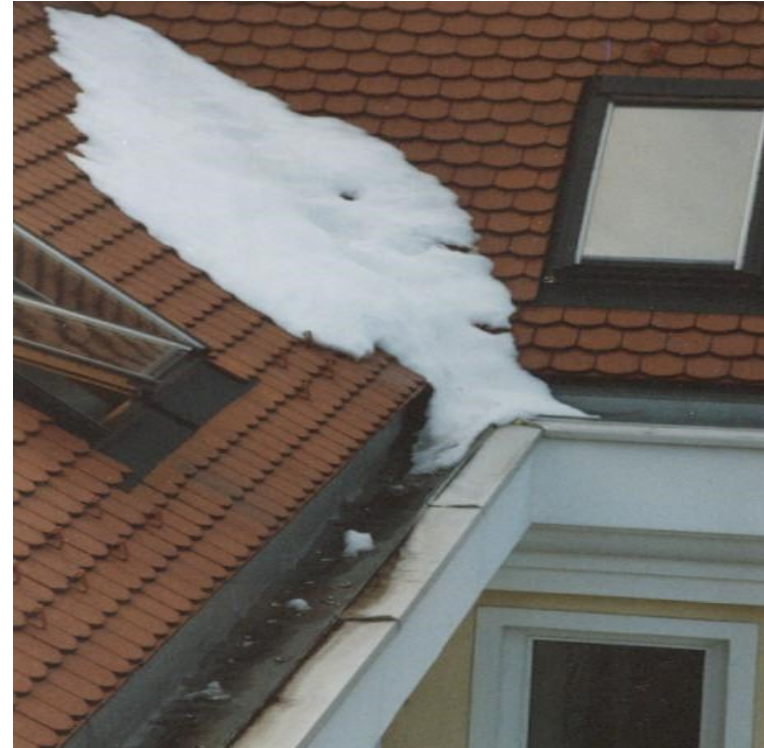
# PITCHED ROOF STRUCTURE AND ROOF COVERING FAILURES

- Timber mistakes (cracks, twisting etc.) – usually minor problems
- Water penetrations (mainly at the eaves and at the penetrations like chimney, dormer windows, skylight windows etc.)
- Biological deteriorations (fungal infection, insects)
- Frost damages

- Visual inspection – at daylight, from inside out
- Water test (leakage)

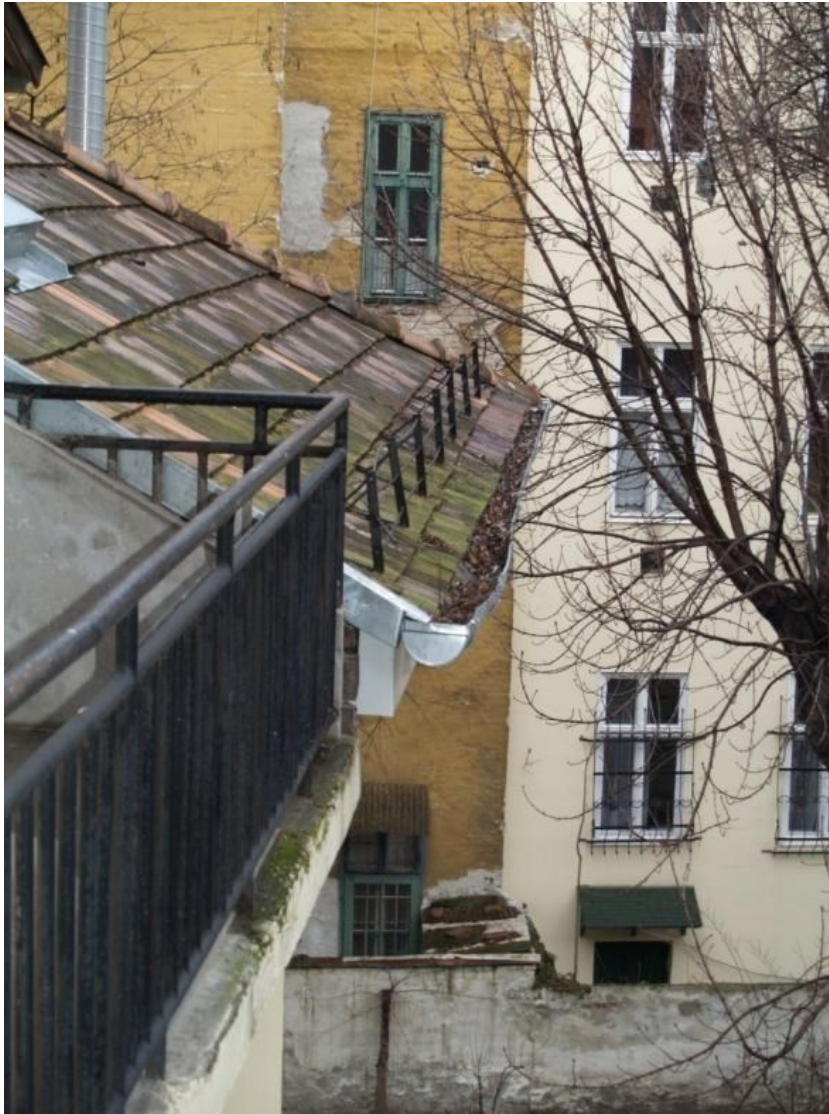
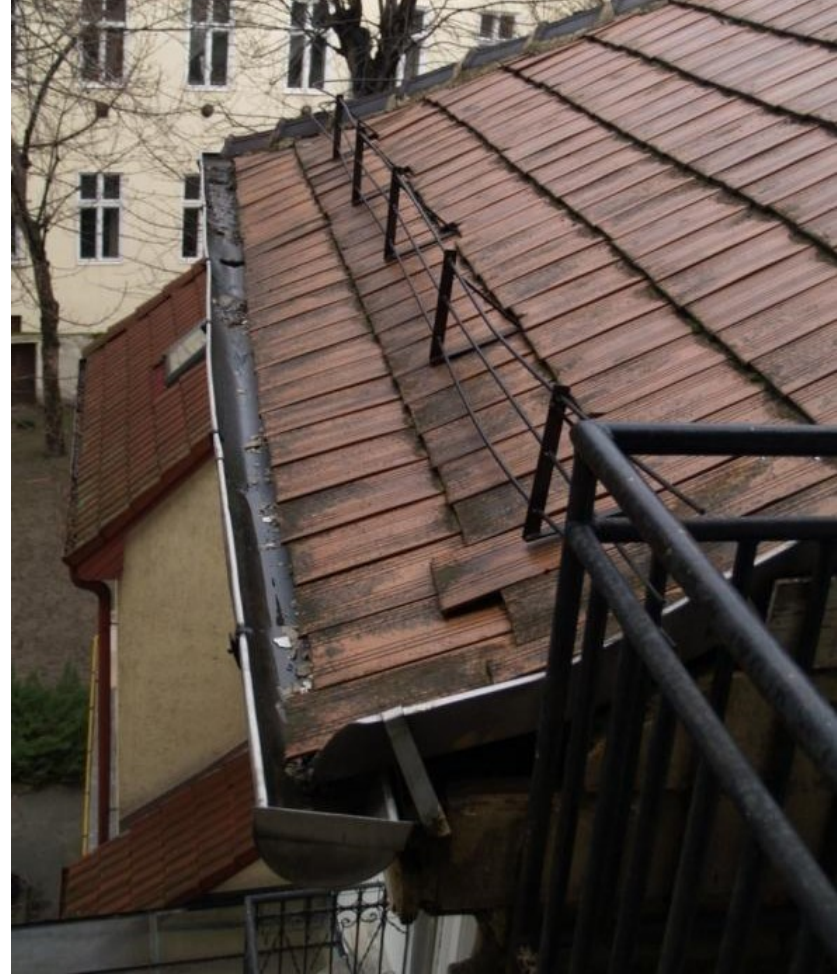
# RAINWATER SYSTEM FAILURES

- Improper inclination
- Frost – icicles (mechanical damage and/or overload of the gutter)
- Snow – avalanche
- Lack of maintenance (cleaning – twice a year)

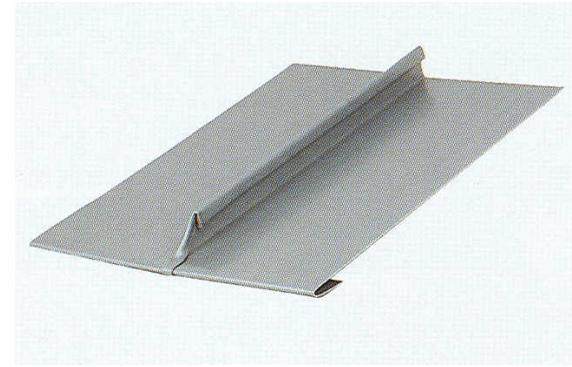
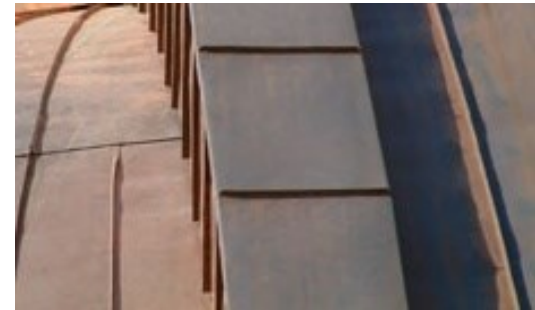
Copper

**Contact corrosion** has to be considered when different kind of metals have physical connection or connection via rainwater or dewatering:

- water drained away from copper surfaces may not make  
contact with any other metal;
- a separating layer must be built in between incompatible  
components;
- the majority of timber conservation substances attack  
metals;
- concrete and plastered surfaces release calcium - hidroxide  
that destroys aluminium and zinc.

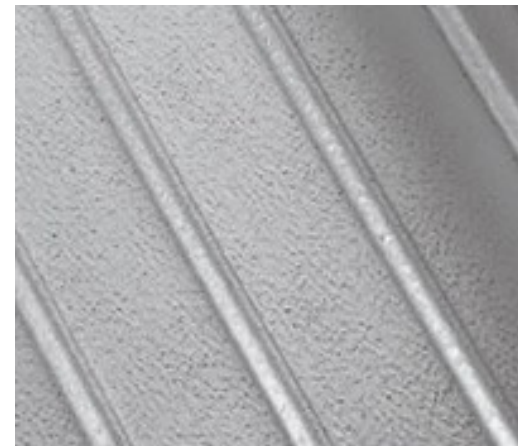
Pre-weathered aluminium

**Contact corrosion** has to be considered when building in /  
connecting metal components :

- water drained away from copper surfaces may not make  
contact with any other metal;
- a separating layer must be built in between incompatible  
components;
- the majority of timber conservation substances attack  
metals;
- concrete and plastered surfaces release calcium- hidroxide  
that destroys aluminum and zinc.
