BUILDING REHABILITATION

3. WATERPROOFINGS, FLAT ROOFS, DOORS AND WINDOWS

Lajos Gábor, Takács PhD

BME Department of Building Constructions

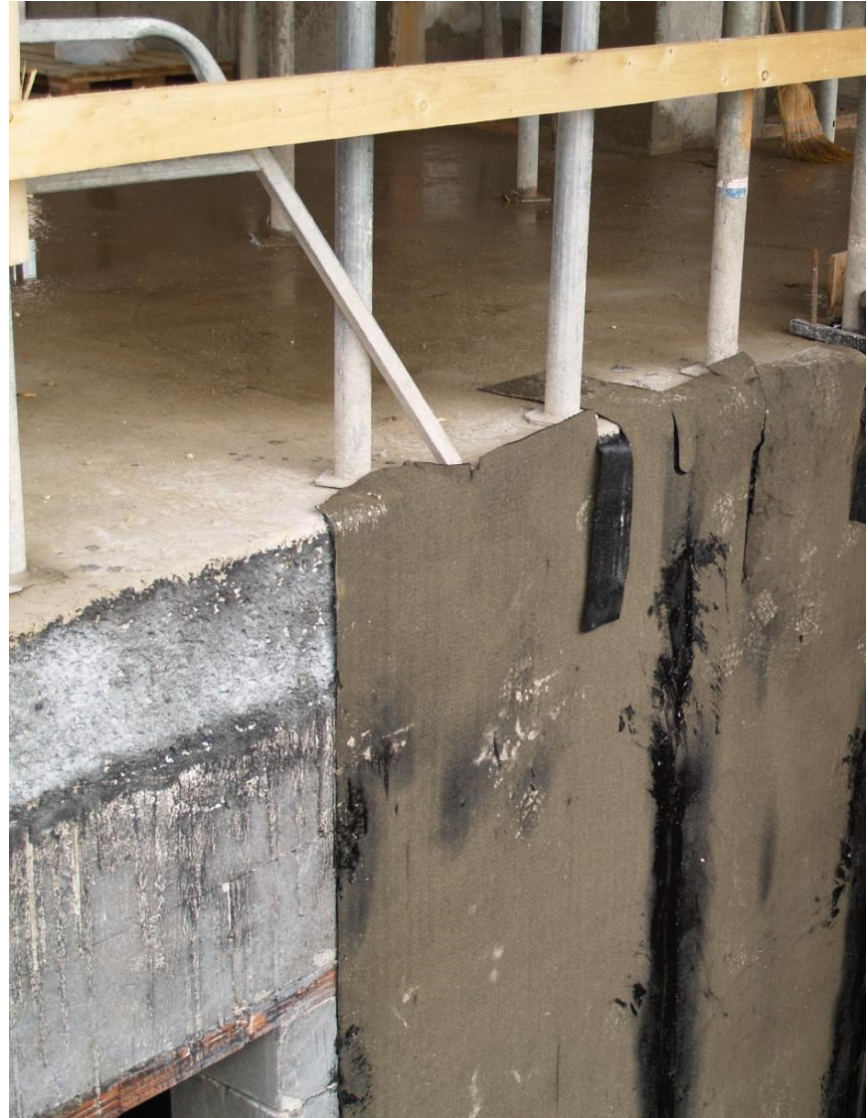
WATERPROOFINGS – TYPICAL MISTAKES

- Design and construction failures
- Mechanical damage
- Lack of performance based design – inadequate waterproofing for the given exposure (f.i. 1 layer of bituminous sheet against subsoil water)
- Discontinuous waterproofing – missing parts or inadequate joints

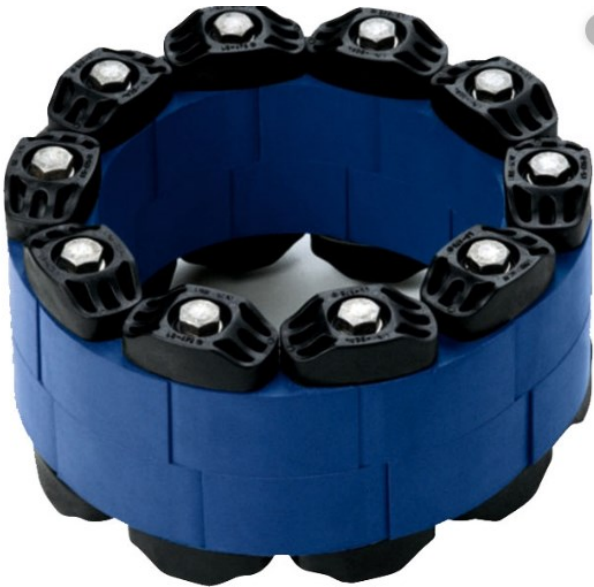
PIPE PENETRATIONS OF WATERPROOFINGS – SLEEVE + LINK-SEAL

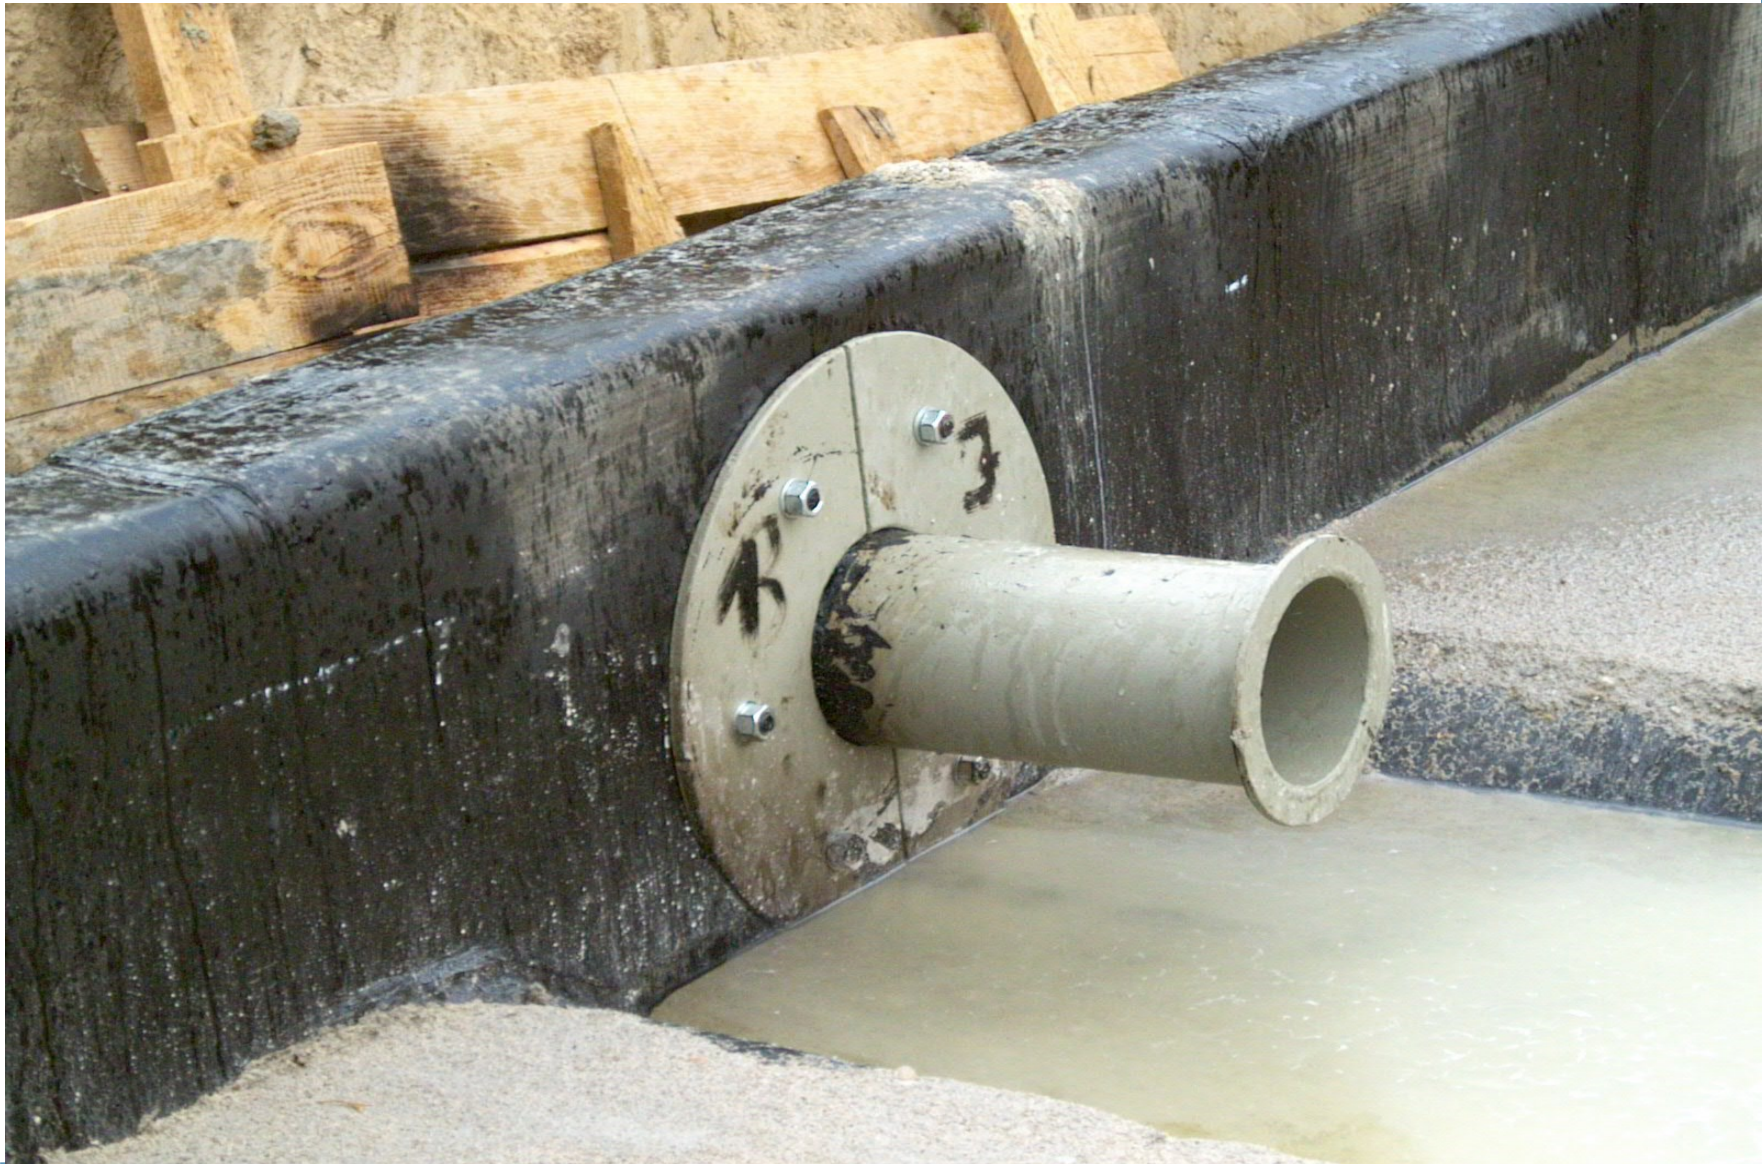
PIPE PENETRATIONS OF WATERPROOFINGS – SLEEVE + LINK-SEAL

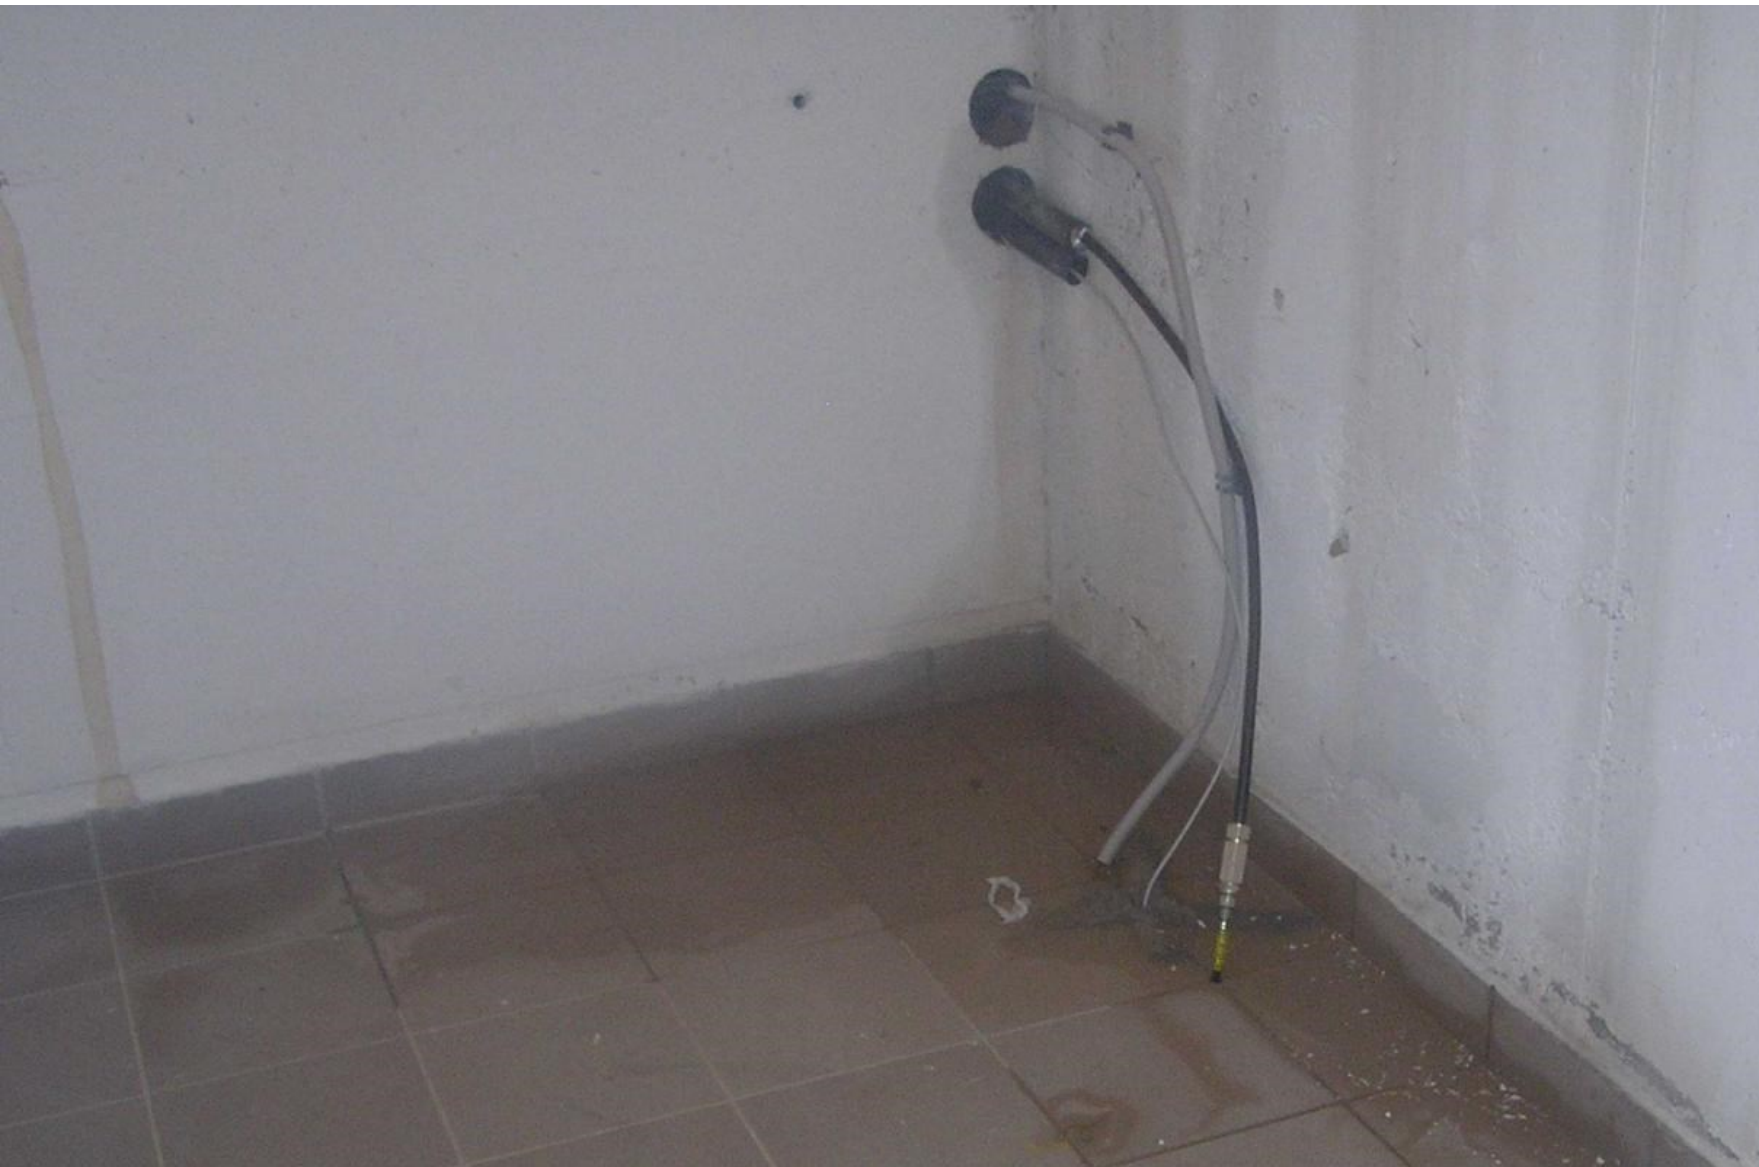
FAILURE: MISSING SLEEVE + LINK-SEAL

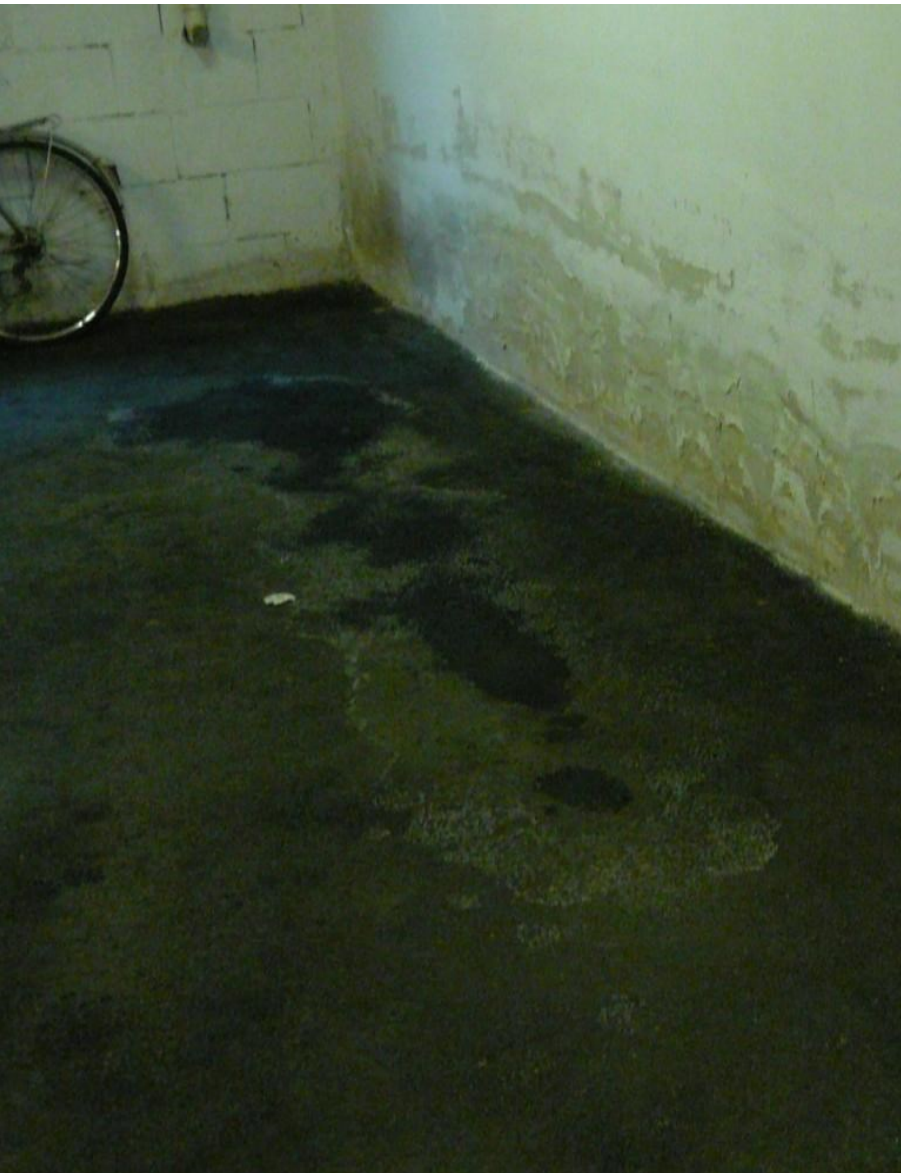
FAILURE: MISSING SLEEVE + LINK-SEAL

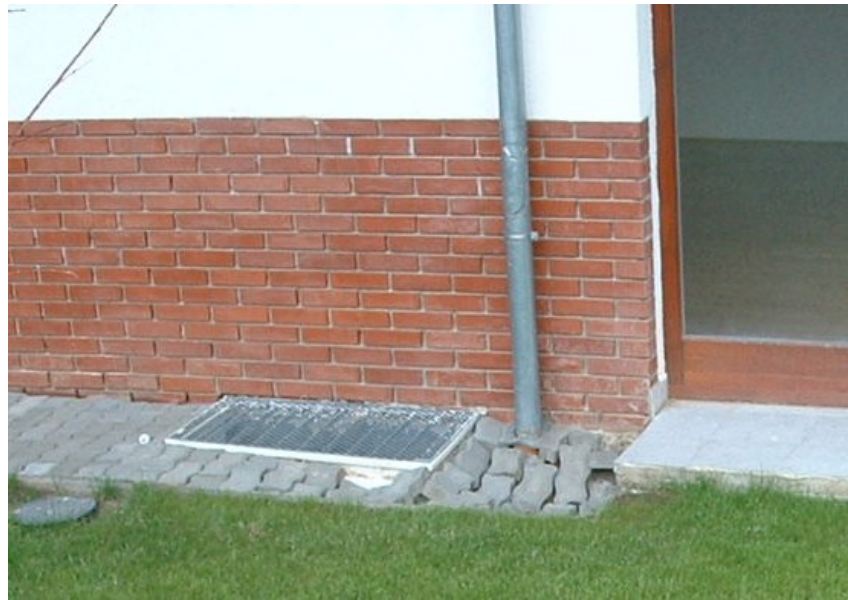
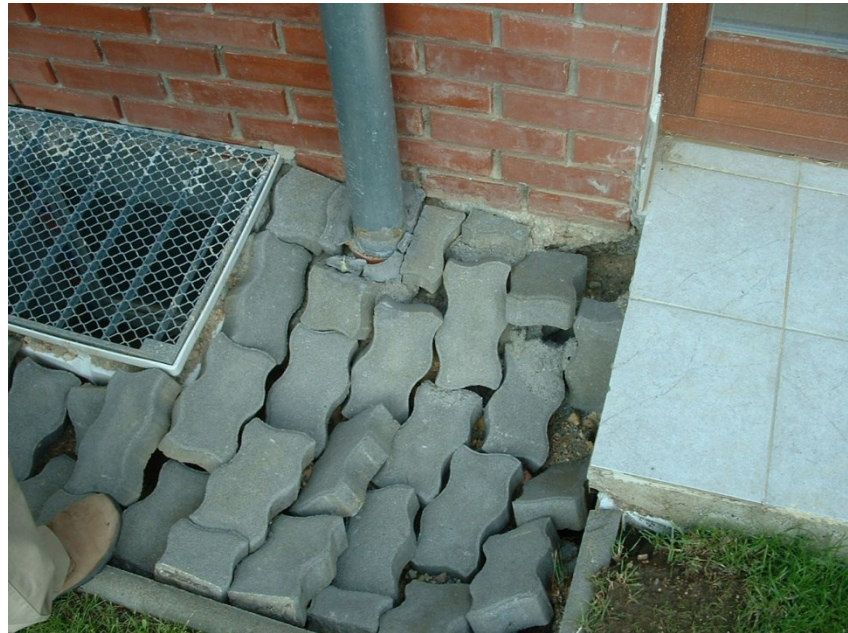
INADEQUATE SOIL BACKFILL POOR COMPRESSING

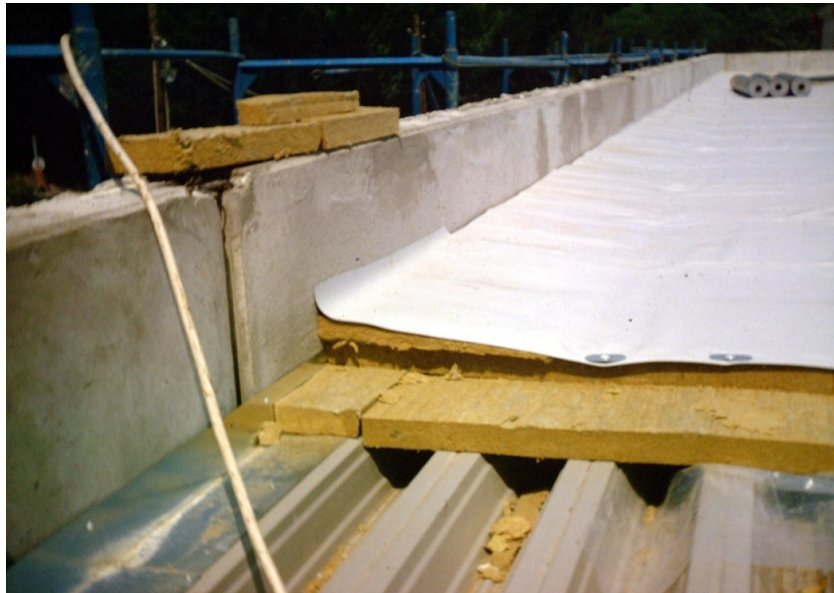
FLAT ROOFS – INCLINATION

- with the loadbearing structure
- screed, lightweight screed
- special thermal insulation

Minimum 2 % (over lightweight structures, minimum 3 %)

Pointwise drainage – linear drainage is not allowed in Hungary!

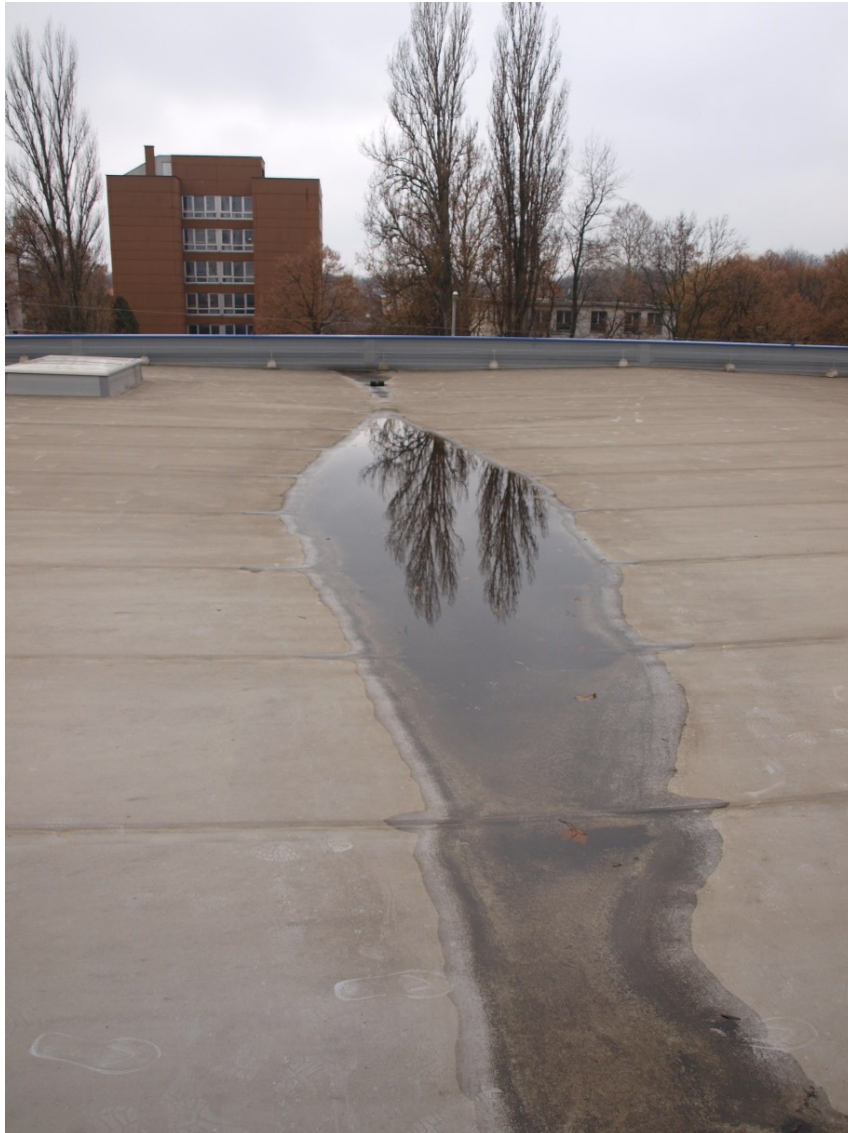
Csarnok lejtésképe

FLAT ROOFS – INCLINATION

szigetelés aljzatának minimális lejtése:
 - hőszigetelt aljzat esetén 2,5%
 - trapézlemez esetén 3% (lehajlás miatt)

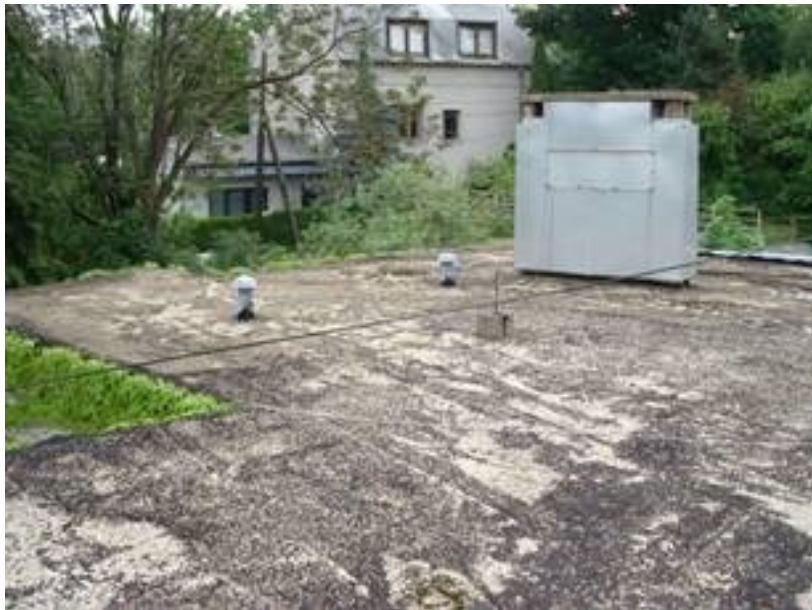
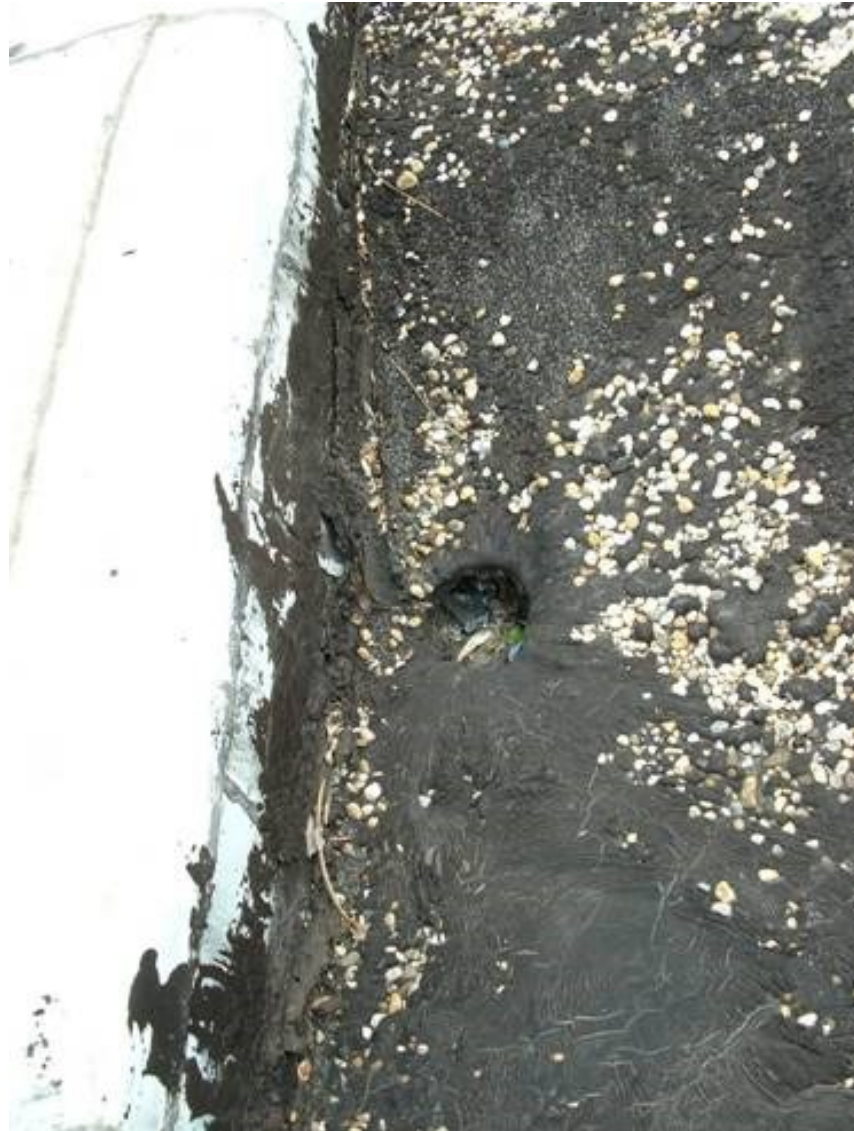
FLAT ROOFS – TYPICAL MISTAKES

- Ageing – especially at bituminous waterproofings (UV protection)
- Inadequate vapour barrier – condensation under the bottom level of the waterproofing
- Inadequate thermal insulation
- Inadequate inclination – water accumulation – ageing, plants
- Blocked rainwater outlets (gullies)
- Inadequate protection against root acid

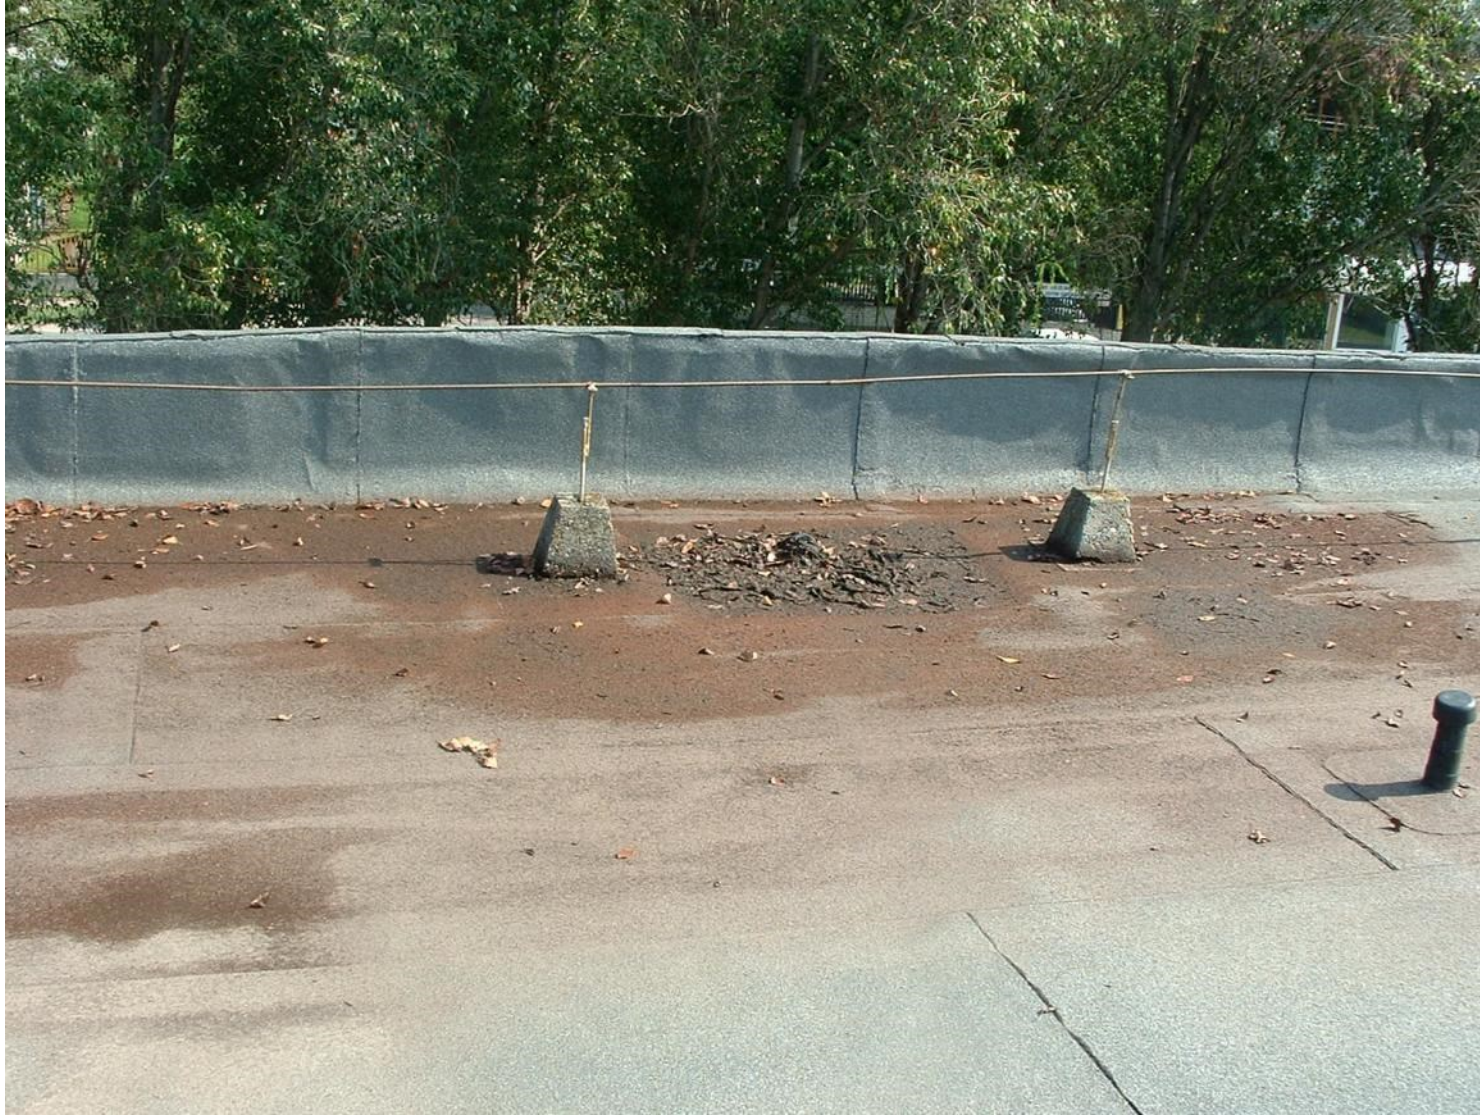
FLAT ROOFS – INADEQUATE INCLINATION

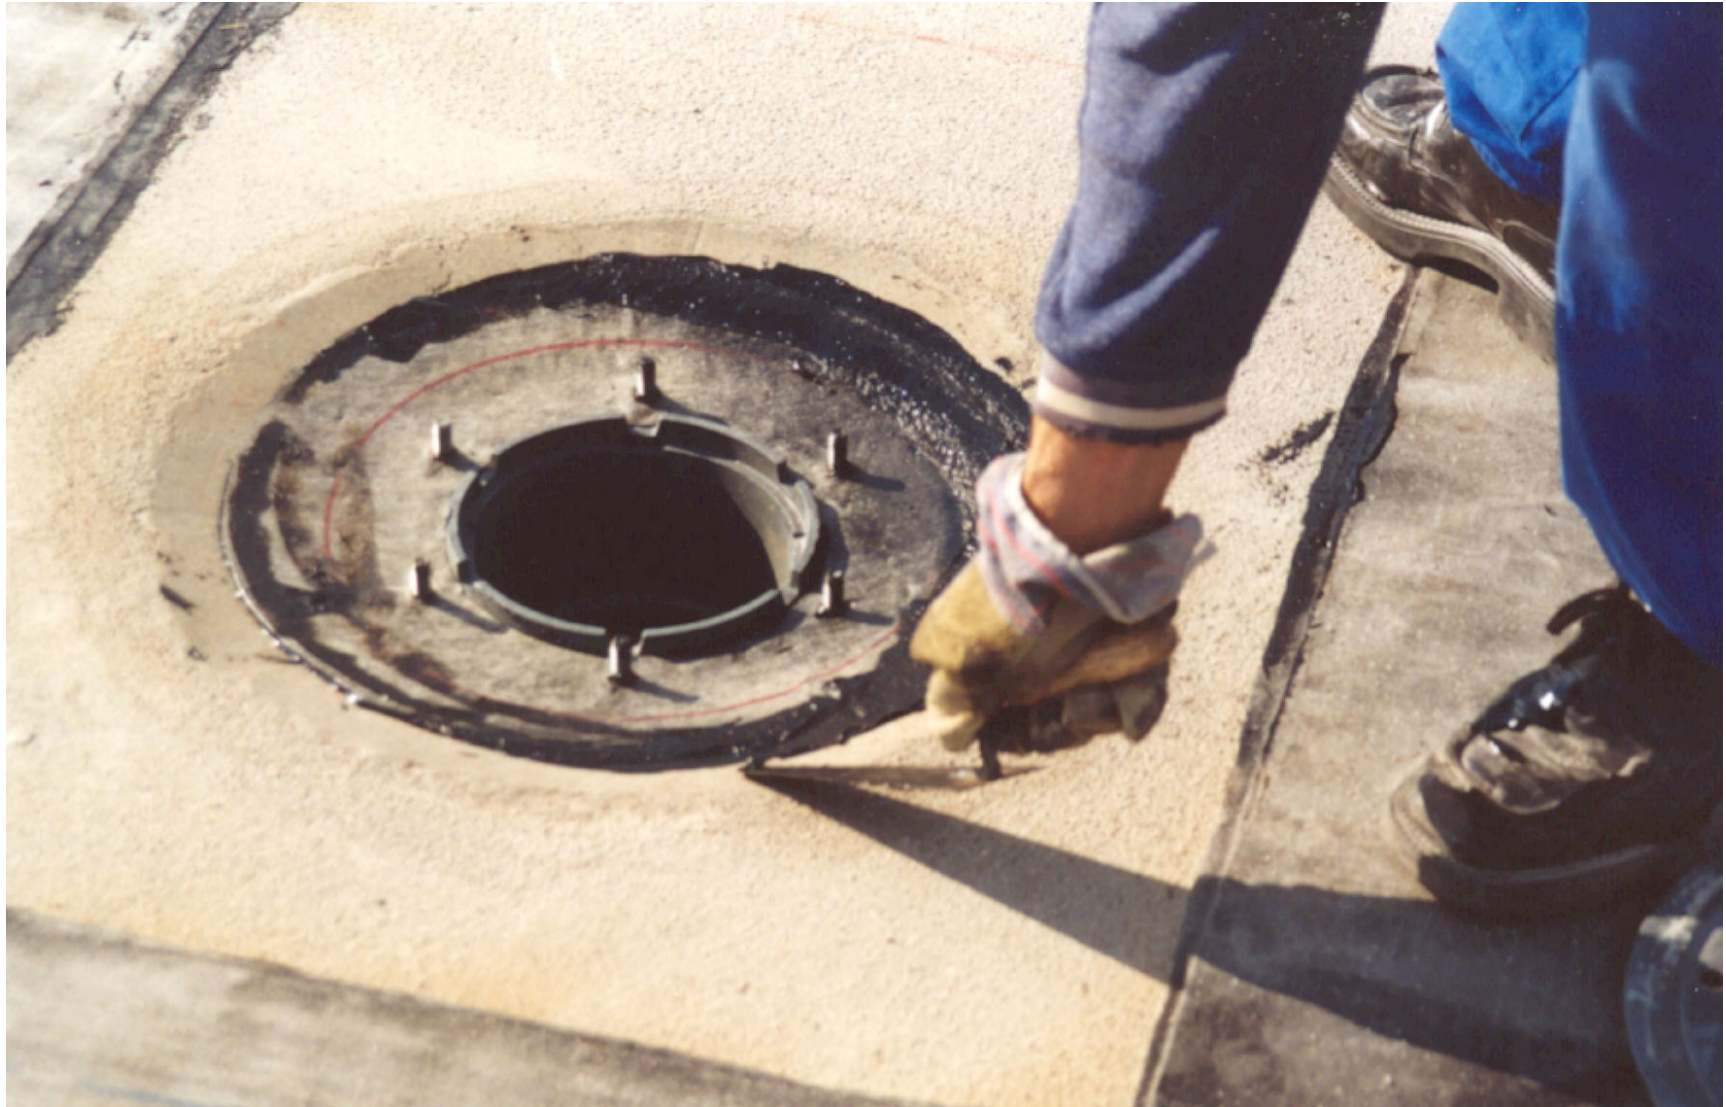
GULLY ALTERNATIVES

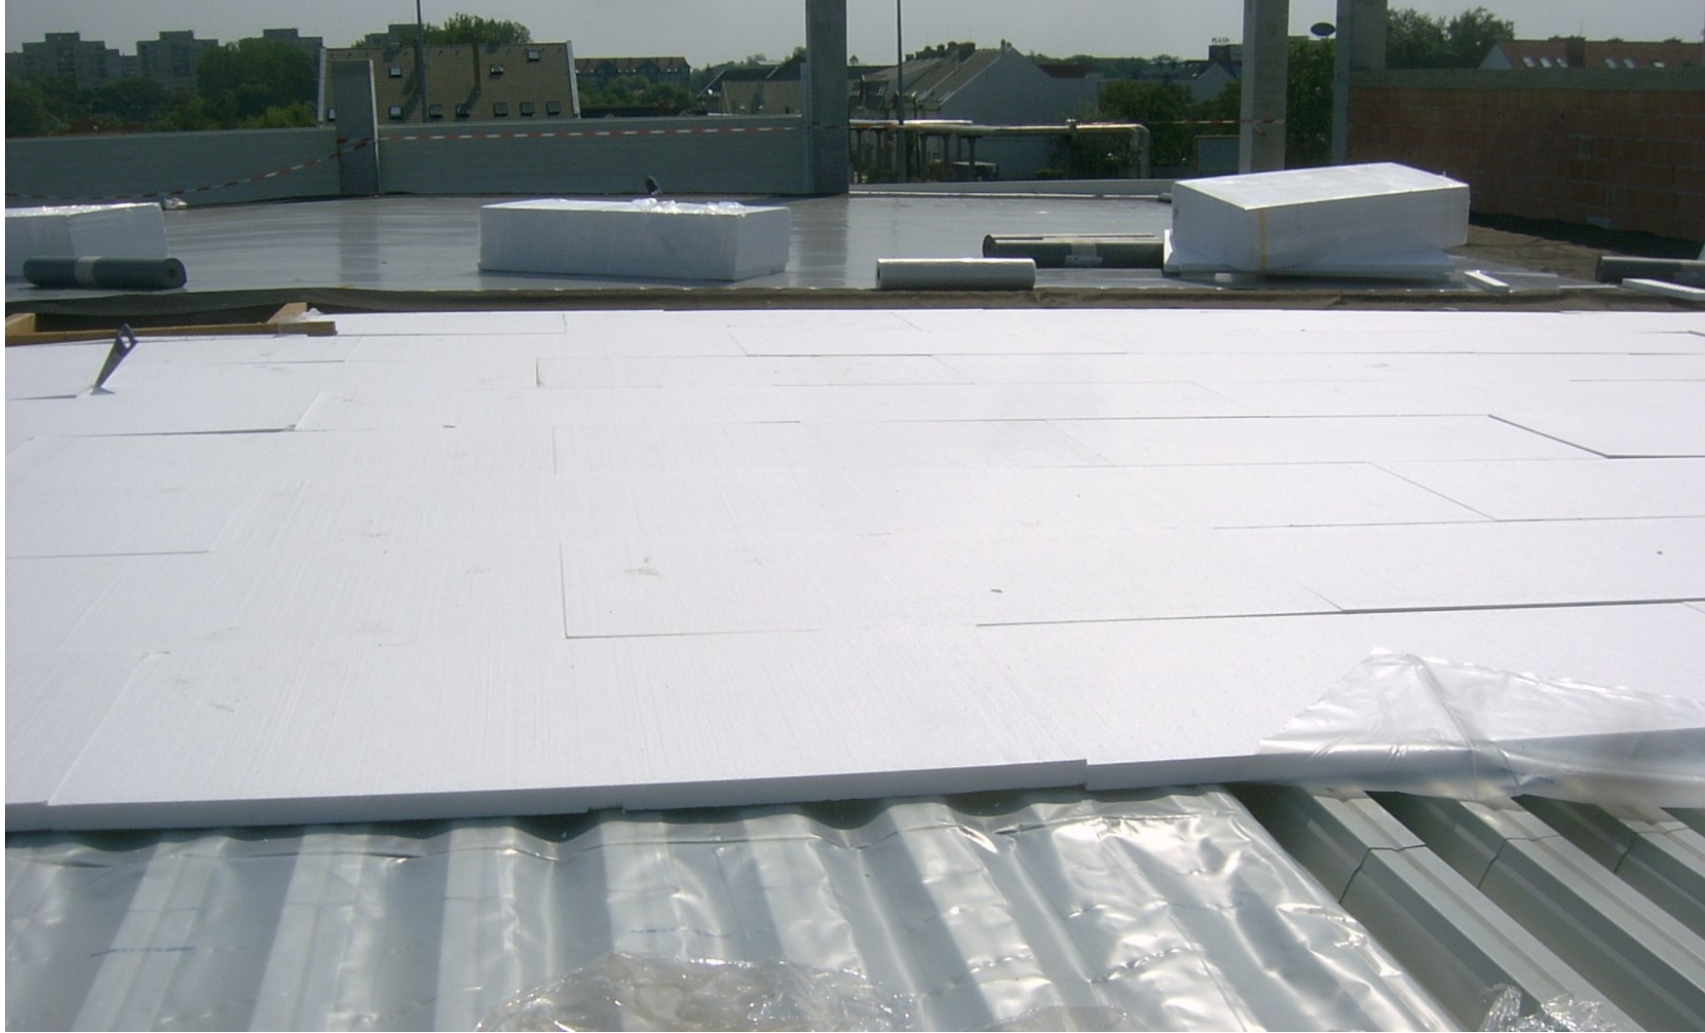
FLAT ROOFS – LACK OF VAPOUR BARRIER CANNOT BE REPLACED WITH TECHNOLOGYCAL FOIL!

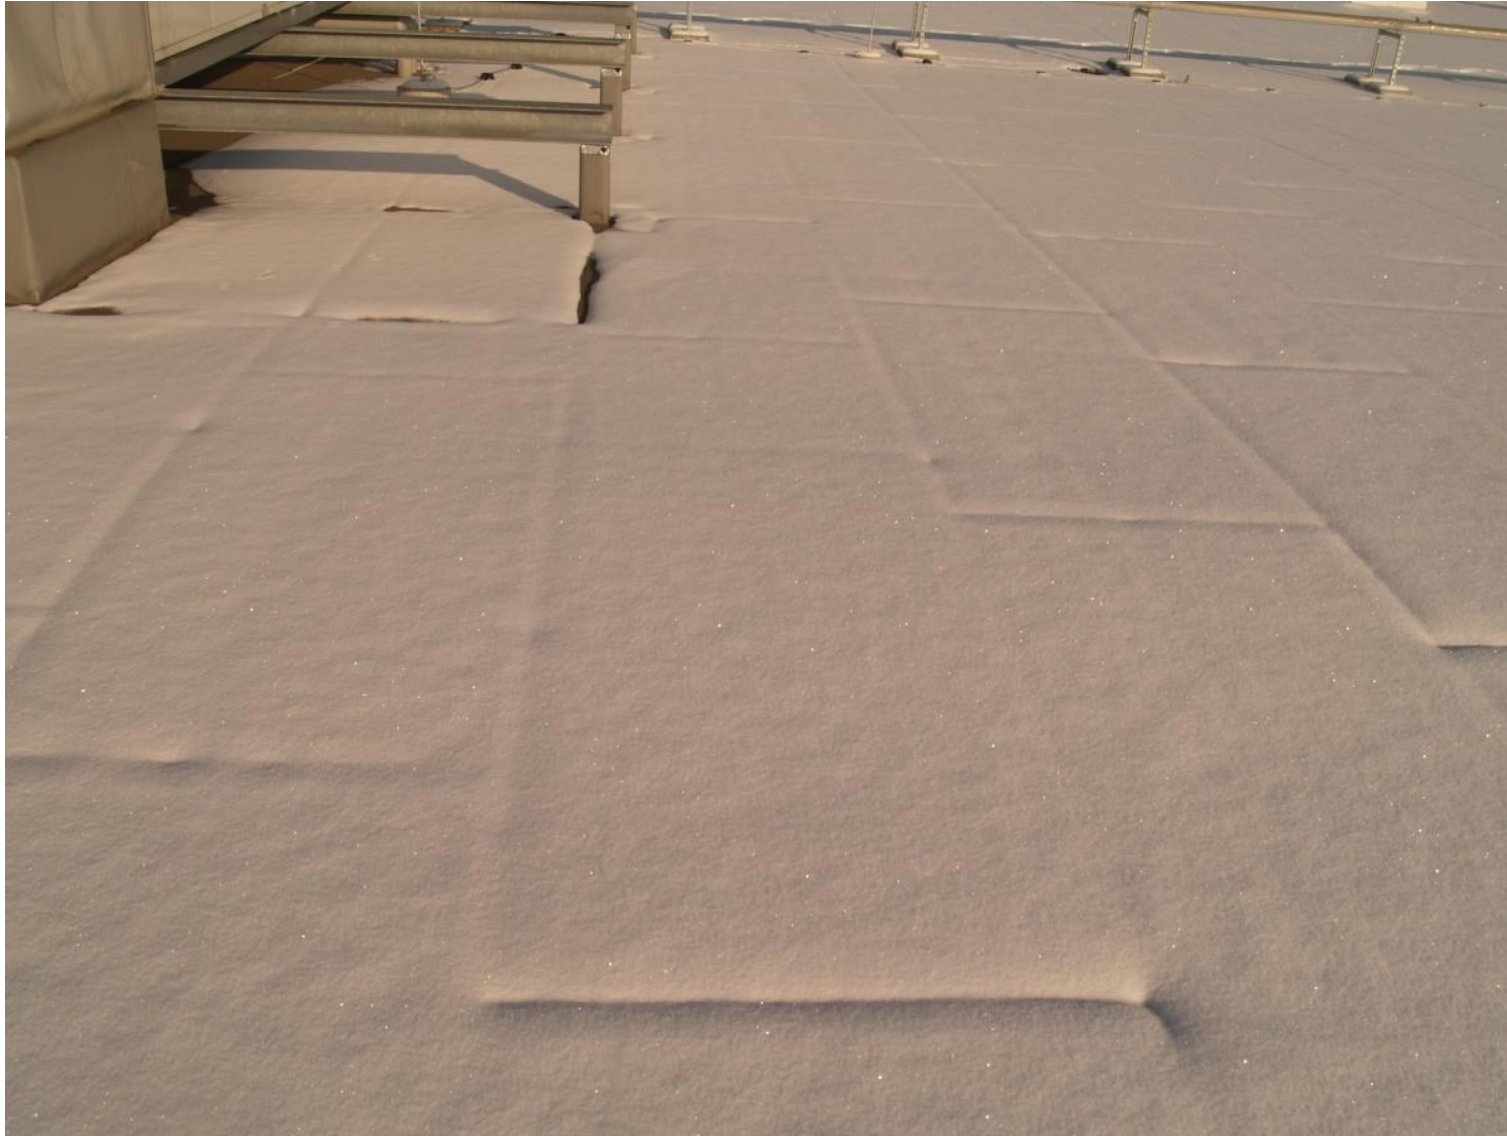
FLAT ROOFS – THERMAL INSULATION BOARD SHRINKING

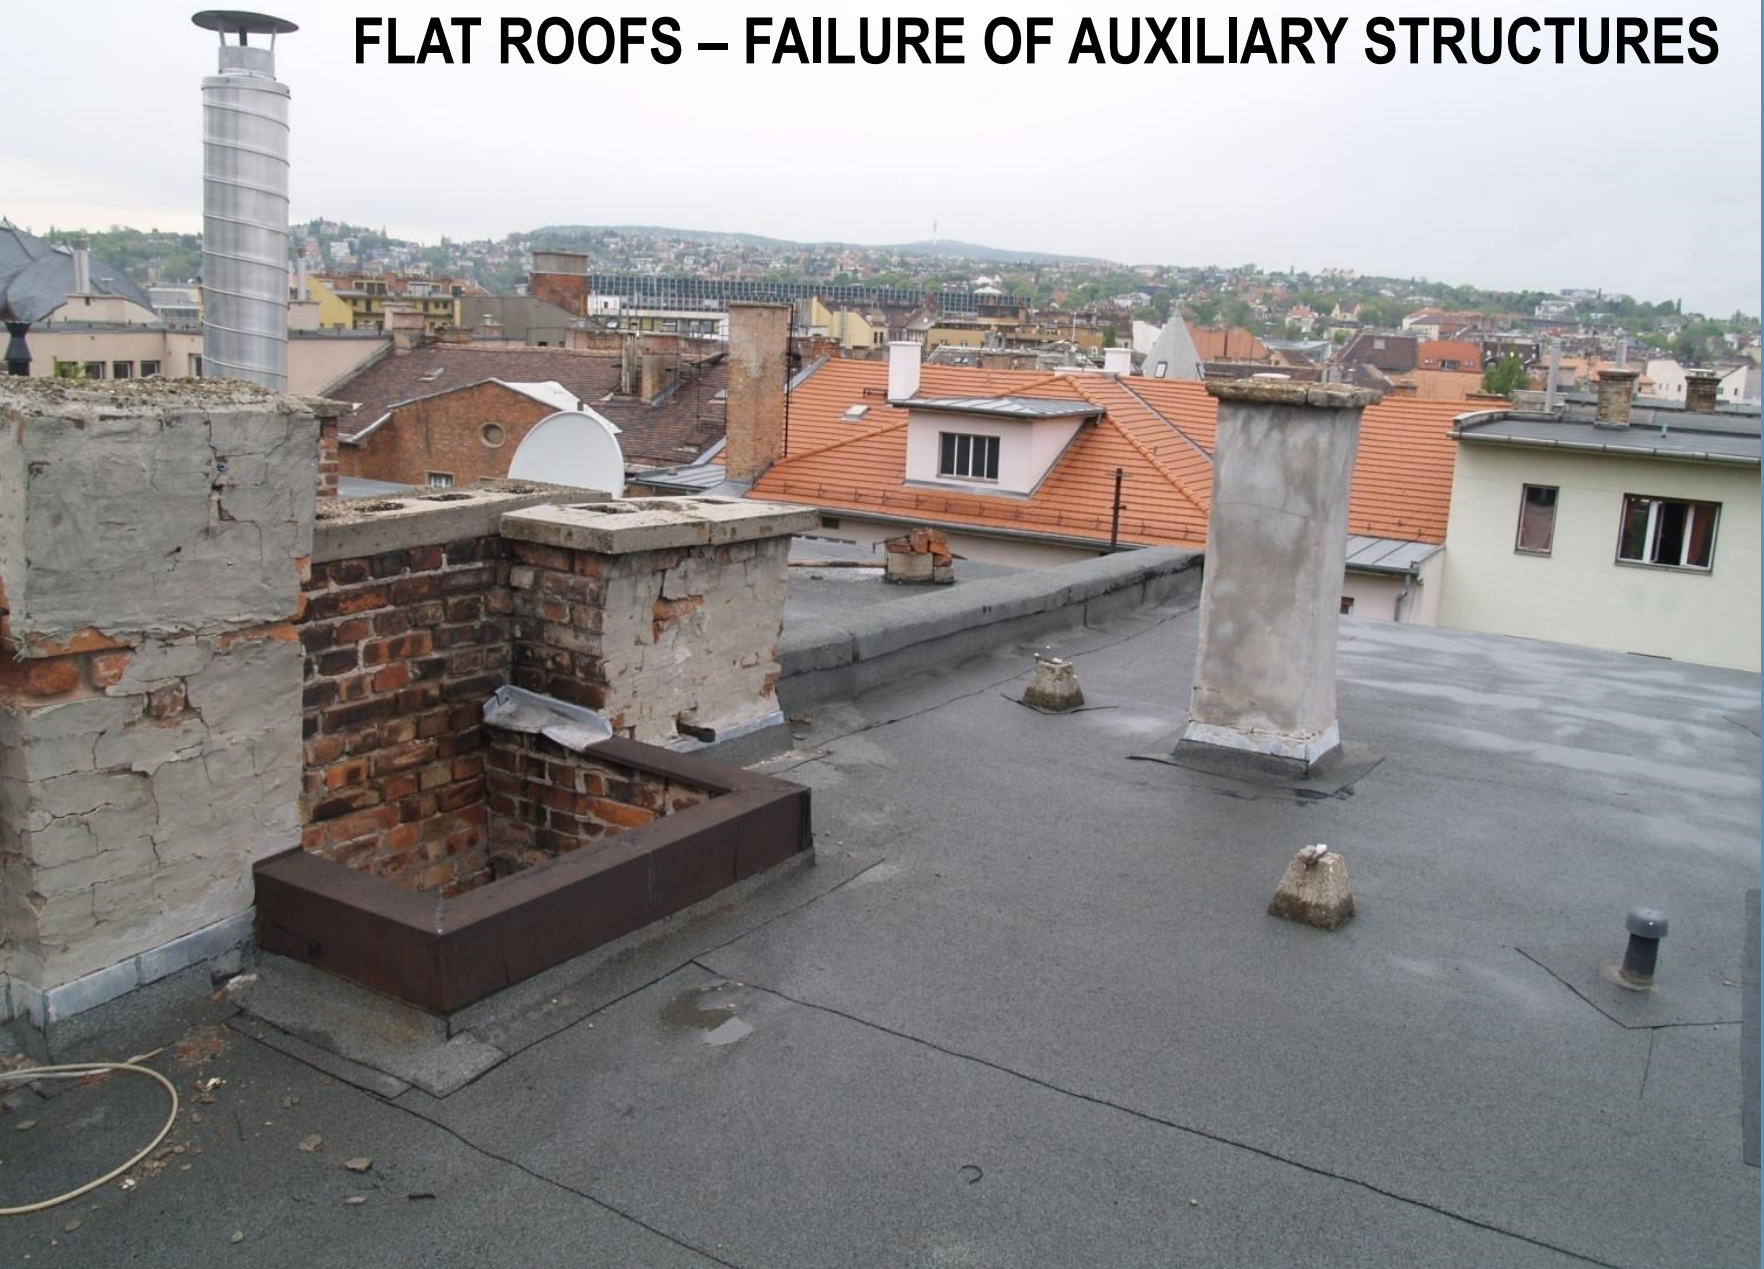
FLAT ROOFS – FAILURE OF AUXILIARY STRUCTURES

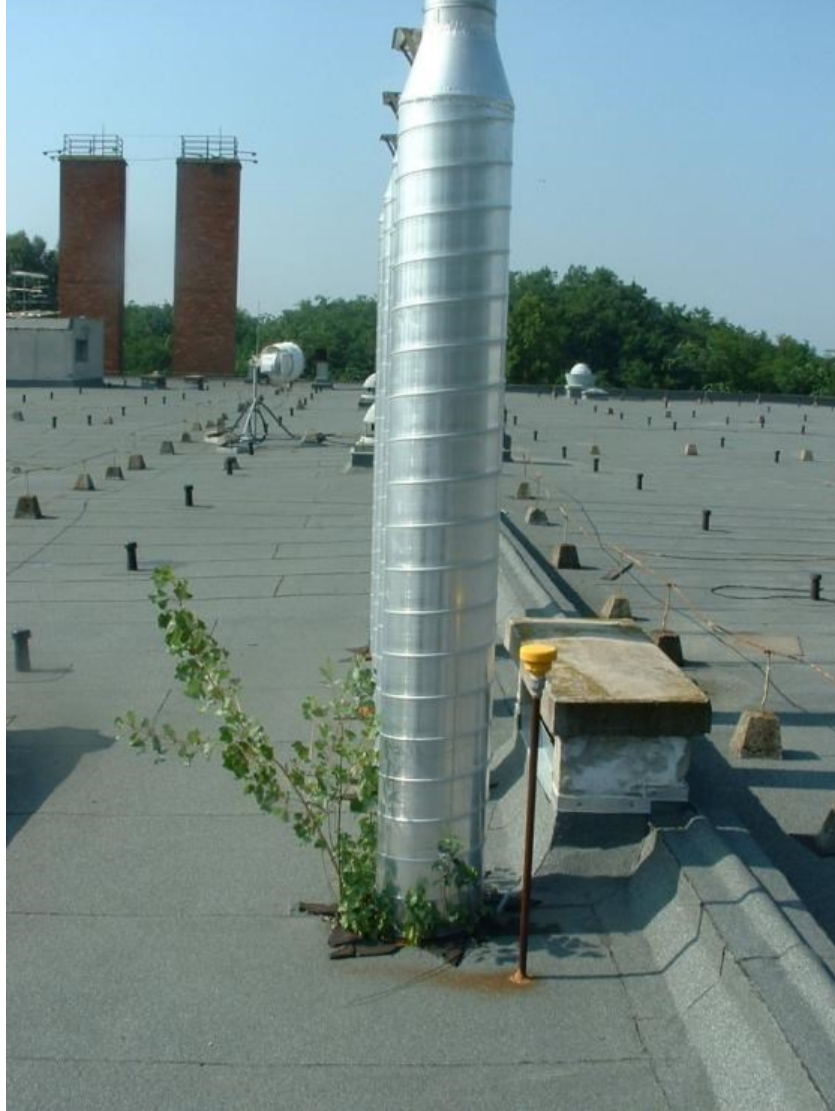
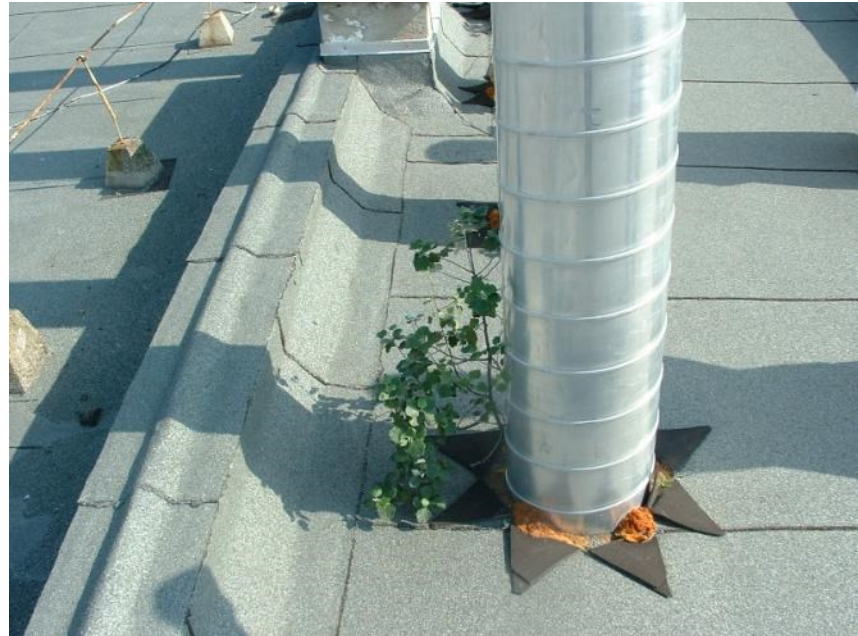
FLAT ROOFS – IMPROPER CRAFTMANSHIP

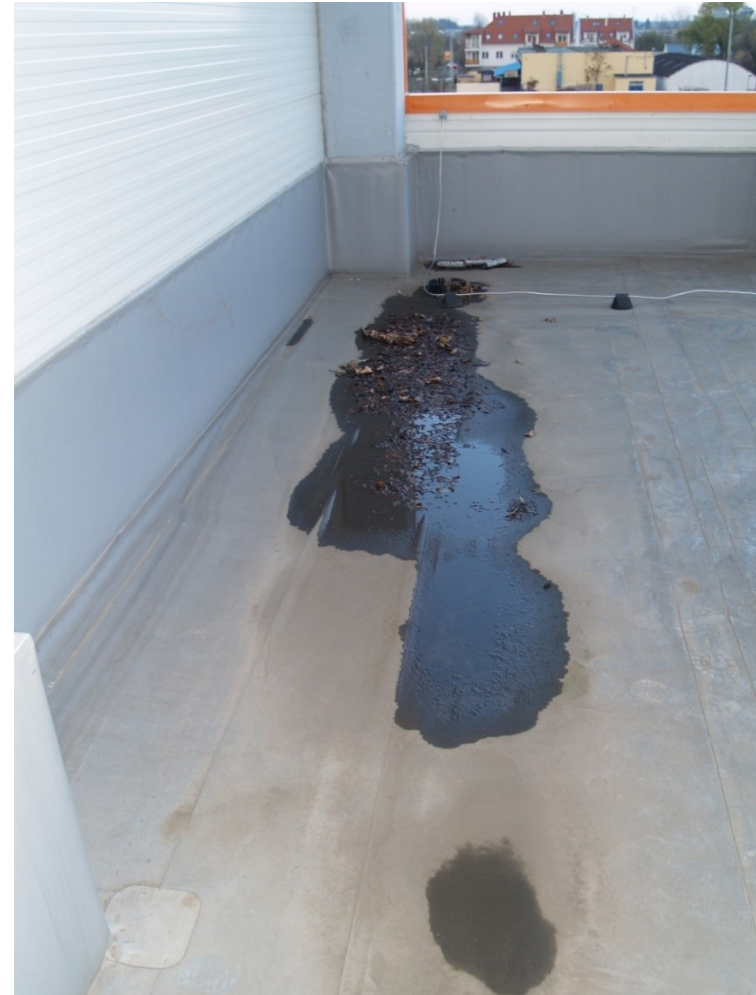
FLAT ROOF FAILURES
