BUILDING REHABILITATION

3. WATERPROOFINGS, FLAT ROOFS, DOORS AND WINDOWS

Lajos Gábor, Takács PhD

BME Department of Building Constructions

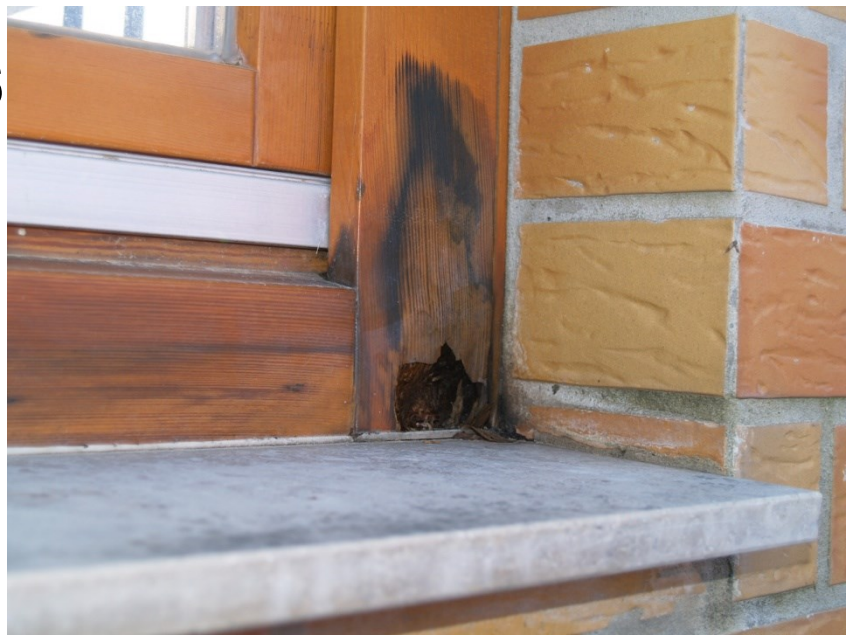
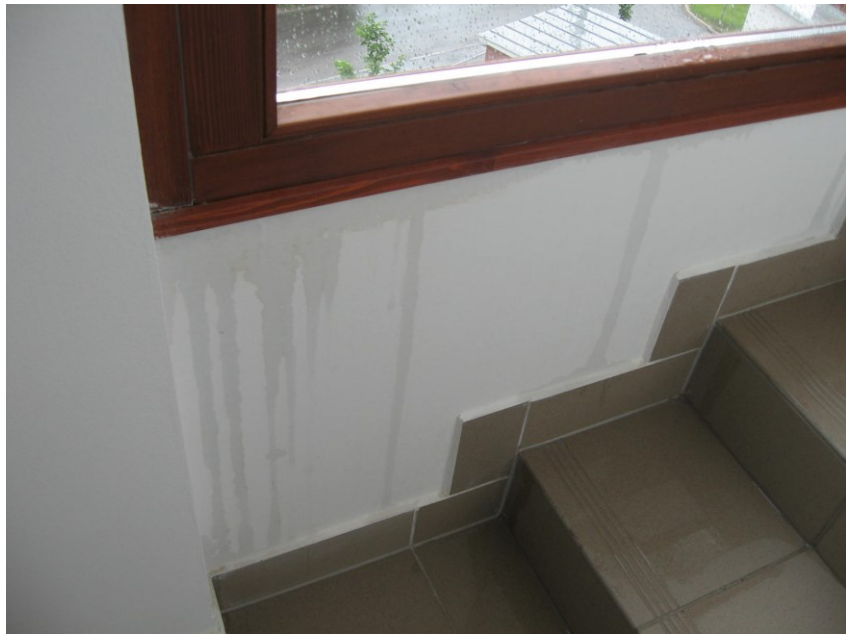
EXTERNAL DOORS AND WINDOWS

- Missing lintel – deformation
- Improper installation – missing external wind-and raintight foil, missing vapour barrier
- Thermal bridge – poor thermal insulation around the door or window
- Mechanical failure – lack of maintenance
- Failure of finishing (especially at timber windows)
- Missing connection to the waterproofing – water penetration

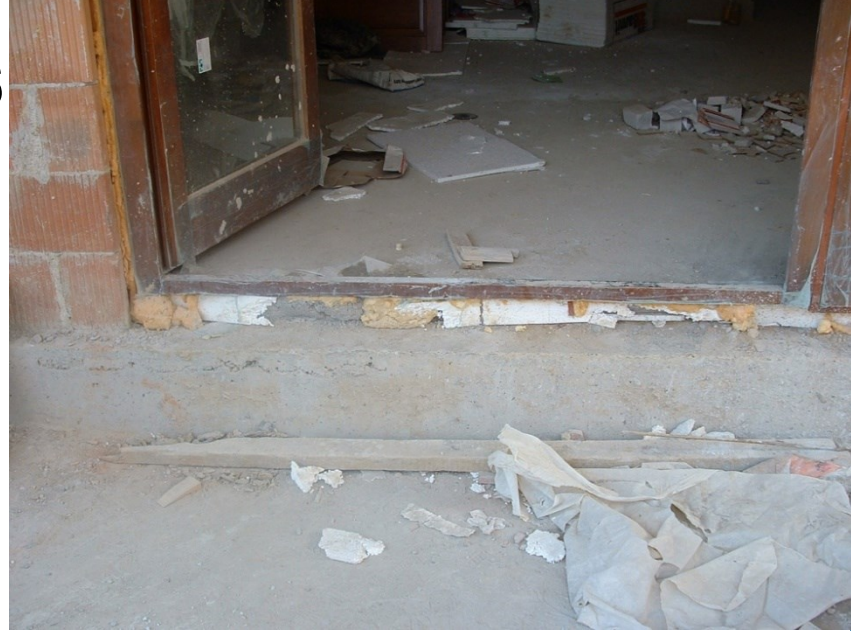
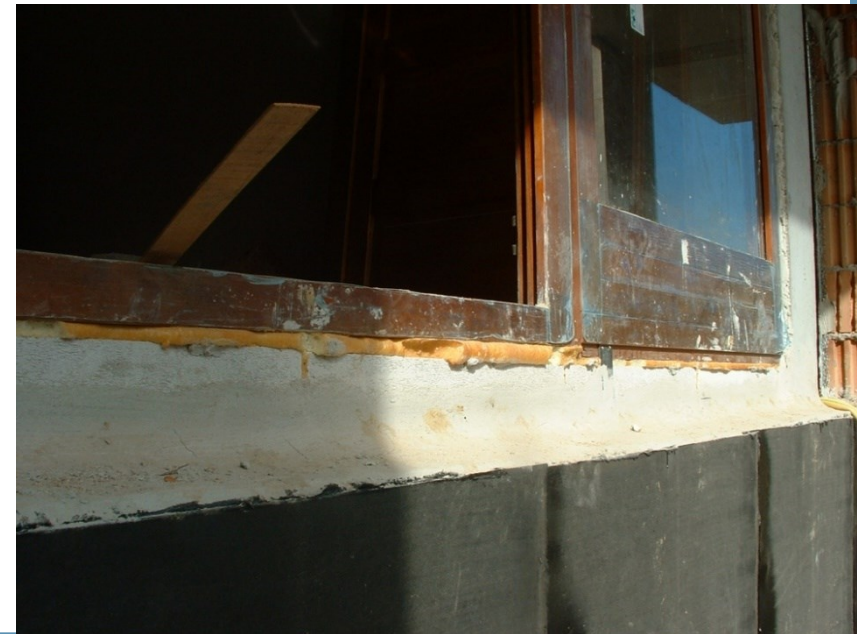
EXTERNAL DOORS AND WINDOWS

- Missing lintel – deformation
- Improper installation – missing external wind-and raintight foil, missing vapour barrier
- Thermal bridge – poor thermal insulation around the door or window
- Mechanical failure – lack of maintenance
- Failure of finishing (especially at timber windows)
- Missing connection to the waterproofing – water penetration

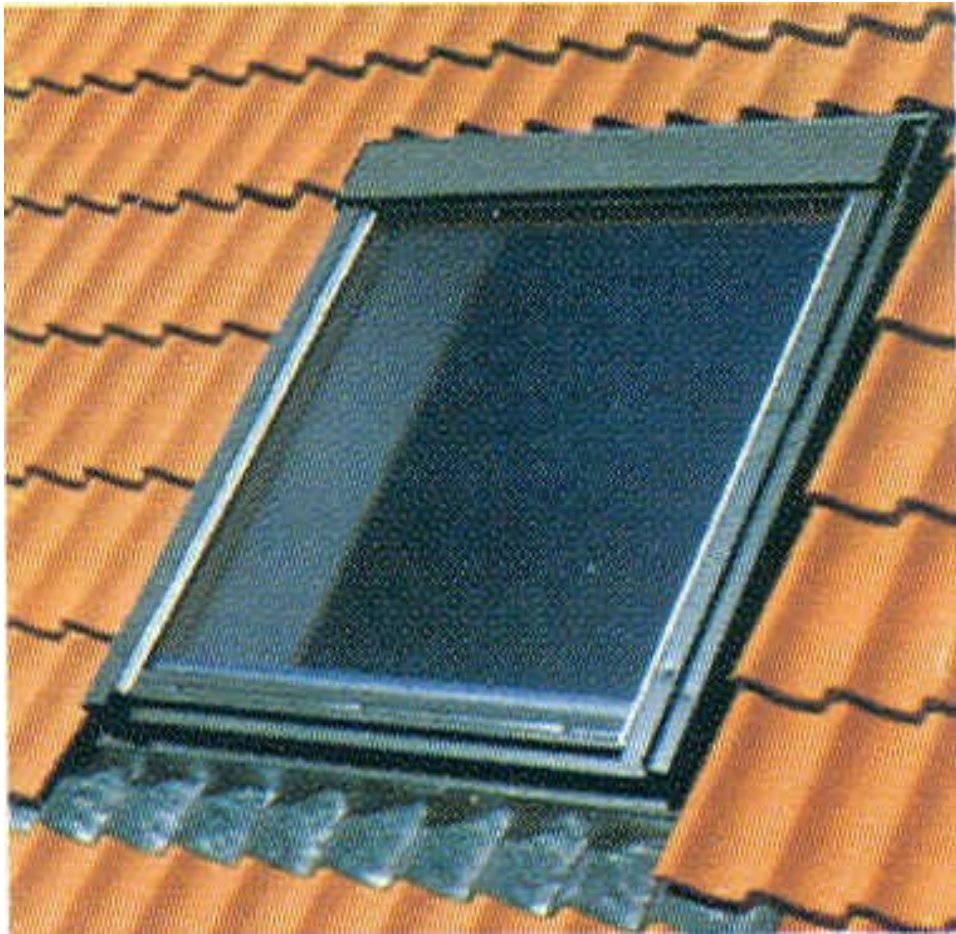
SKYLIGHT WINDOWS – INSTALLATION

↑protection of bottom edge with ribbed lead sheet

gutter strips around the window frame →

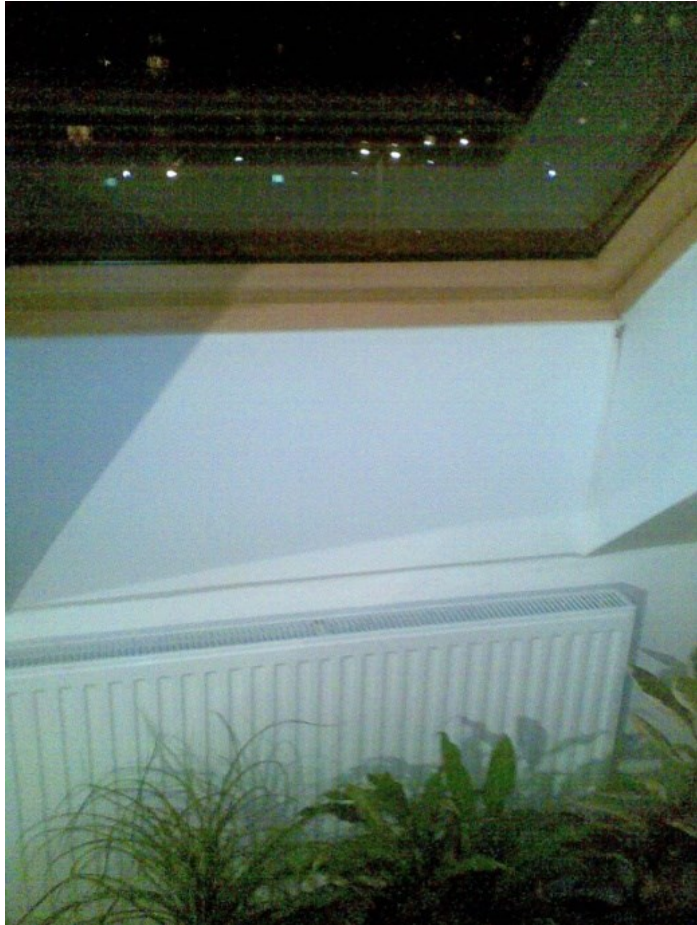
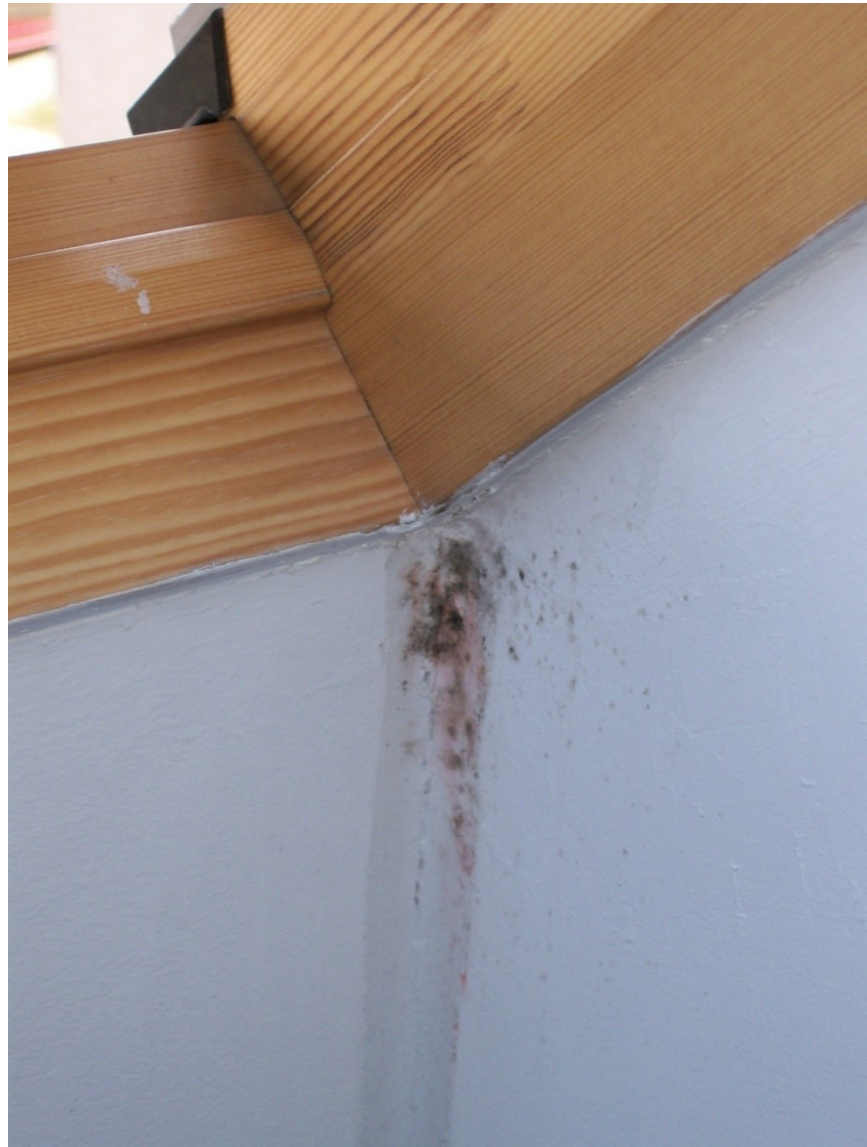
SKYLIGHT WINDOWS – IMPROPER INSTALLATION

Vapour condensation „open sky”
problem (overcooling problem) – must
be compensated with local heating unit!

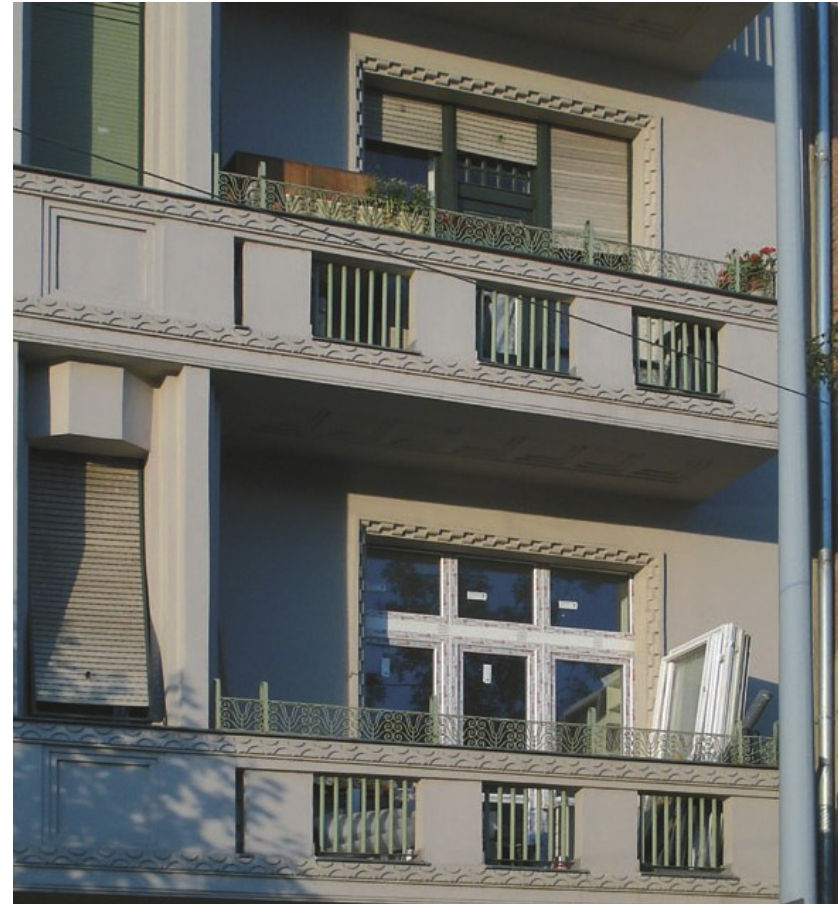
REPLACEMENT OF TRADITIONAL DOUBLE SASH WINDOW TO SINGLE SASH UP-TO-DATE CONSTRUCTION INCREASING THERMAL BRIDGE EFFECT

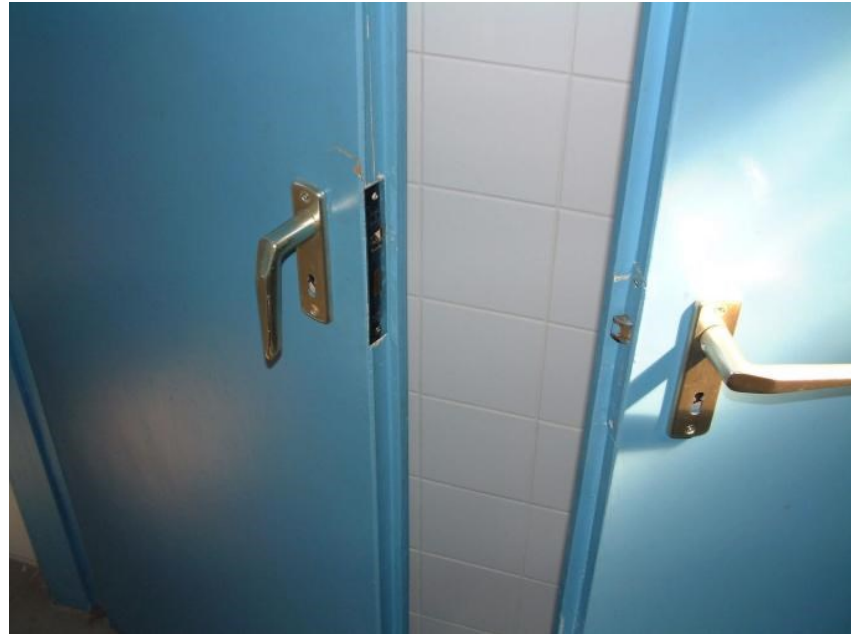
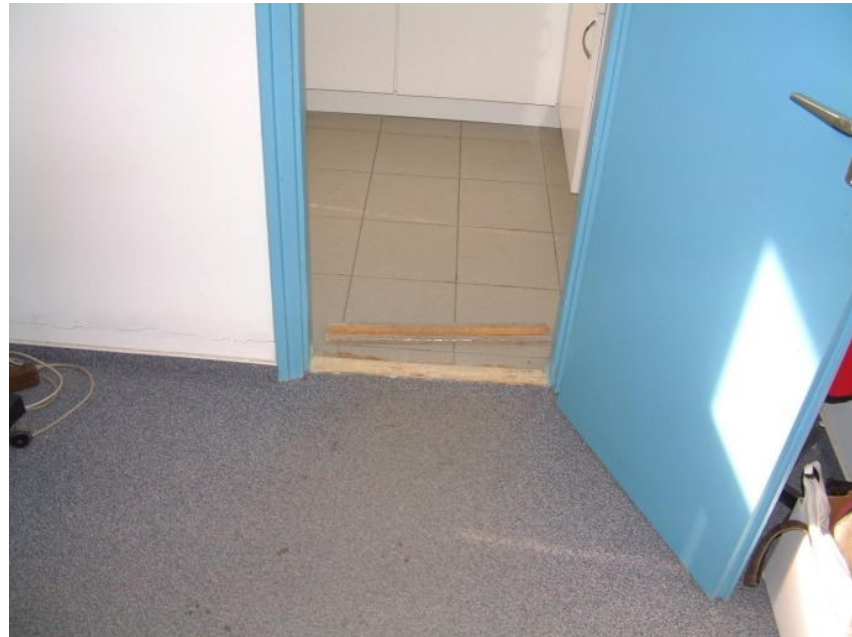
FAILURES OF INTERNAL DOORS

- Missing lintel – deformation
- Improper installation

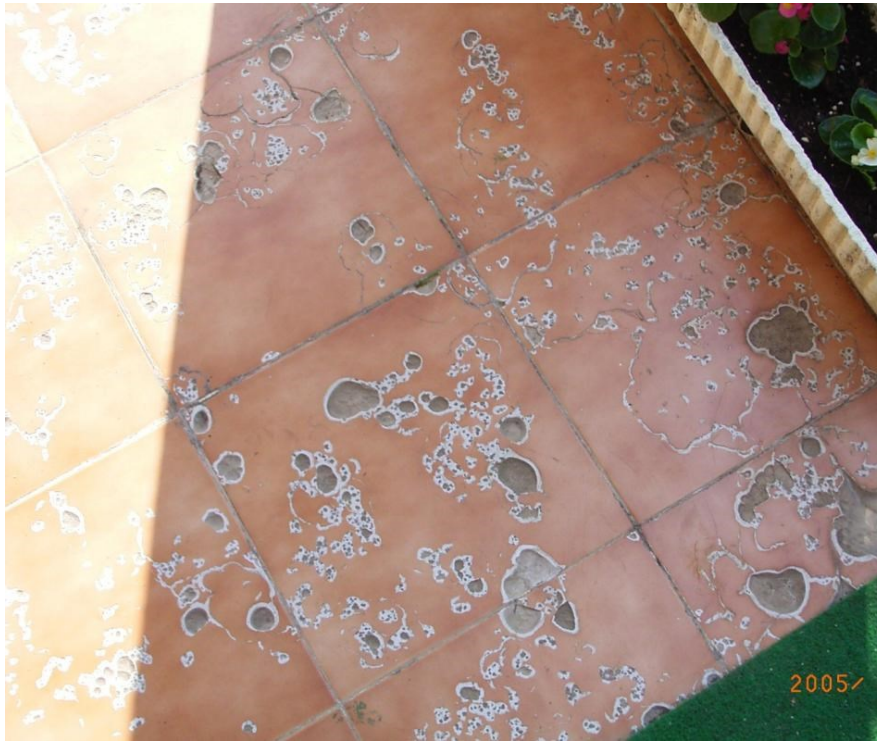
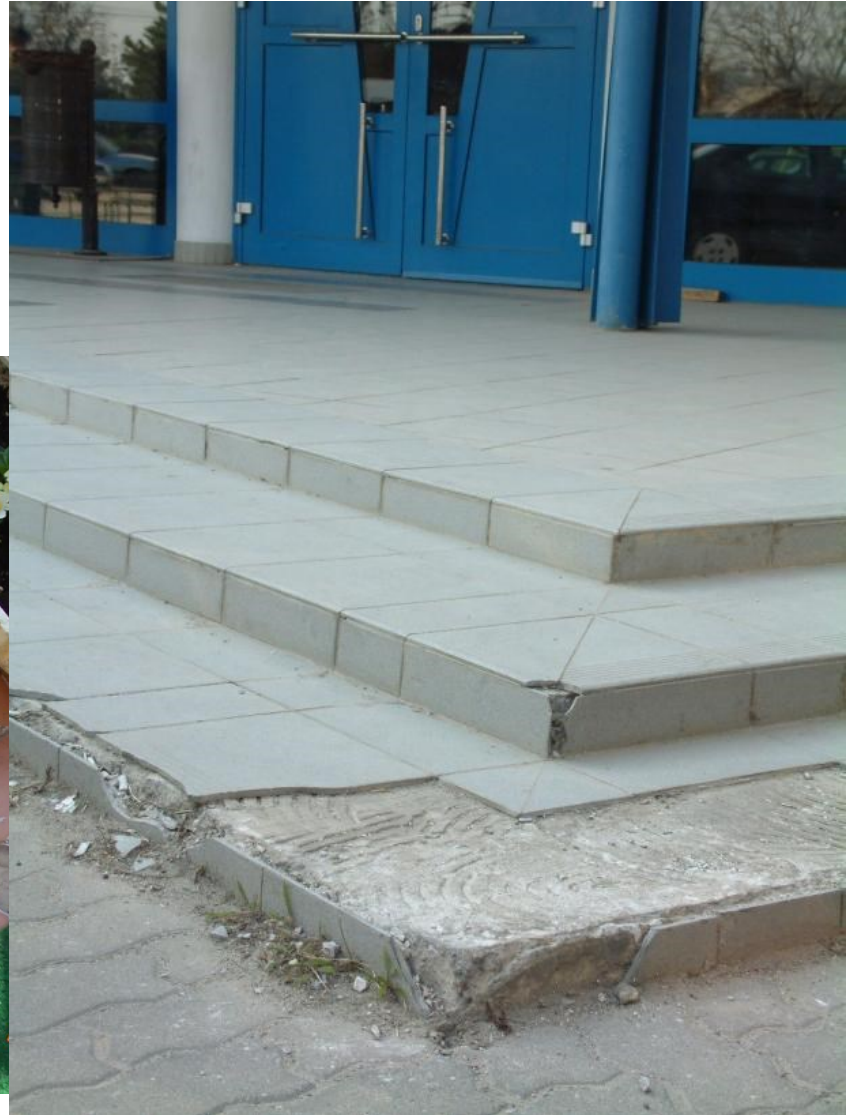
FLOOR COVERING FAILURES

Typical failures are:

- Frost damage
- Mechanical damage
- Improper anti-slippery performance
