Curtain wall of the staircase - View 1:50

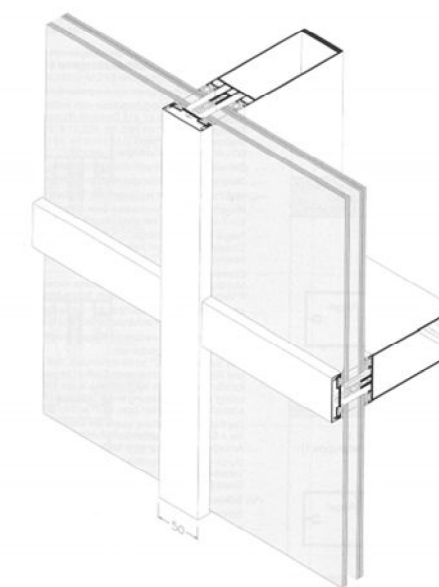
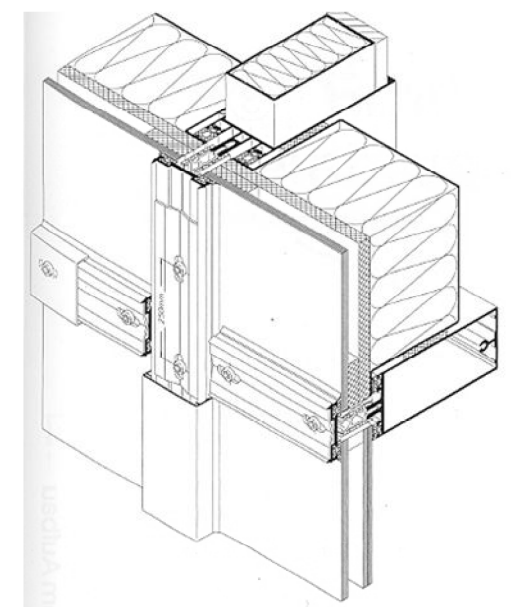
Axonometric view of
the glazing and glazed panels
