**Window lintel and internal slab connection Detail No 2. S=1:5**

**Window side Detail No. 3 S=1:5**

**Window sill Detail No. 4 S=1:5**

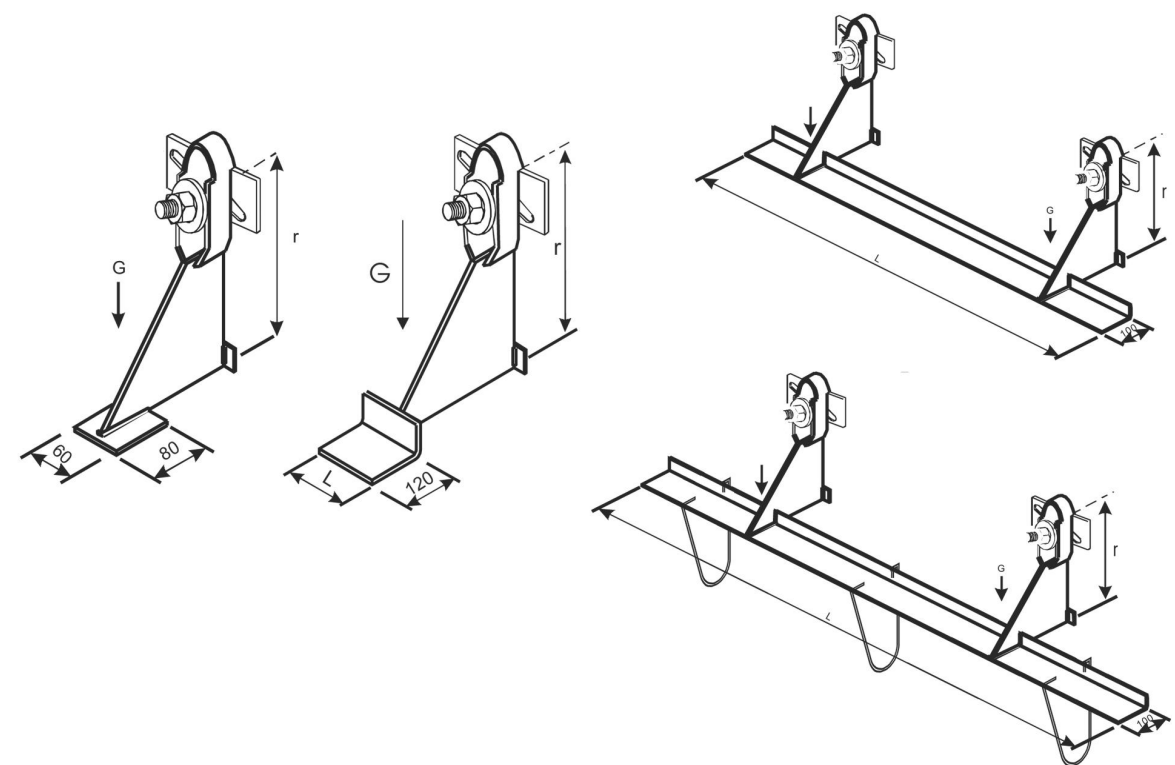
Support system alternatives

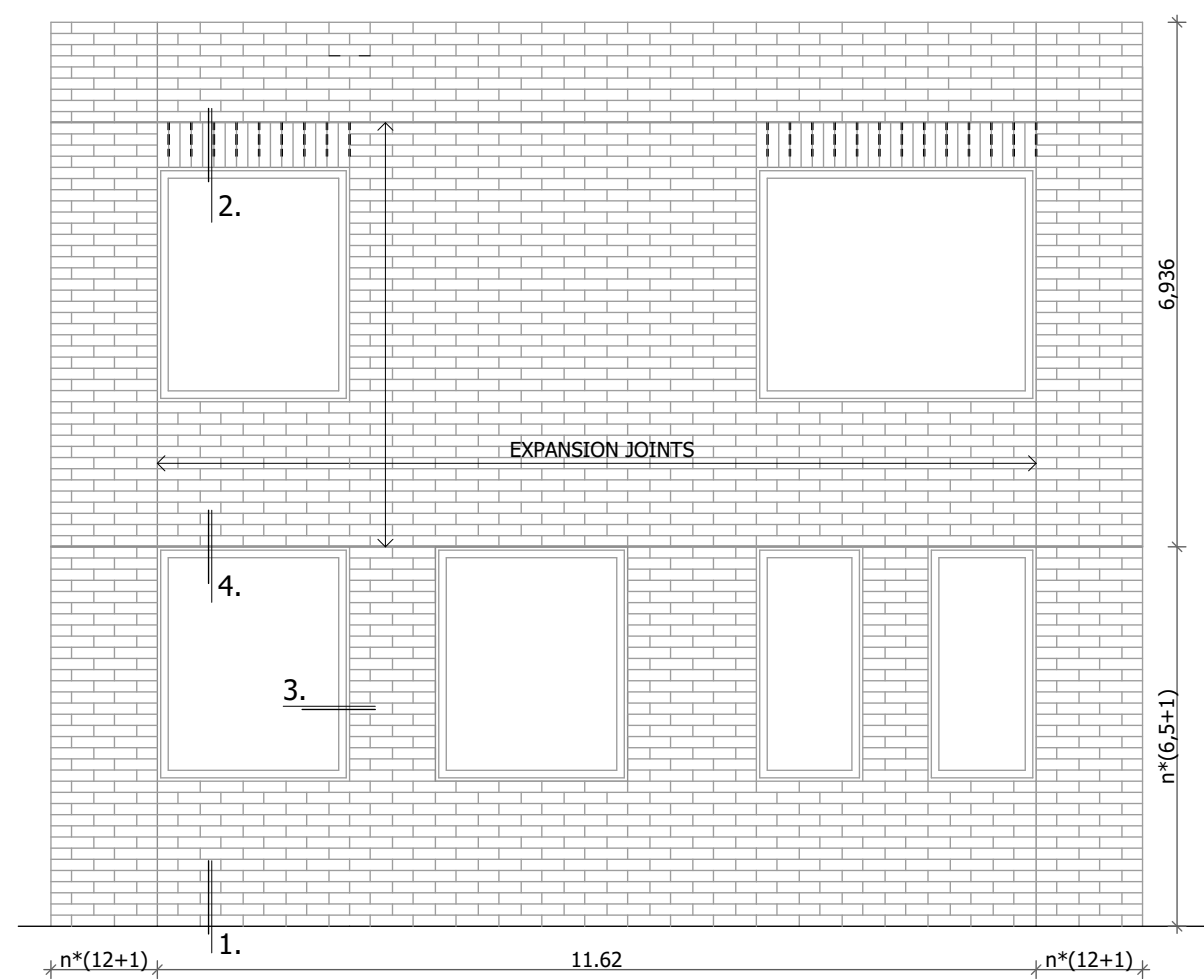
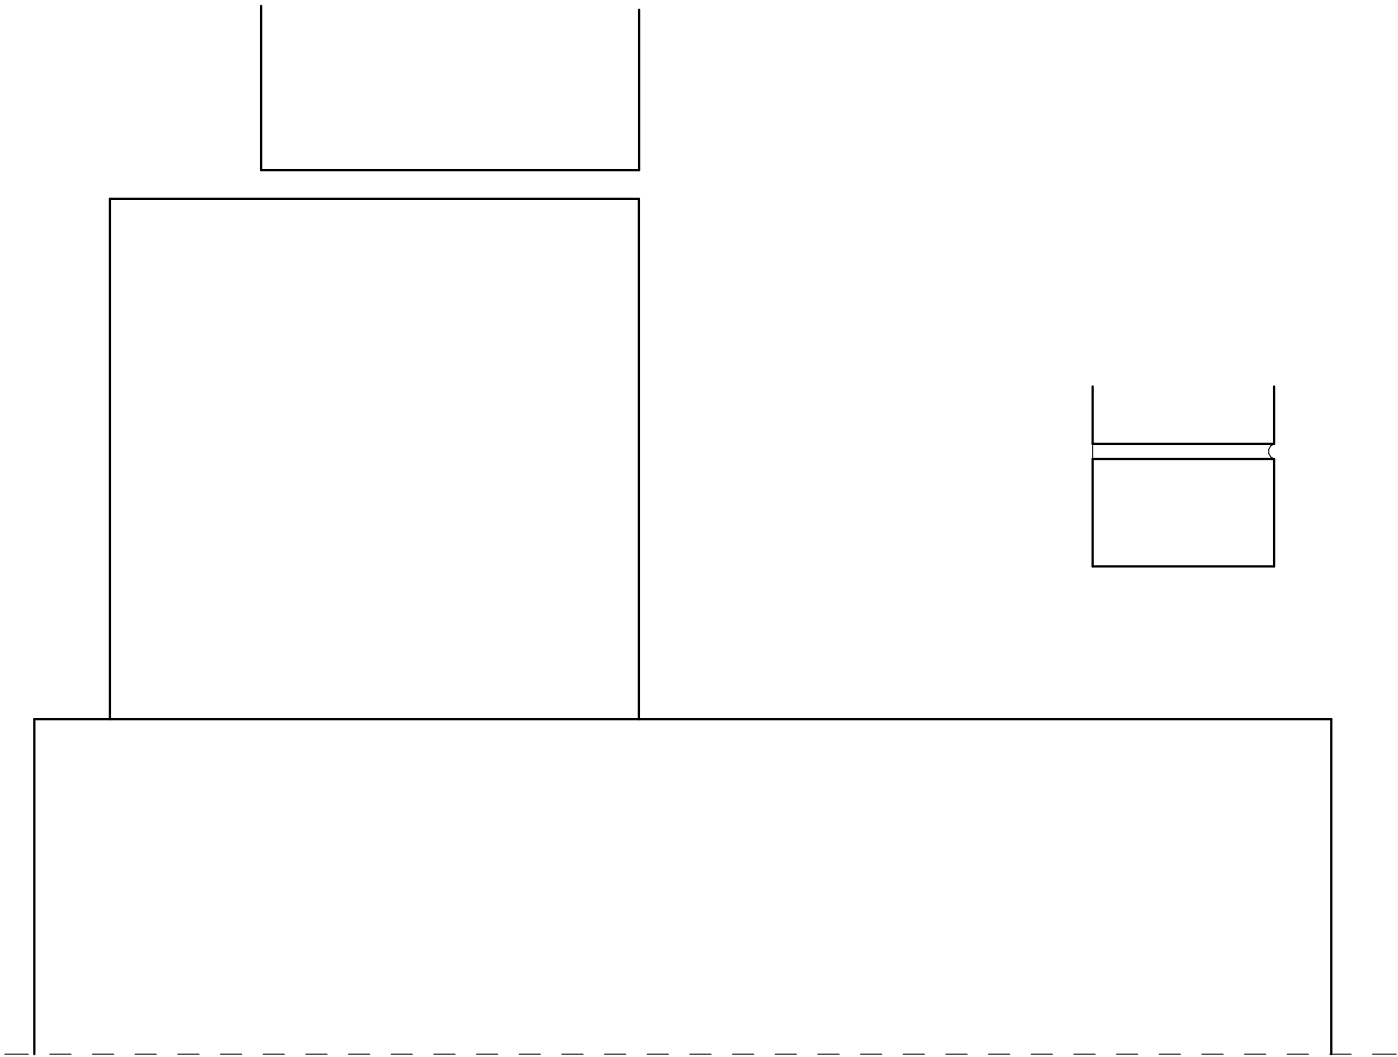
Arrangement of the expansion joints on the facade view
