Support system alternatives

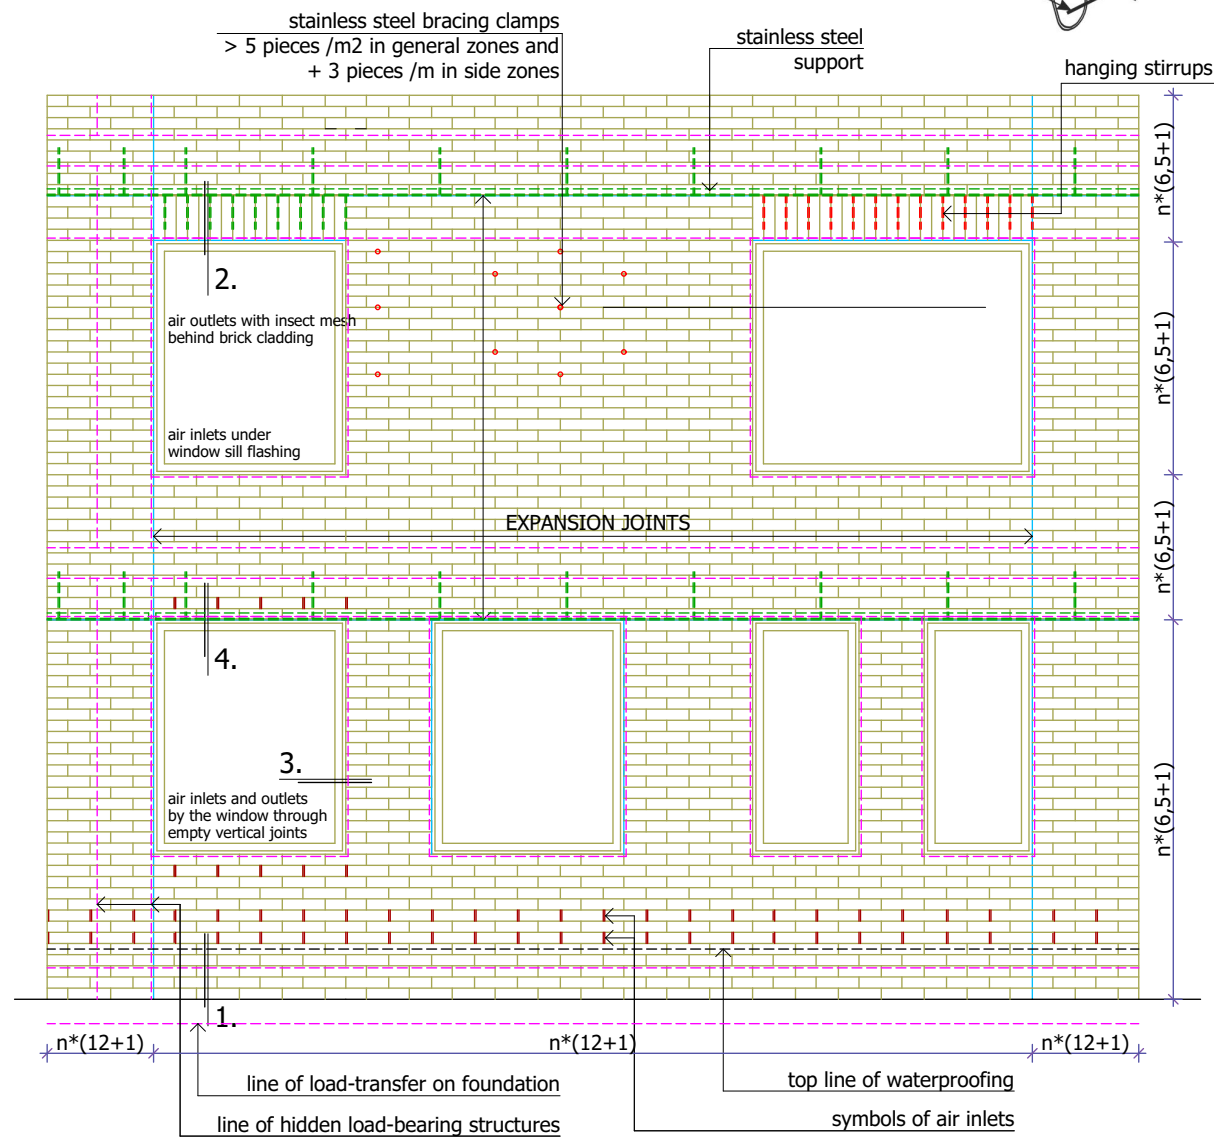
Arrangement of the expansion joints on the facade view

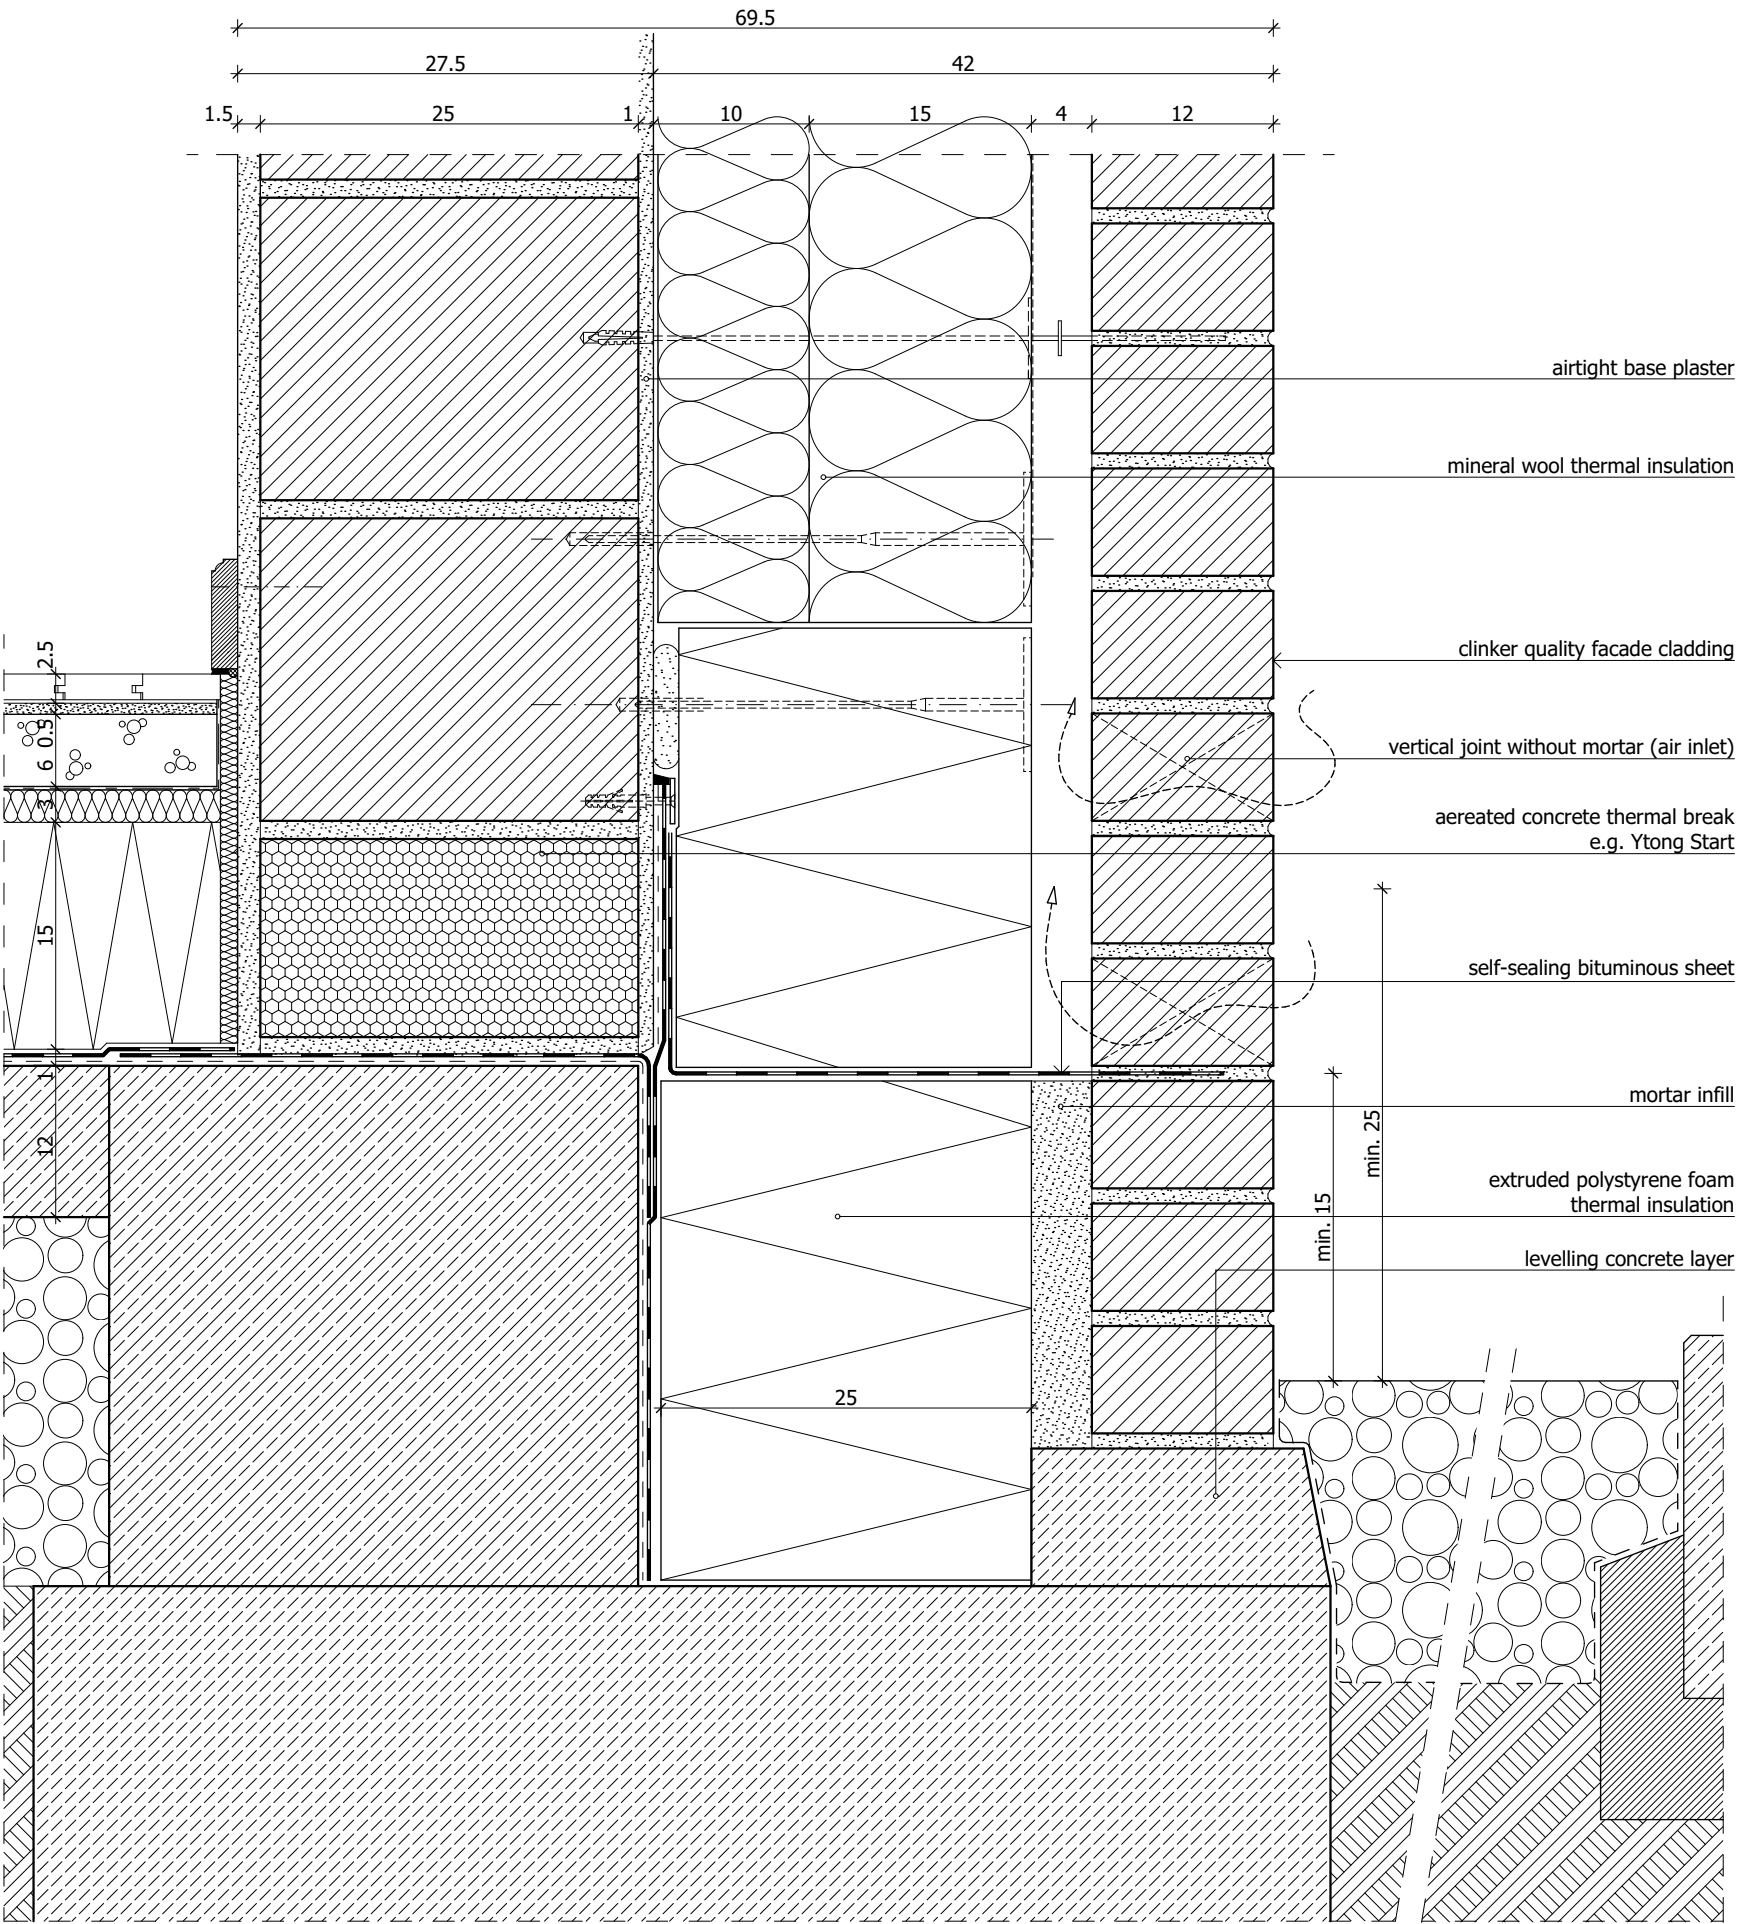
Footing Detail No. 1 S=1:5

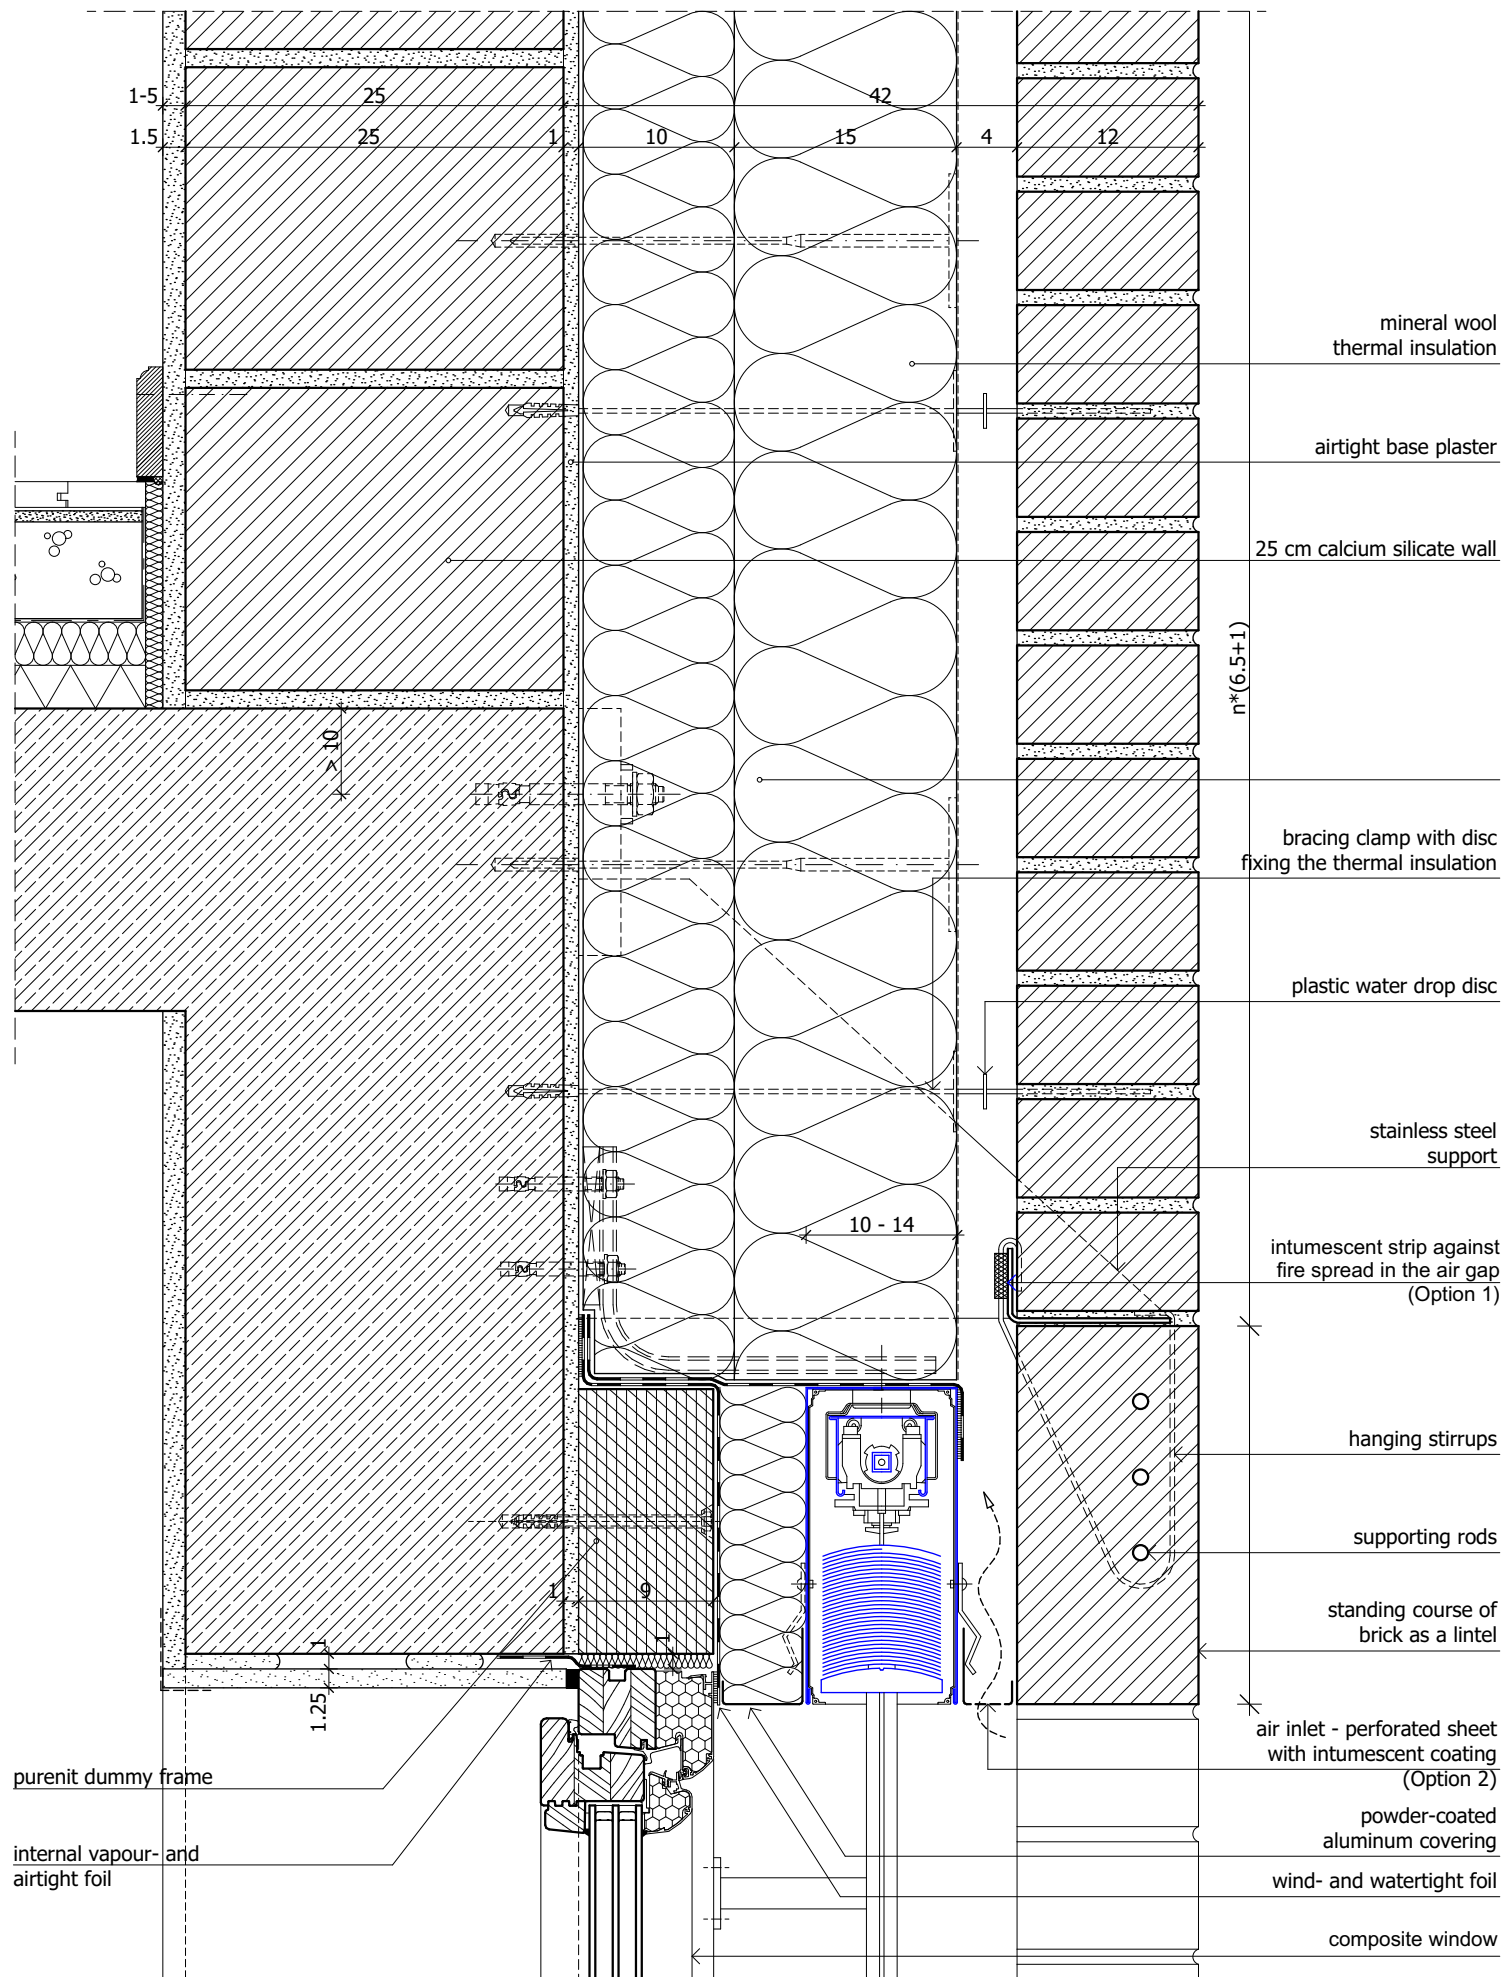
Window lintel and internal slab connection Detail No 2. S=1:5

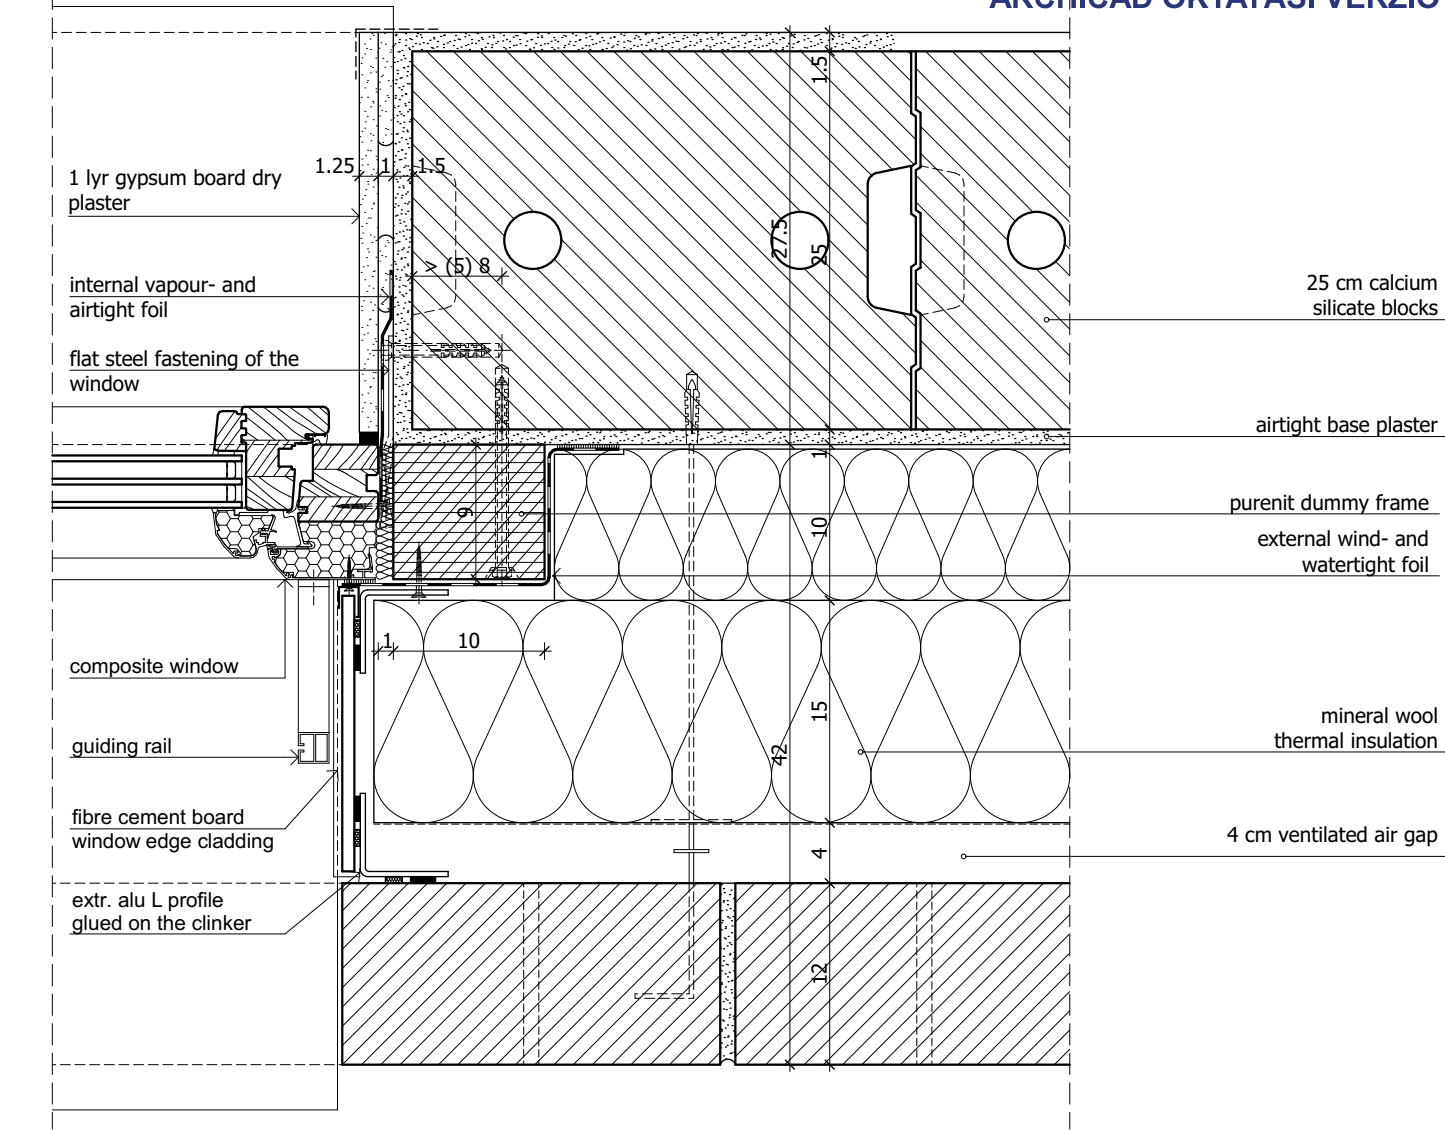
Window side Detail No. 3 S=1:5

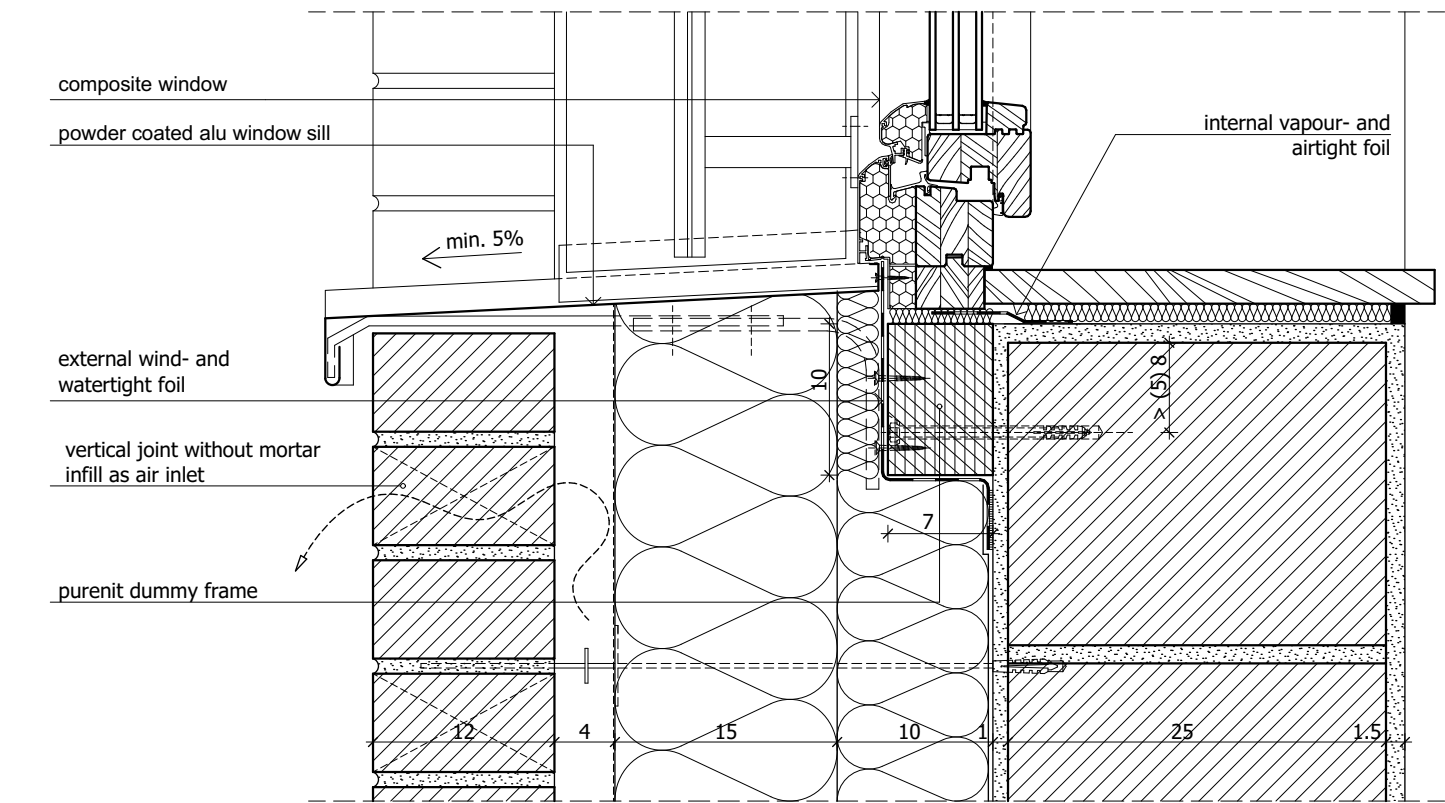
Window sill Detail No. 4 S=1:5
